2016 ILLICIT DISCHARGE INVESTIGATIONS IN OAKLAND COUNTY'S PORTION OF THE ROUGE RIVER WATERSHED

FINAL REPORT

**PREPARED FOR:
ALLIANCE OF ROUGE COMMUNITIES**

**PREPARED BY:
OAKLAND COUNTY WATER RESOURCES COMMISSIONER**

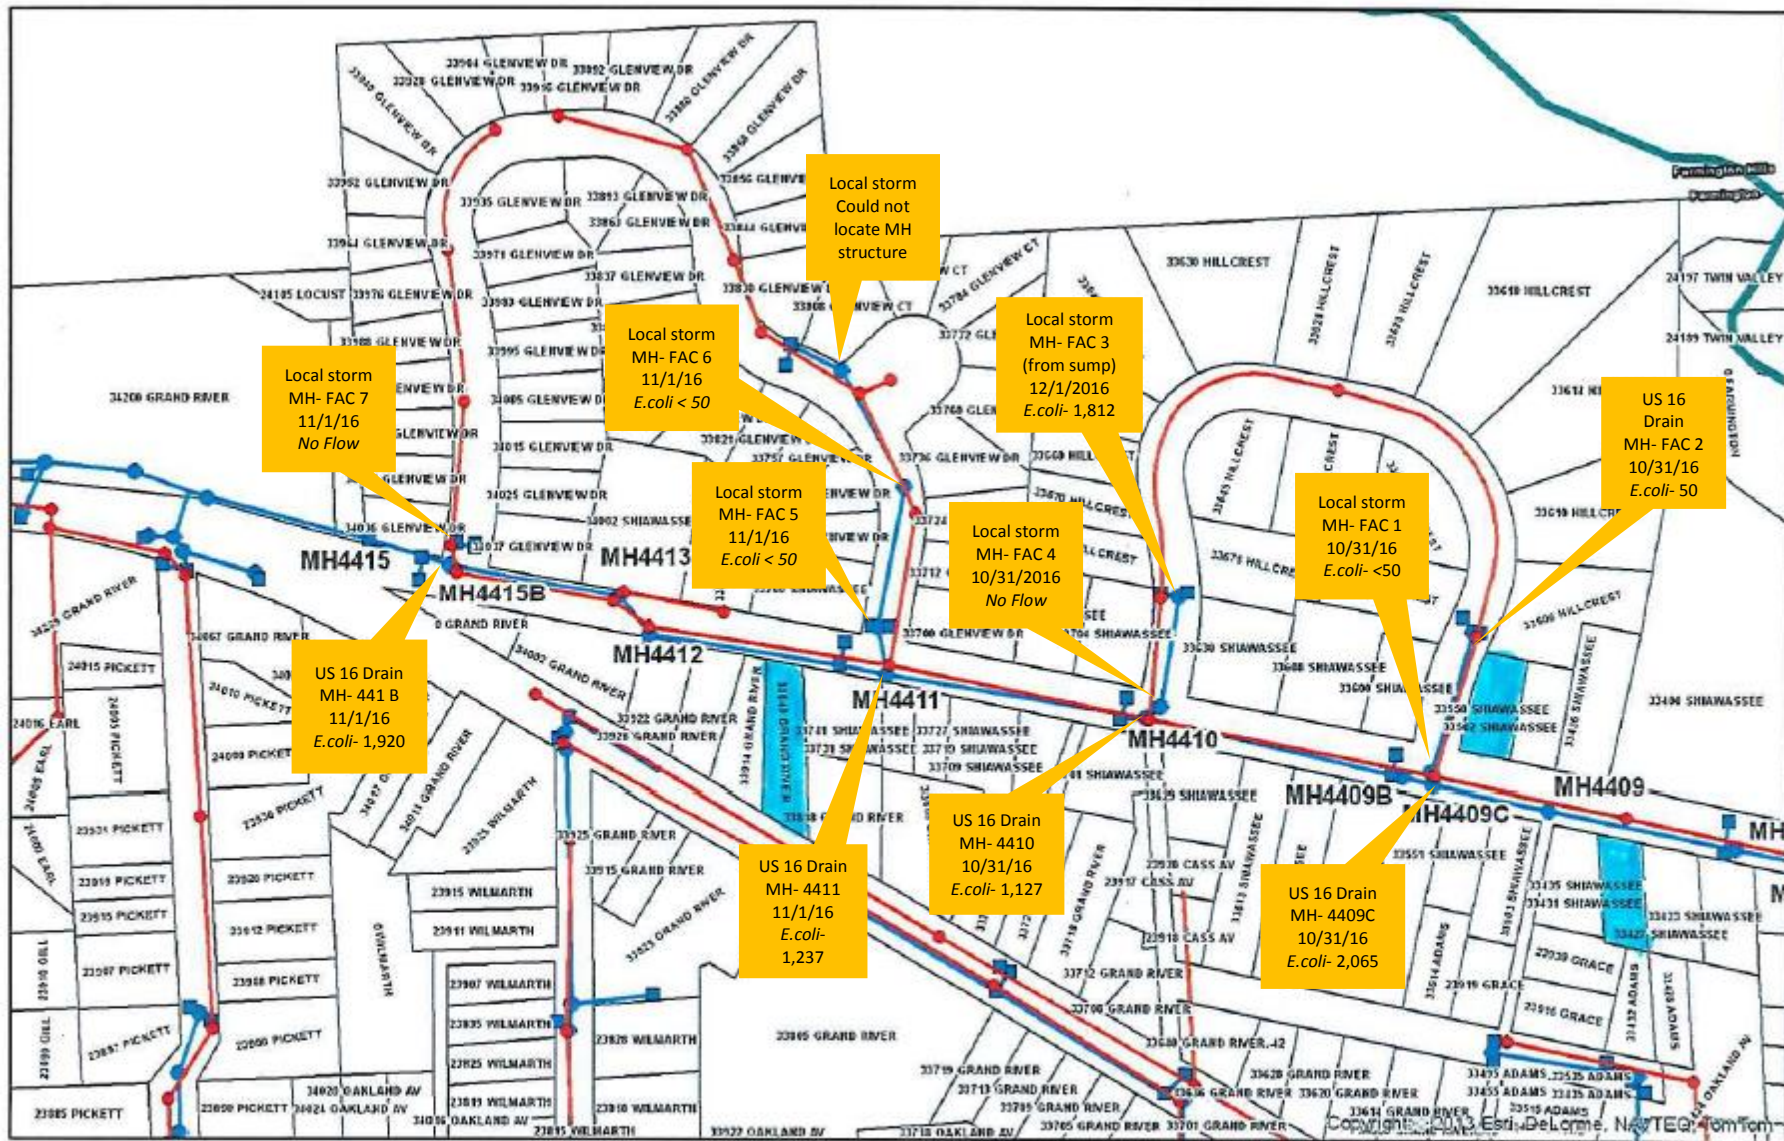
Figure 2: US 16 Drain Sampling and Investigation Location Map

In March of 2015, the City of Farmington completed a CCTV inspection of the US 16 Drain and sanitary sewer system along Shiawassee. Results identified three illicit connections to the drain with evidence of sanitary sewage. Inspections of the potential leaking bulk headed, sanitary overflow connections and side street storm lateral connections identified in the 2014 report did not reveal any additional issues. In December of 2015, the City with assistance from WRC, dye tested and confirmed sanitary connections from 3 houses, 33550 and 33431 Shiawassee Rd and 33840 Grand River Ave. to the US 16 Drain.

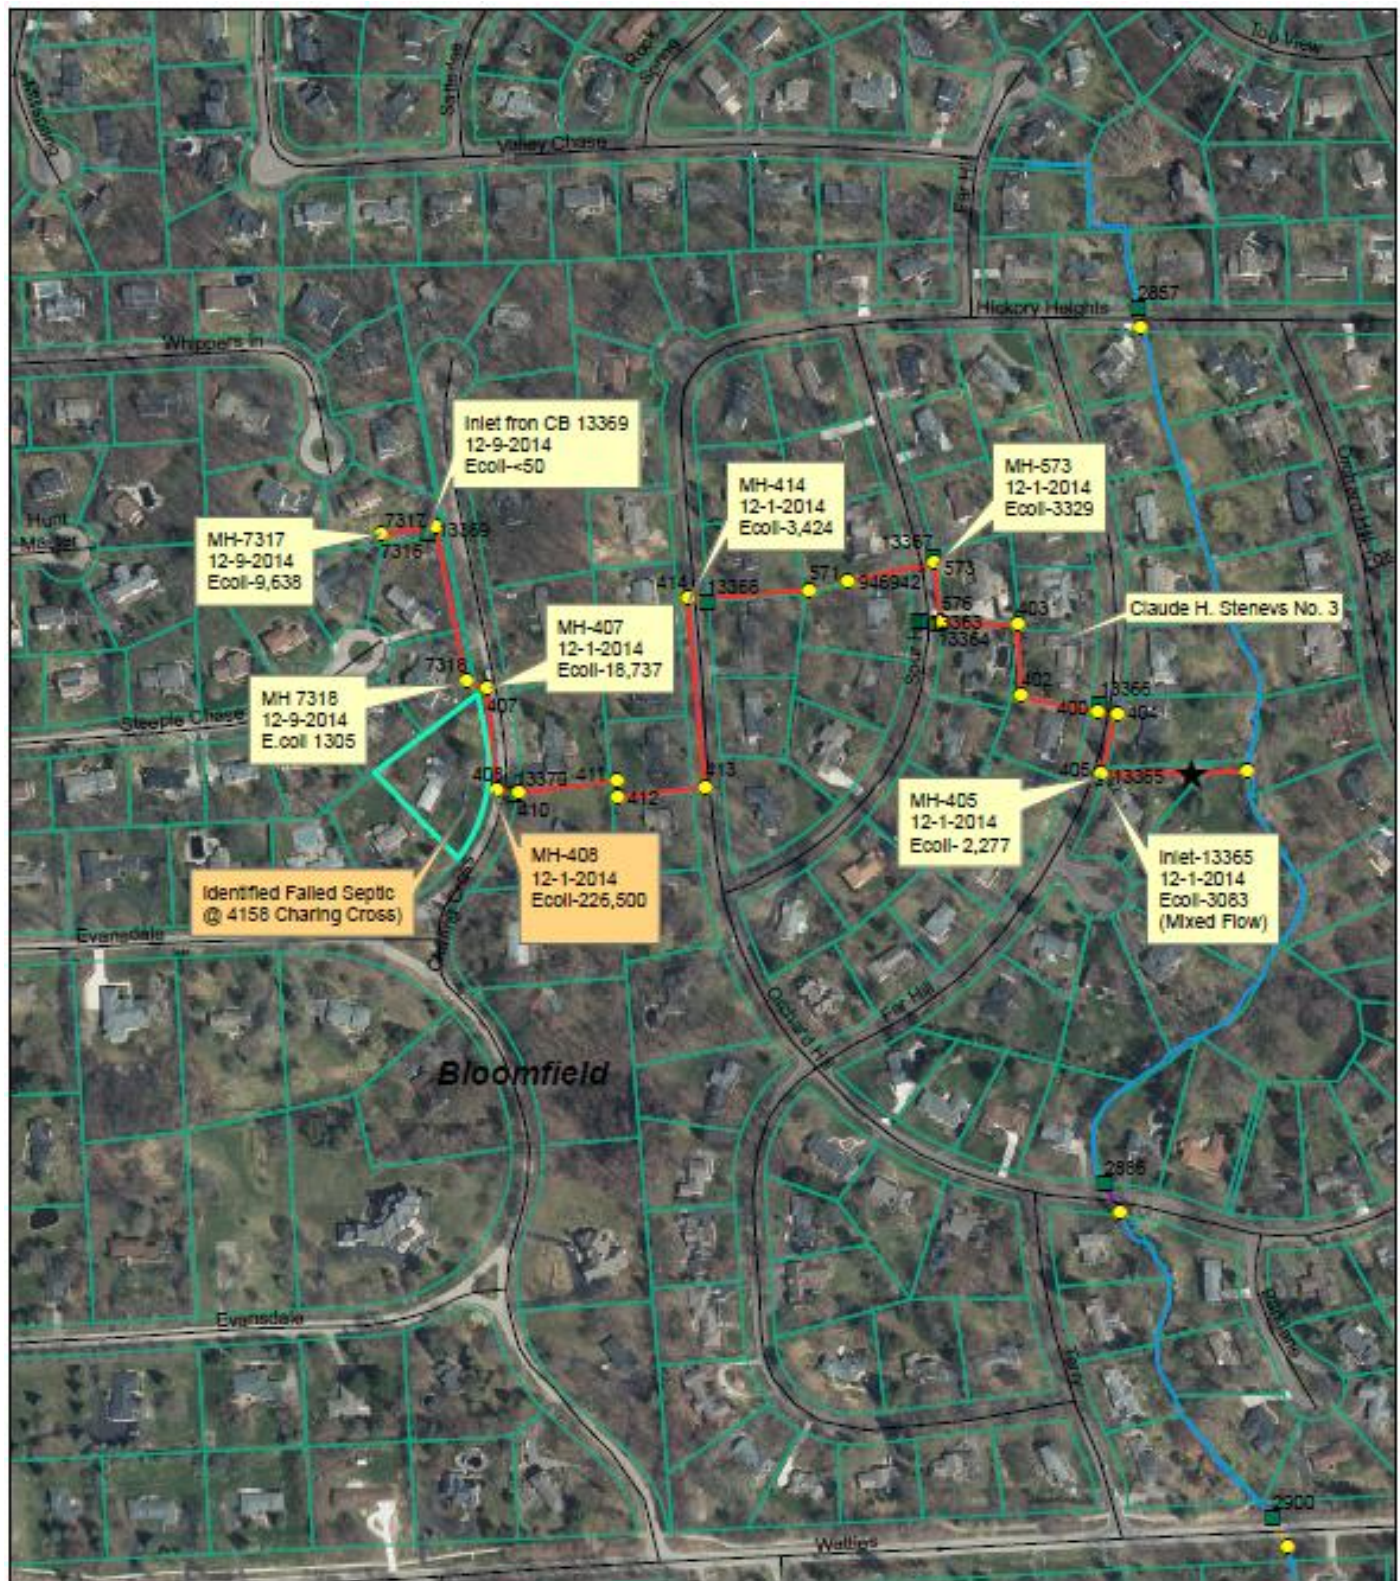
Figure 8: Claude H. Stevens No. 3 Drain Illicit Discharge Investigation

An examination of the property at 4158 Charring Cross indicated a sewage odor and ponding of sewage on top of the drain field. The drain field is located in the south east portion of the front yard of the property less than 50 ft. from the roadway. Soap suds were also evident in the road drainage ditch flowing into MH 408 to the north. The Health Department sampled effluent from the drain field and is in the process of notifying the Homeowner of the failing system. A location map and photo are attached as Figures 8 and 9.

- OCHD is in the Process of Notifying the Homeowner of the septic system failure.
- Bloomfield Twp. has already been notified and indicated that a sanitary connection is available along the southern edge of the property and that their ordinance requires a connection to the sanitary sewer. They will send the homeowner a notice to connect to the sanitary sewer as soon as notification of the failed system is received by the homeowner.
- Additional sampling of the drain will be conducted by WRC after corrective actions have been made to determine if any additional IDEP Investigations are needed to locate other potential sources.

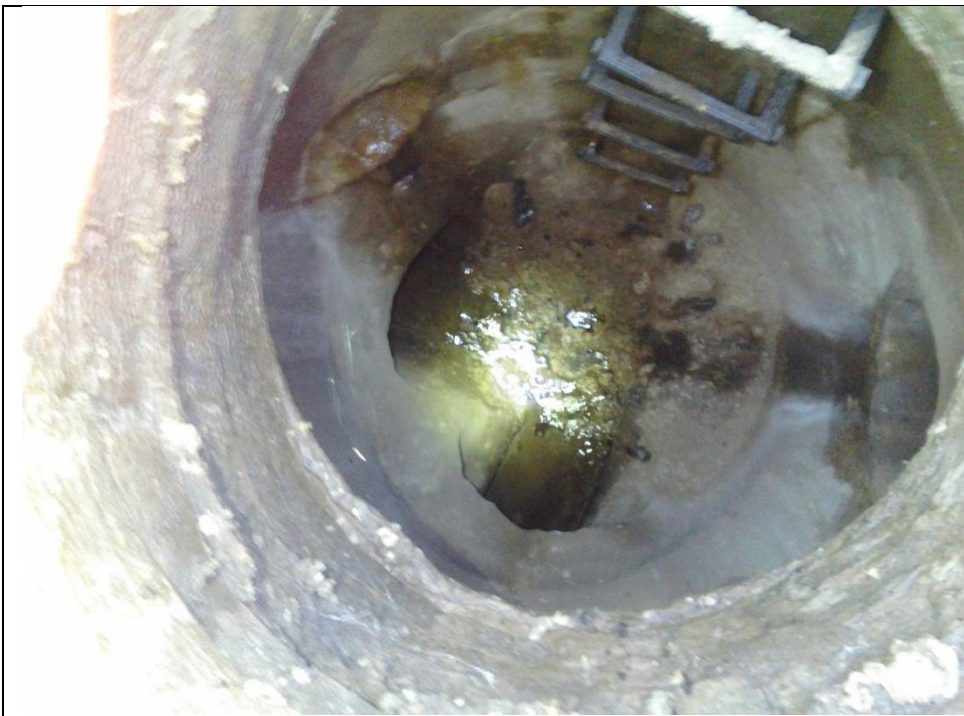
MH 6194 (071) Seminole & Adelein. Is N terminus for Seminole. NE, NW Road drain inlets were dry. Flow from W. on Adelein. Sampled.

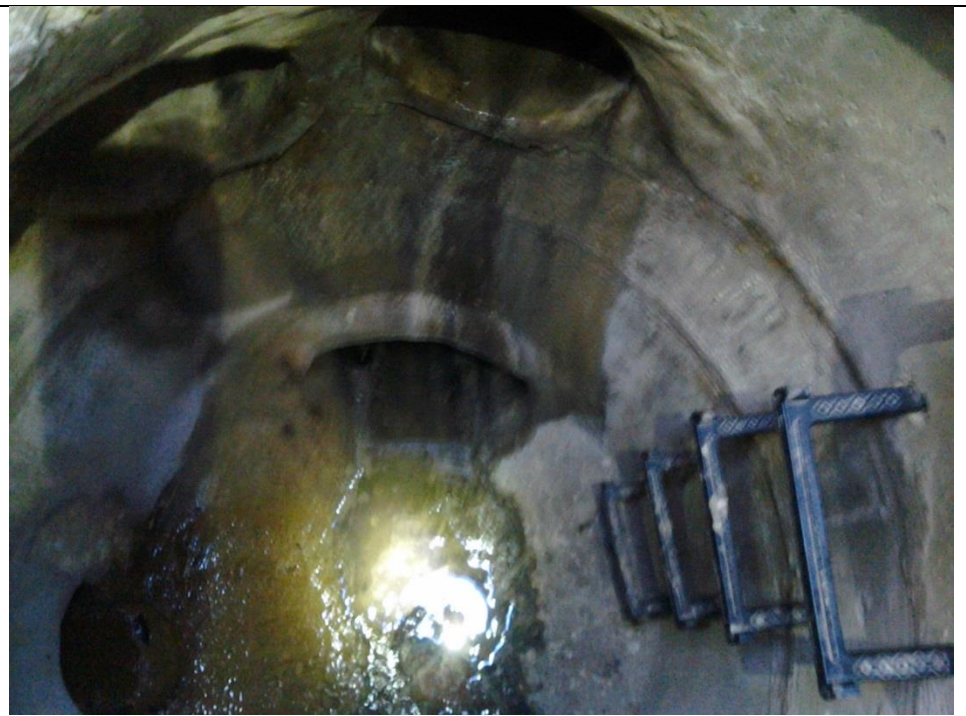
MH 6193 (065) @ 21847 Seminole. NW, NE road drain inlets were dry. Flow from N has grey water. Inlet from W has flow w possible sanitary pipe is under driveway at 21823 Seminole.

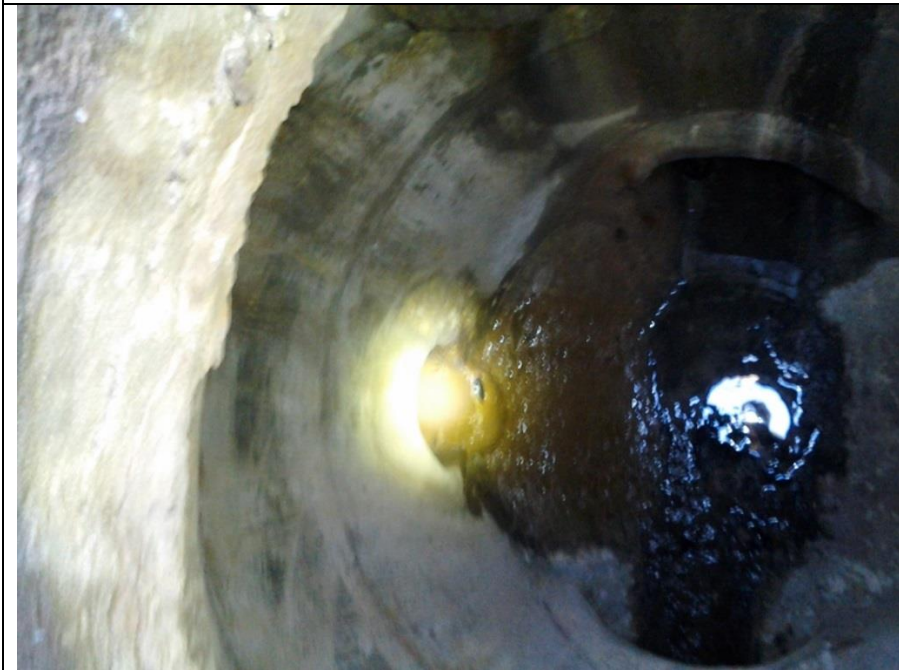
Tap with flow from W. tied into MH 6193 (065). Pipe runs under driveway for 21823 Seminole. May be an illicit connection

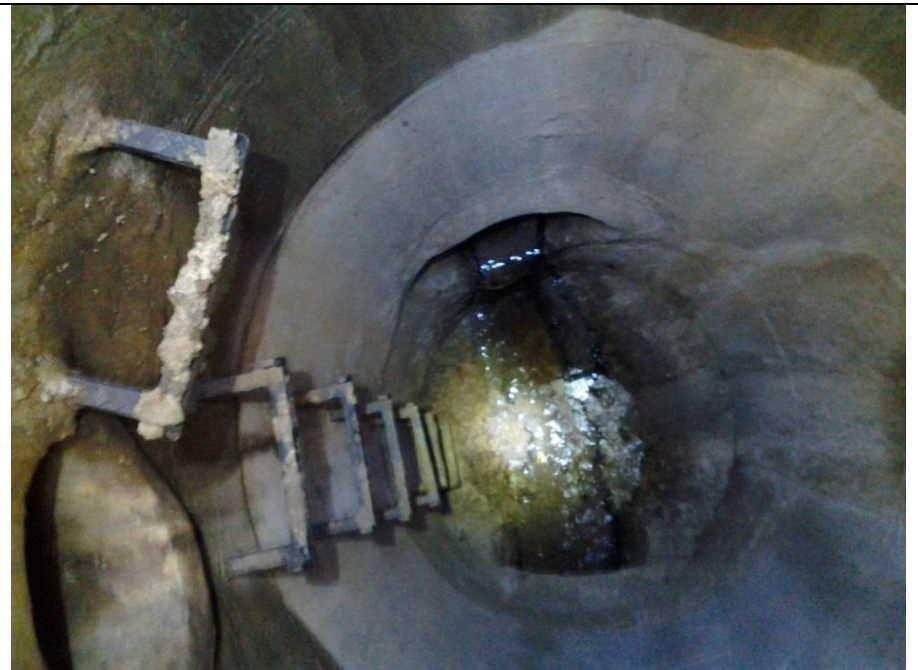
6192 (059) @ 21745 Seminole. W & E Road Drain Inlet were dry. Grey water, toilet paper, grease in flow from N. Sampled

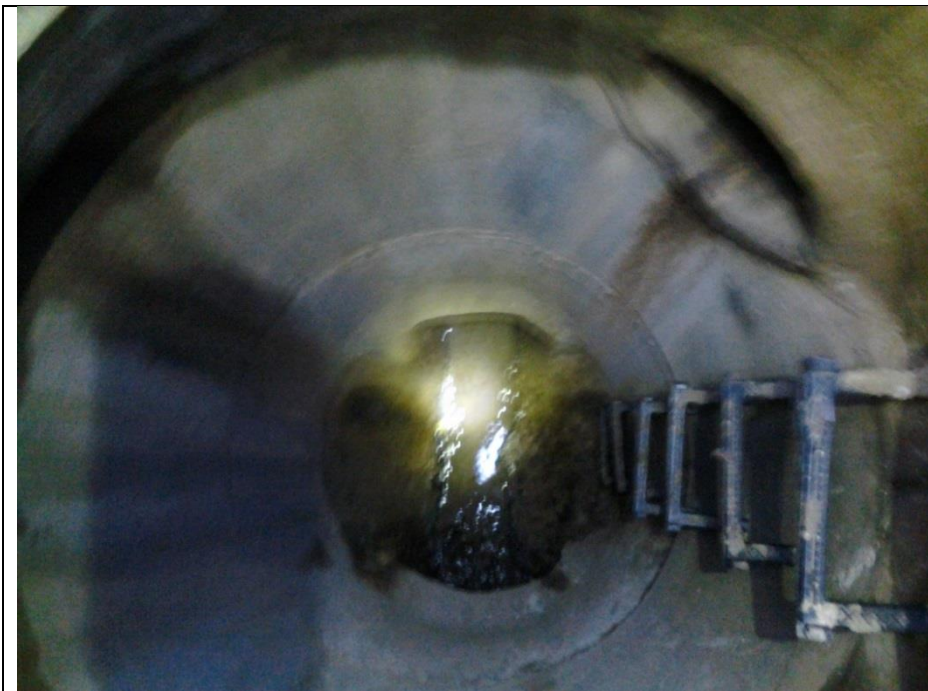
MH 6191 (053) @ Park on E. Seminole. NW & NE road inlets were dry. Flow from N. has grey water & possible toilet paper. Sampled

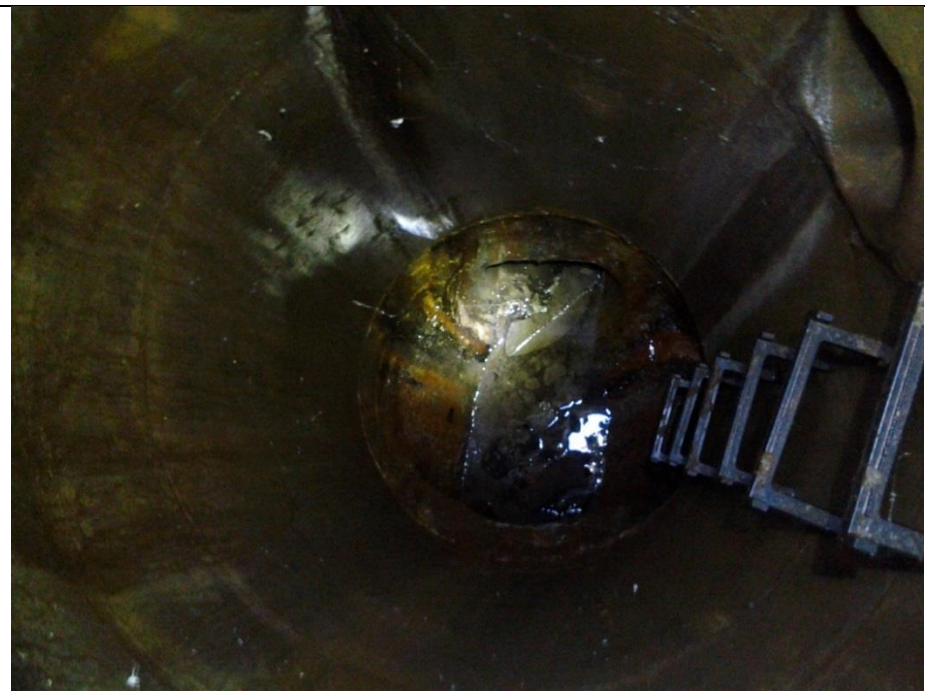
MH 6190 (045) Shiawassee @ Seminole. MW,NE,SW,SE Inlets for road drain ditches were dry. Additional E&W inlets for Shiawassee Rd. (not in GIS) w staining. Flow from N .has toilet paper

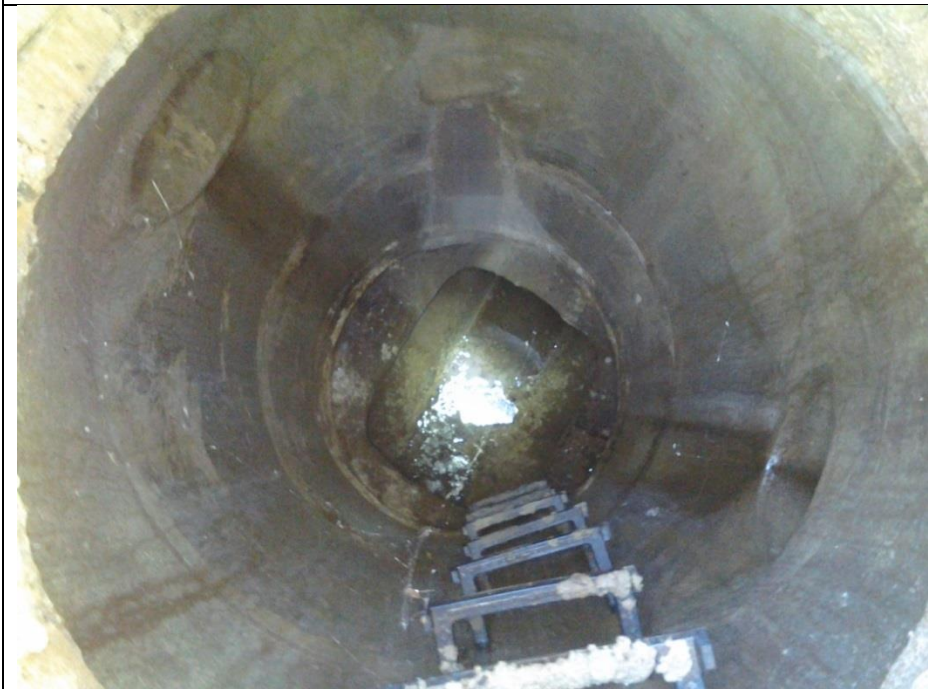
MH 6241 (291) @21394 Seminole. NW, NE, road drain inlets were dry. Flow from N. on Seminole was clear. Sampled

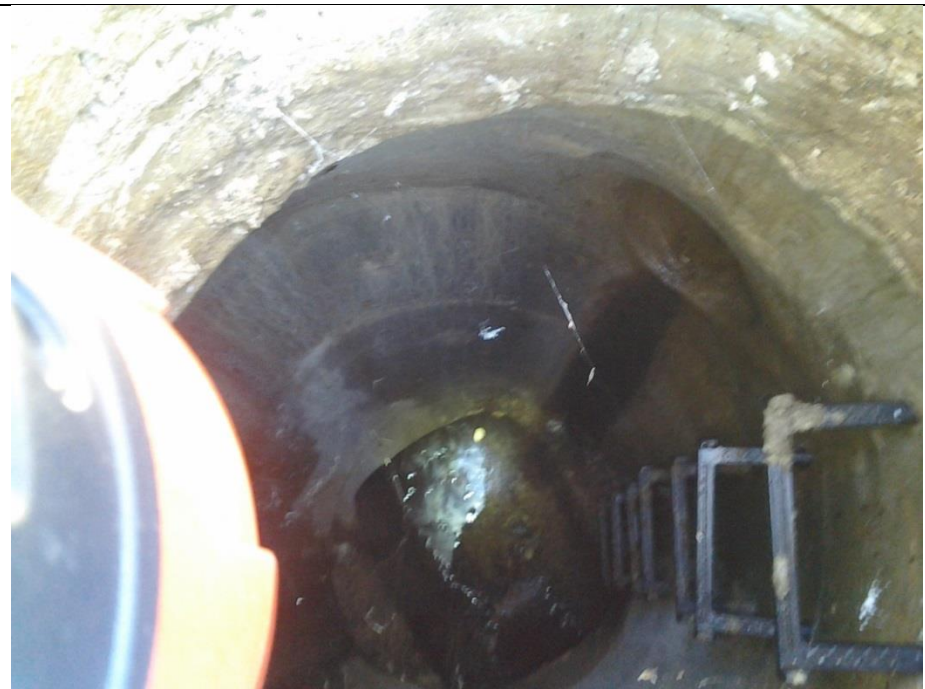
concentration being greater than 1,002,500 cfu/100 mL at manhole 6240 located on Seminole, north of Sedalia. A summary of the results is provided in the table below. A complete table of sampling results can be found in Appendix C.

MH 6240 (269) @ 21351 Seminole, SE, SW road drain inlets were dry, Toilet paper, grease ,sanitary, in flow from N. Sampled

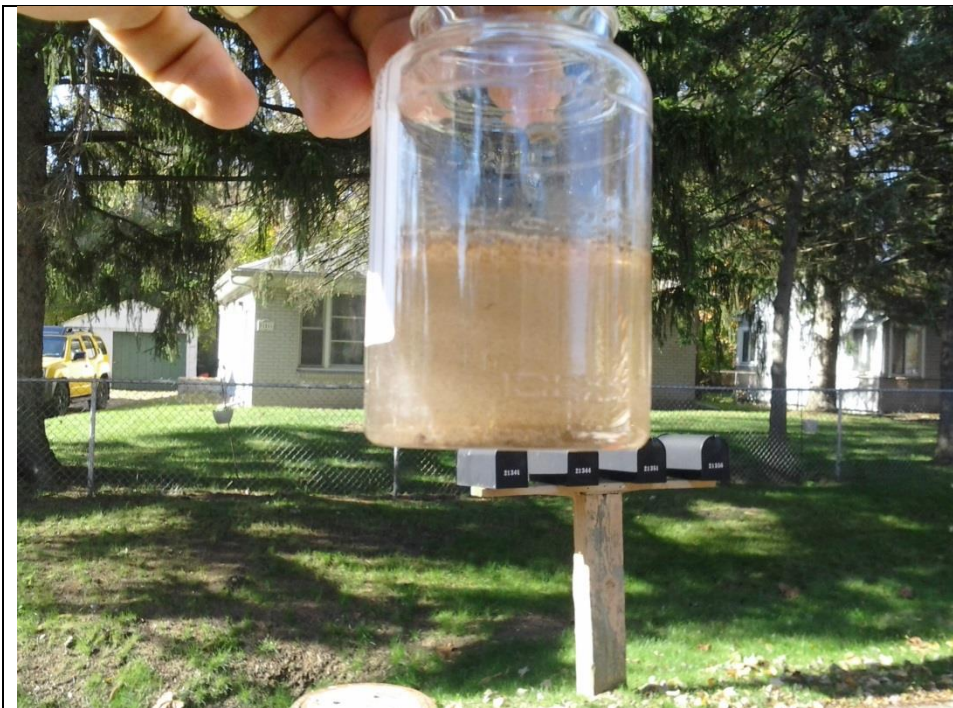
Sample from MH 6240 (269) @ 21351 Seminole. Sample from MH, Toilet paper, grease, and sanitary debris

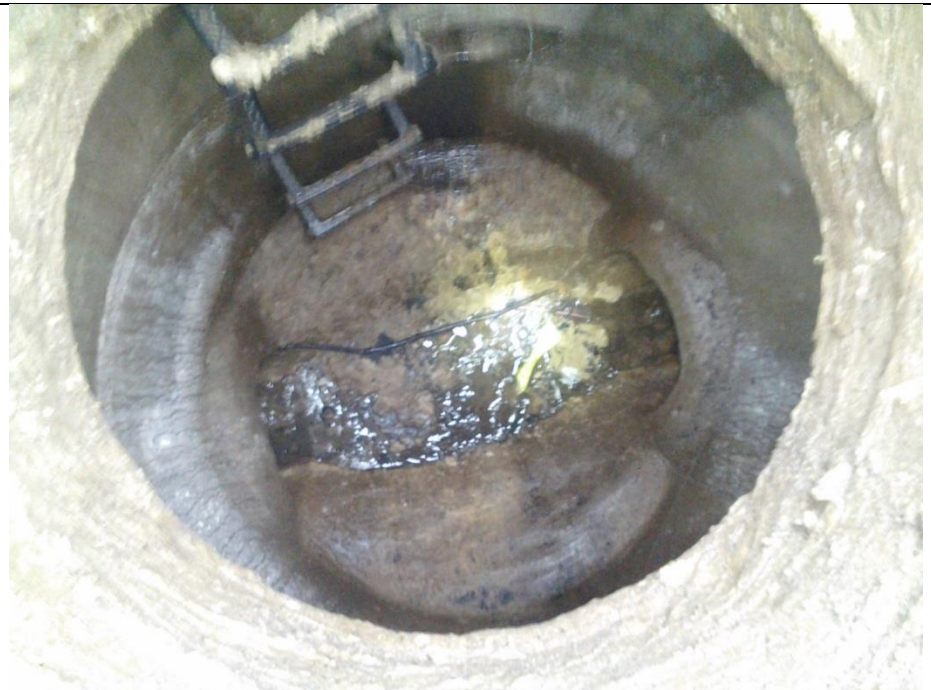
MH 6186 (018)@21596 Poinciana. Low flow in Main channel sampled. Possible grey water. E &
W Rd. drain CB inlets were dry.

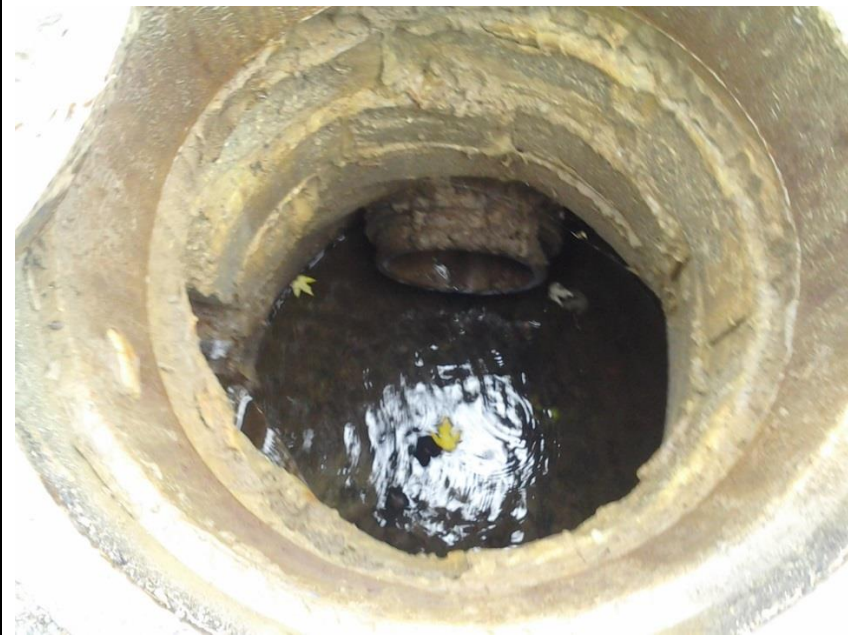
CB 13781 (232) Connected to MH 6233 (226). @27207 Shiawassee Inlets W&S. S Inlet has flow, possible sump connection

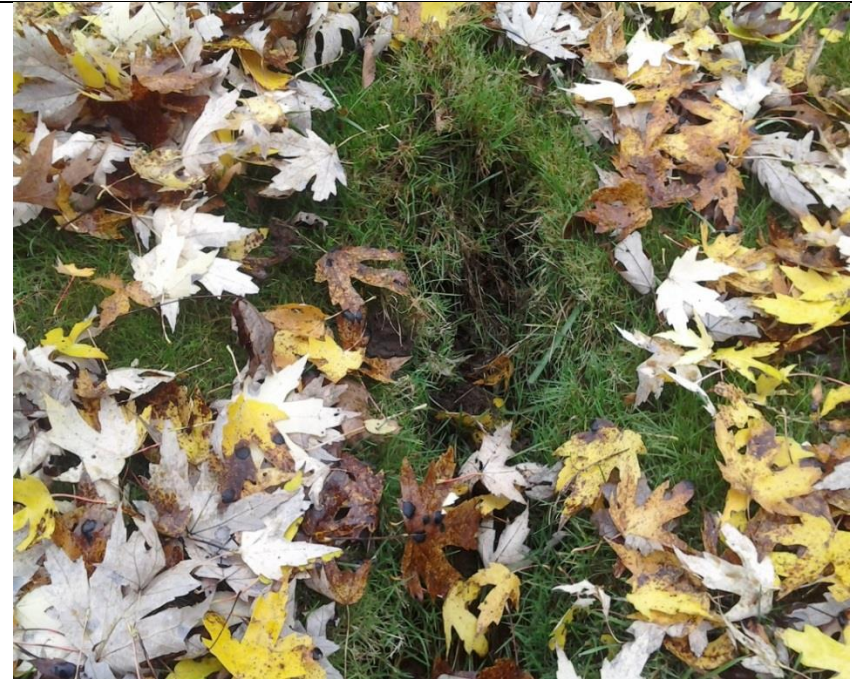
Ditch line from Sump@27207 Shiawassee to CB 13781 (232)

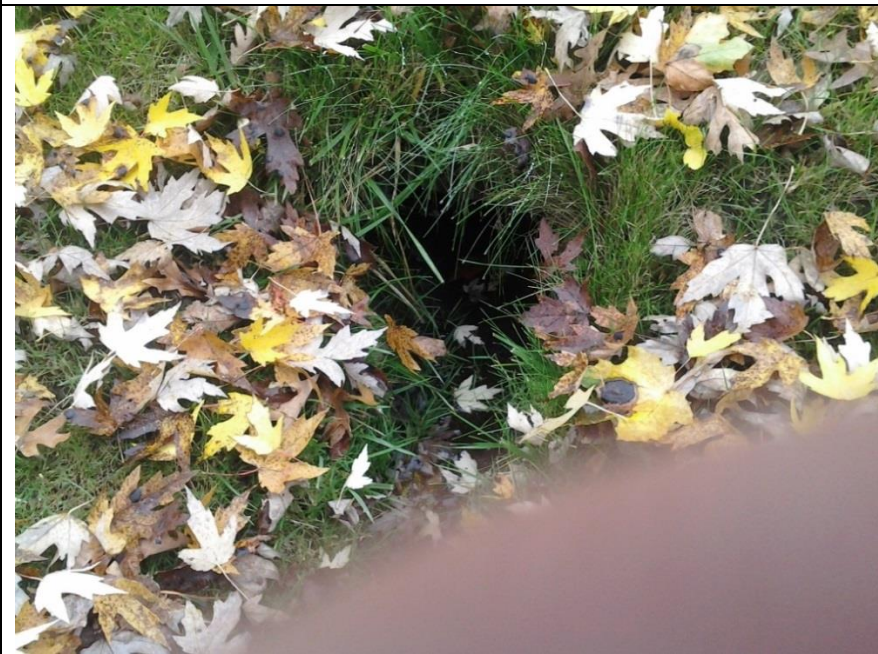
Sump outlet from 227207 Shiawassee to ditchline

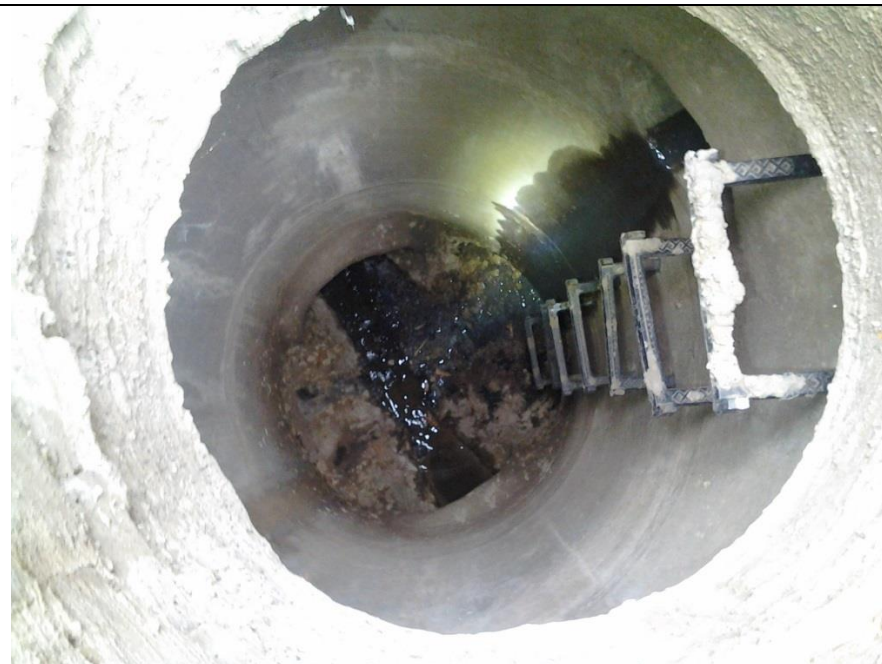
MH 6232 (220)@21349 Poinciana. W. Rd Drain CB w. flow & staining. Sampled flow in channel. Investigated CB 13179

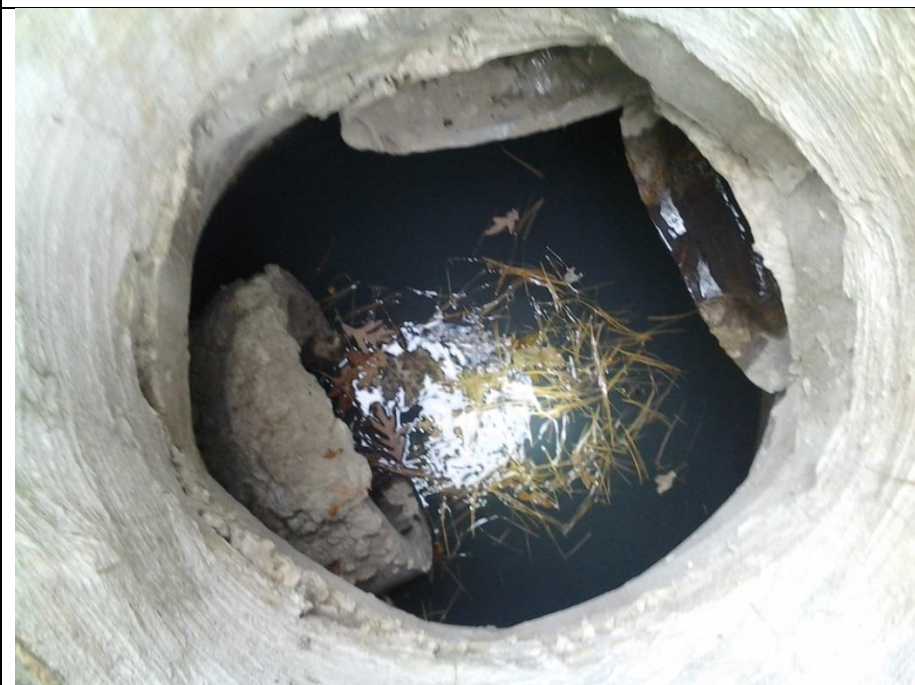
CB 13179 Connected to MH 6232 (220). @ 21349 Poinciana. Grey water in sump. Sampled. Inlets from W & S

Seminole	21159	6 " W	Unknown lead could be sanitary	Need to verify nature of connection
Poinciana	6232	CB	Suspect discharge to connected CB Sump 13779	Investigate to locate discharge source.
Negaunee	6223	6"	Unknown enclosed drain system connected to CB 13758	Determine source, connectivity, & potential for illicit connections
Indian	6209	12" E	Connection with non-sanitary flow identified	Conduct investigation to find flow source.
Indian	6184	NA	Animal feces found in MH	Consider alternative BST methods

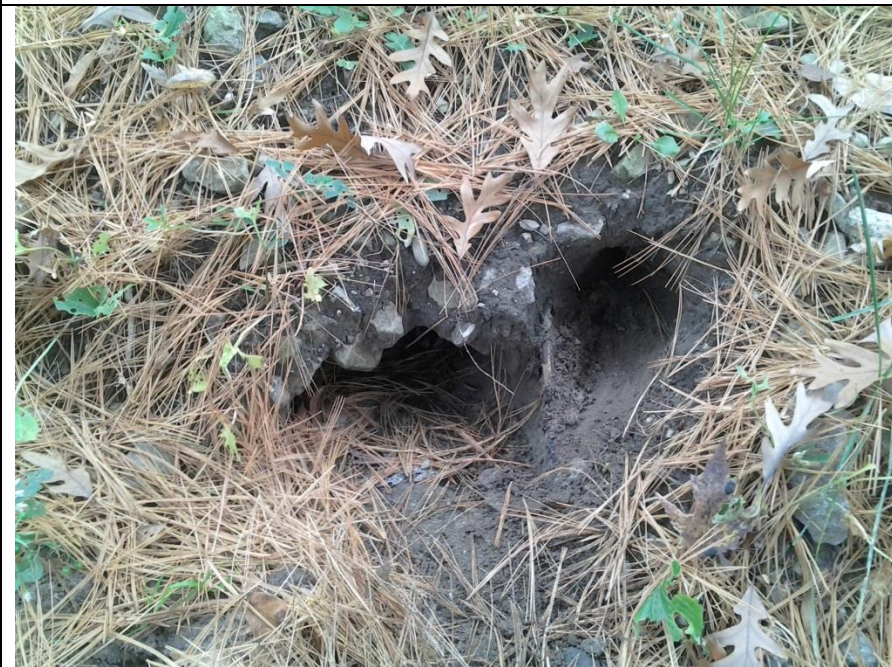
Ditch line N. of CB 13179 @ 21349 Poinciana. Possible Inlet to older drain system. Connection unknown.

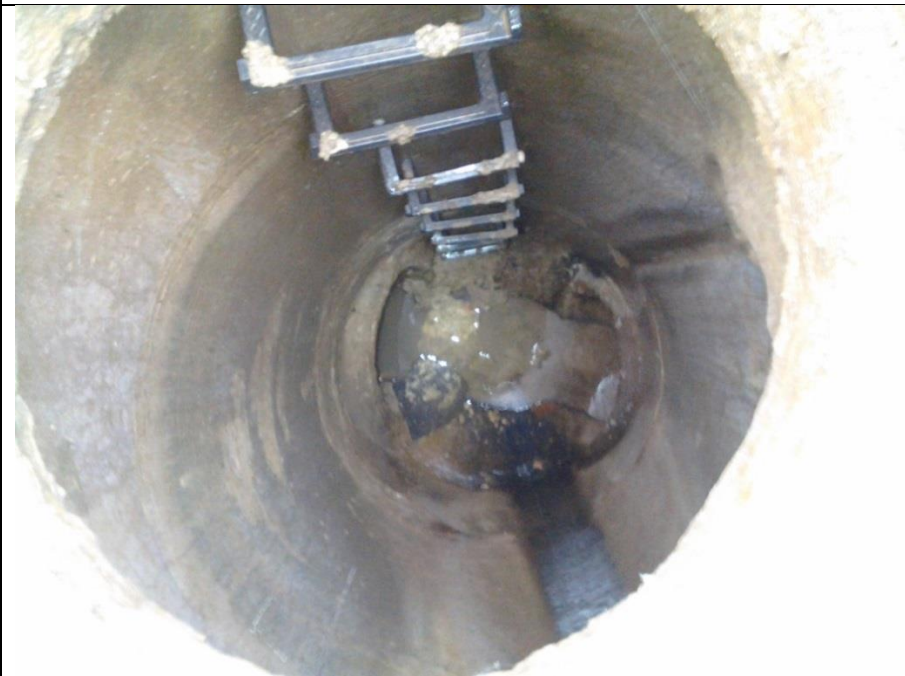
MH 6230 (204) @ 21159 Poinciana. Flow From N. possible get water & toilet paper, sampled Trickle flow from N & E Rd. Drain CB Inlets, not sampled

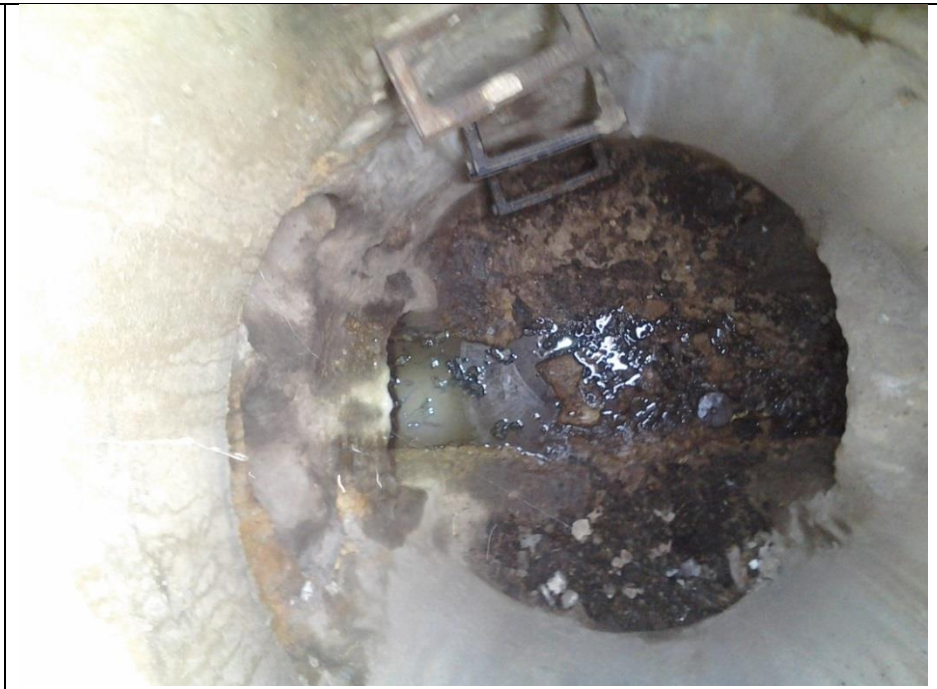
MH 6183 (001) @21545 Negaunee,. Dry MH. Grey water pooled in outlet. Sampled

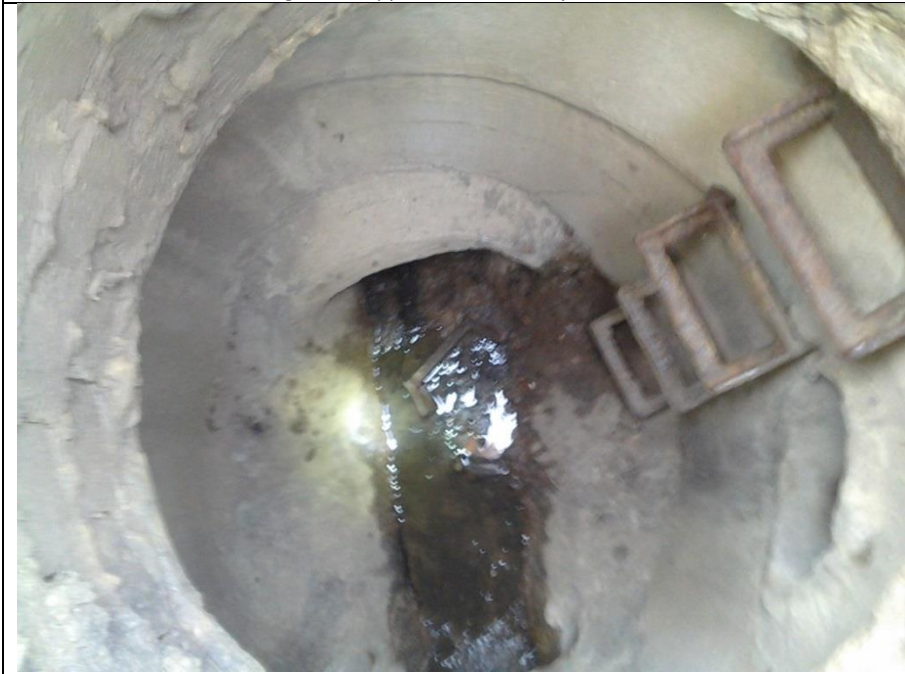
MH 6225 (165) N. Side of Shiawassee@ Negaunee. W & NE Rd. CB Inlets were Dry. Sampled flow from N. Possible sanitary debris

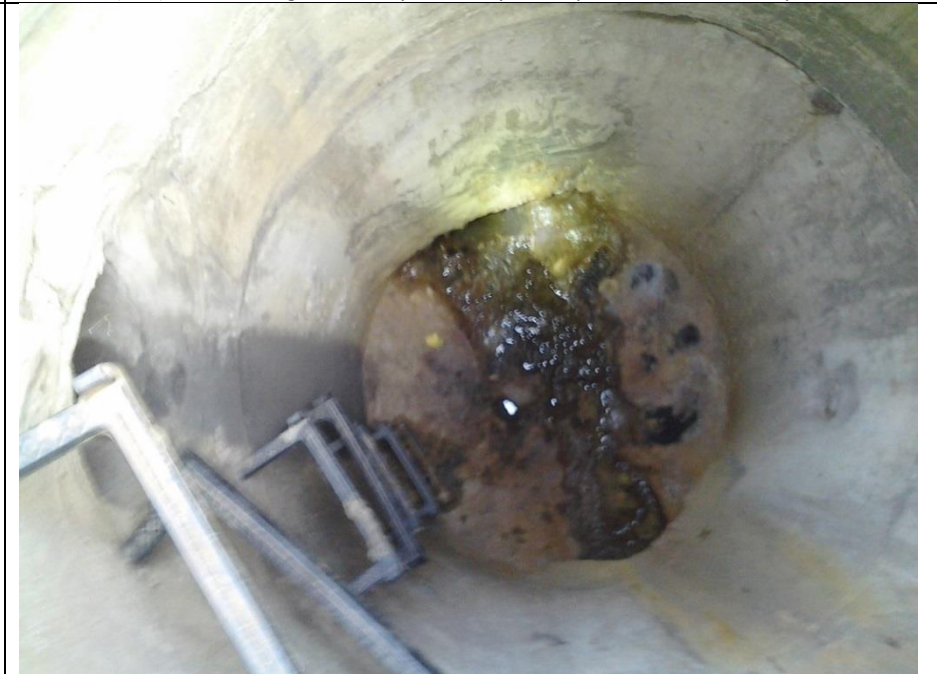
MH 6224 (157) S. Side of Shiawassee @Negaunee. Sampled. Flow from N. W & SE Rd CB Inlets were dry. Possible toilet paper up in pipe. Sampled

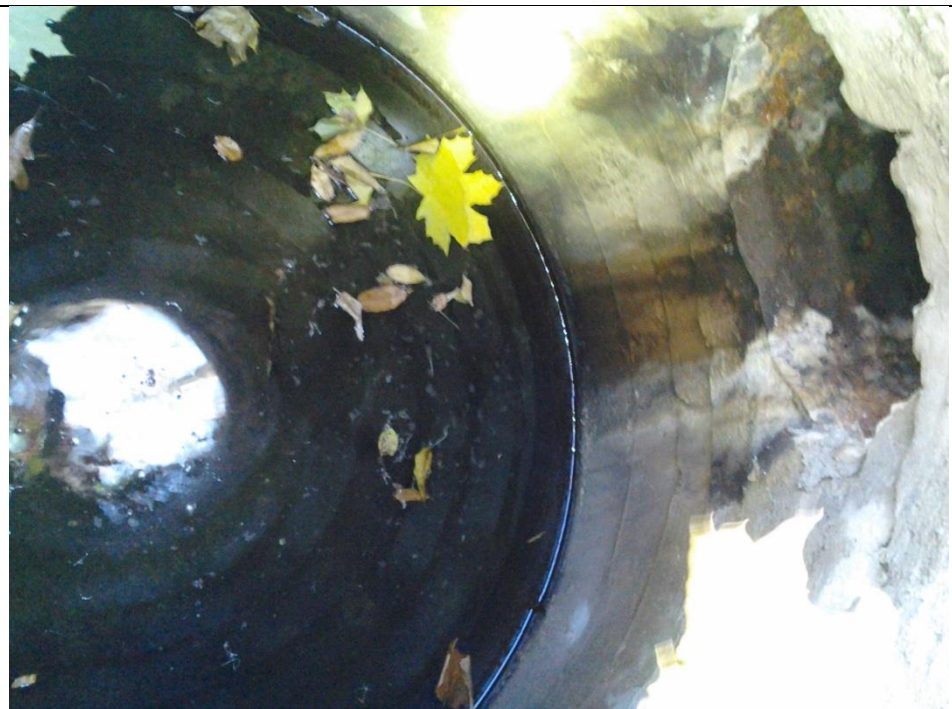
6223 B. CB 13779 connected to MH 6223 w inlet from N. from unknown drain. Sump sampled

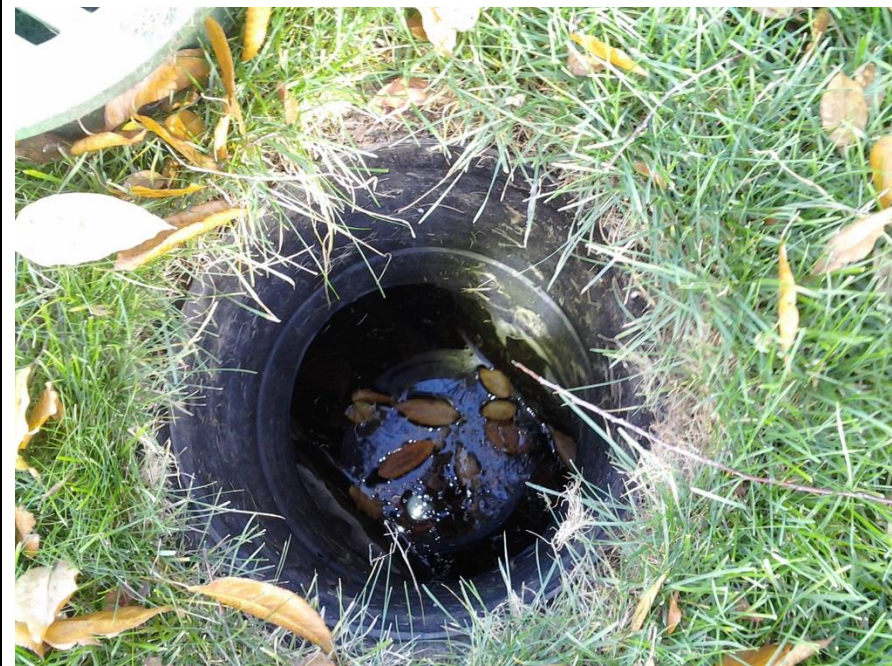
6223 C. Unknown drain connectd to CB 13779 with with unknow connections from N. & S

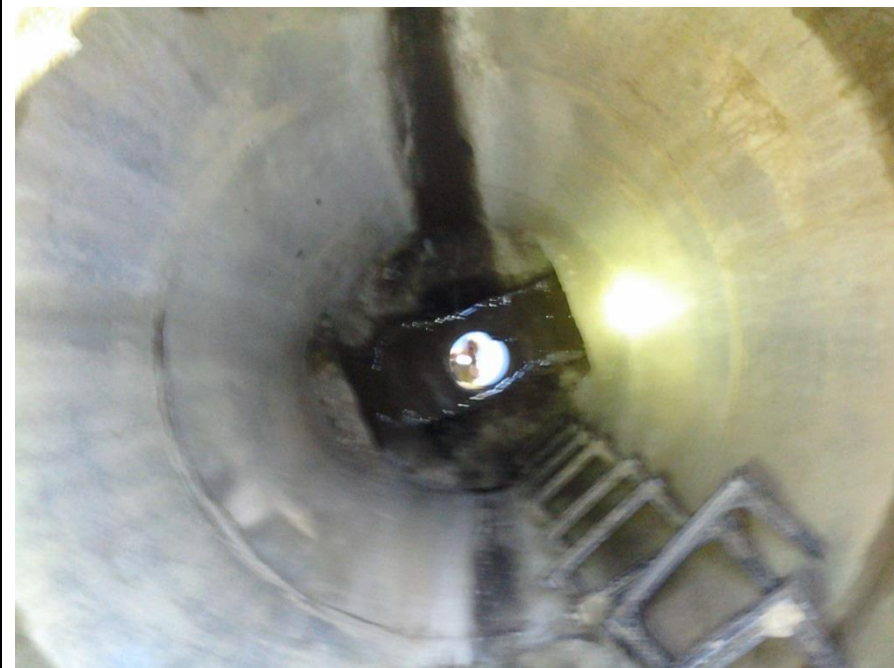
MH 6219 (119) @20963 Negaunee. Sampled flow in main channel from N. Staining on E. Wall. E&W Rd. Drain Inlets were dry

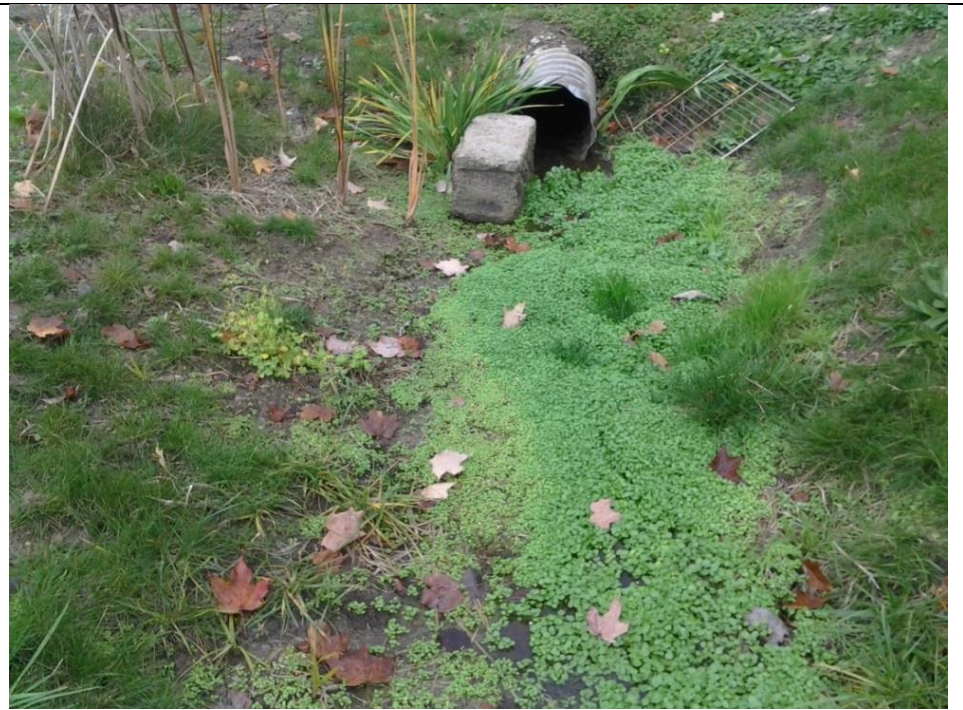
Flow from driveway culvert to ditch line S to inlet 13746 (111). Could hear gurgling sound coming from up in culvert. Flow sampled. Probably a connected sump pump. Sampled flow.

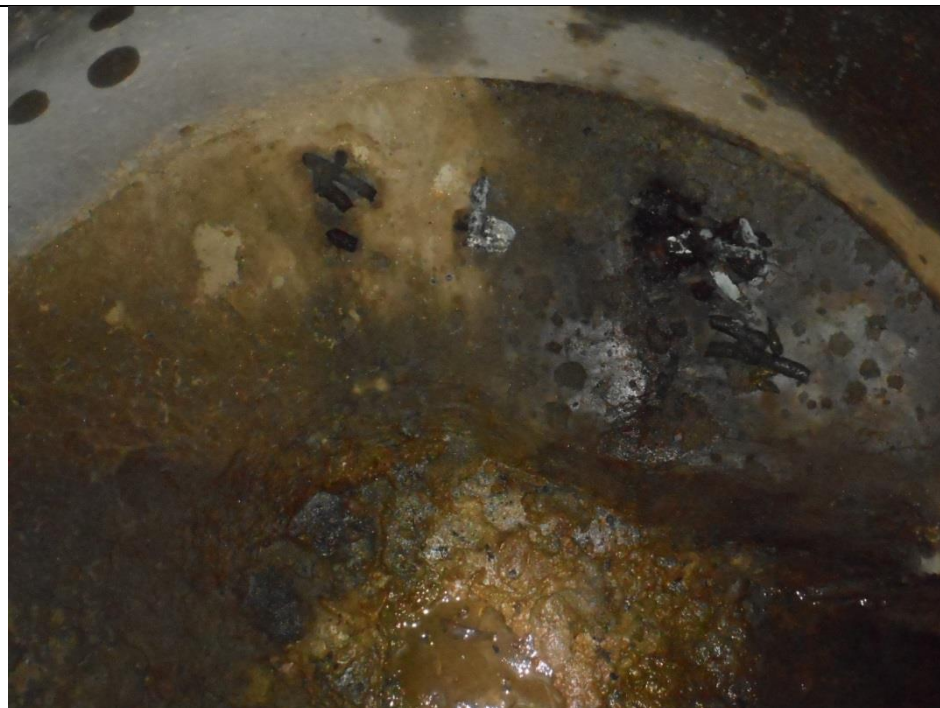
No additional connections were identified from drain segments inspected on Adeline St., Emmet St., Sedalia St. Byron St. and Indian St. No additional illicit discharge issues were found during the visual examination of manholes, connected catch basins and drainage ditches. Evidence of animal feces was noted in the upper terminus manhole (6184) on Indian St.

MH 6215 (091) evidence of animal feces in MH.

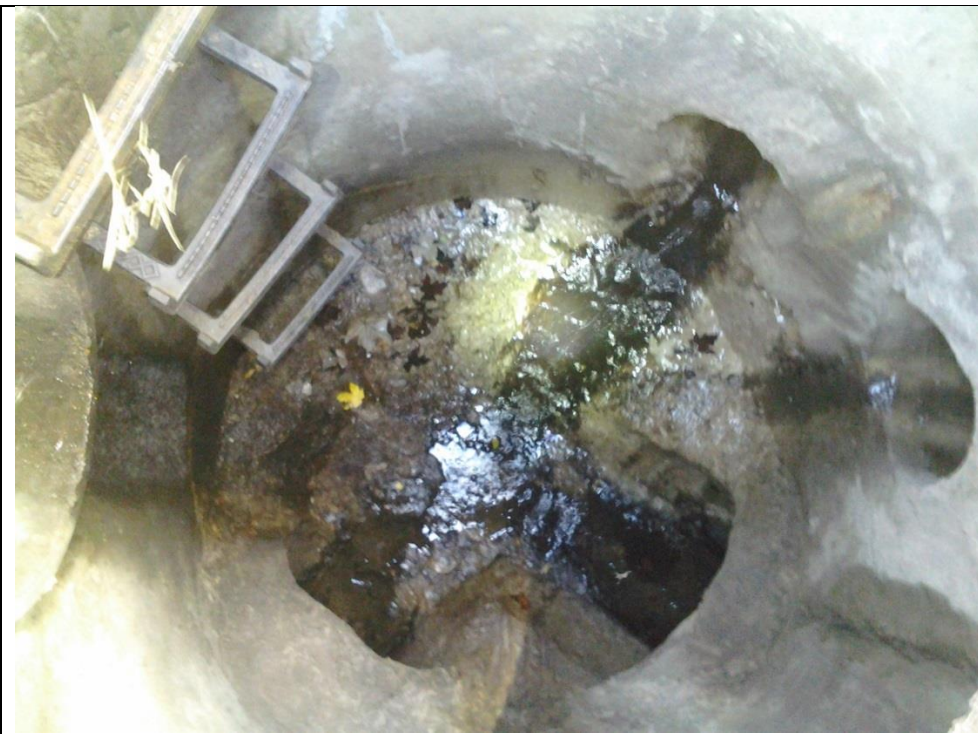
MH 6195 (081)@ Adeiline @ Inkster Rd. Upper Terminus with latreal connection to seminole St. E. Flow from N. connected local storm sampled. SW & NE Rd. Drain CB Inlets were dry.

Street	MH ID / Address	Connection	Potential Issues	Recommended Follow-up Actions
Inkster	6195	12" N	Suspect flow from local storm drain	Additional sampling and investigation needed
Inkster	6248	6" NW	Unknown inlet with staining connected to MH	Determine source, connectivity & potential for illicit connections
Inkster	6243	12" N	Unknown enclosed drain system connected to CB 13802	Determine source, connectivity, & potential for illicit connections
Seminole	6193	12" W	Unknown enclosed drain system connected to MH	Determine source, connectivity & potential for illicit connections
Seminole	6191	12" NW	Unknown enclosed drain system connected to CB 13703	Determine source, connectivity & potential for illicit connections
Seminole	21705	6 " W	Unknown lead could be sanitary	Need to verify nature of connection
Seminole	21351	6 " W	Unknown lead could be sanitary	Need to verify nature of connection
Seminole	21317	6 " W	Unknown lead could be sanitary	Need to verify nature of connection
