2016 ILLICIT DISCHARGE INVESTIGATIONS IN OAKLAND COUNTY'S PORTION OF THE ROUGE RIVER WATERSHED

FINAL REPORT

**PREPARED FOR:
ALLIANCE OF ROUGE COMMUNITIES**

**PREPARED BY:
OAKLAND COUNTY WATER RESOURCES COMMISSIONER**

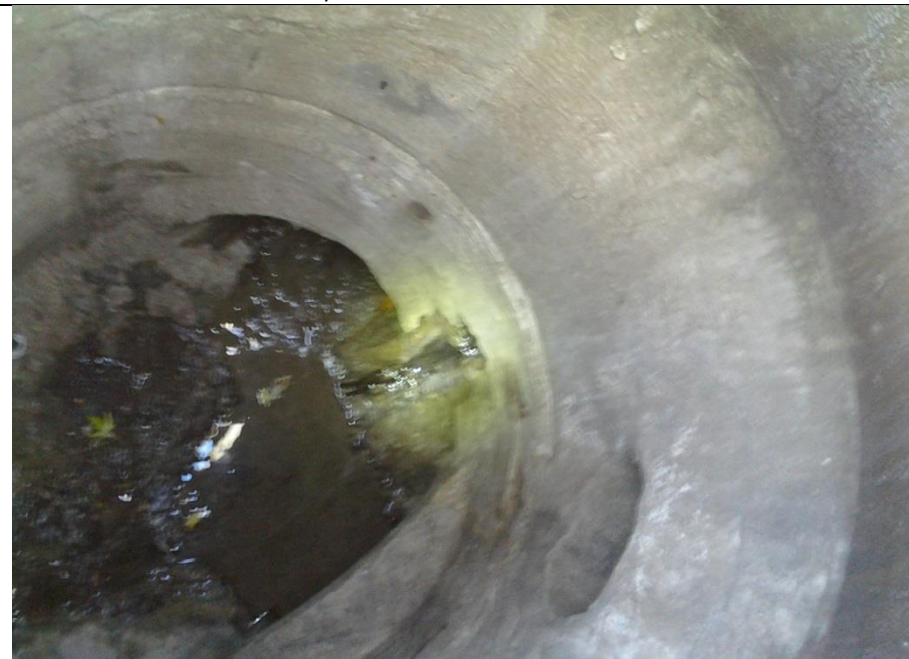
MH 6248 (321) Inkster Rd @ Sedalia. Flow From N. & S sampled. Lateral connection E. to Seminole St. unknown 6" connection with staining in NE corner of MH.

Street	MH ID / Address	Connection	Potential Issues	Recommended Follow-up Actions
Inkster	6195	12" N	Suspect flow from local storm drain	Additional sampling and investigation needed
Inkster	6248	6" NW	Unknown inlet with staining connected to MH	Determine source, connectivity & potential for illicit connections
Inkster	6243	12" N	Unknown enclosed drain system connected to CB 13802	Determine source, connectivity, & potential for illicit connections
Seminole	6193	12" W	Unknown enclosed drain system connected to MH	Determine source, connectivity & potential for illicit connections
Seminole	6191	12" NW	Unknown enclosed drain system connected to CB 13703	Determine source, connectivity & potential for illicit connections
Seminole	21705	6 " W	Unknown lead could be sanitary	Need to verify nature of connection
Seminole	21351	6 " W	Unknown lead could be sanitary	Need to verify nature of connection
Seminole	21317	6 " W	Unknown lead could be sanitary	Need to verify nature of connection

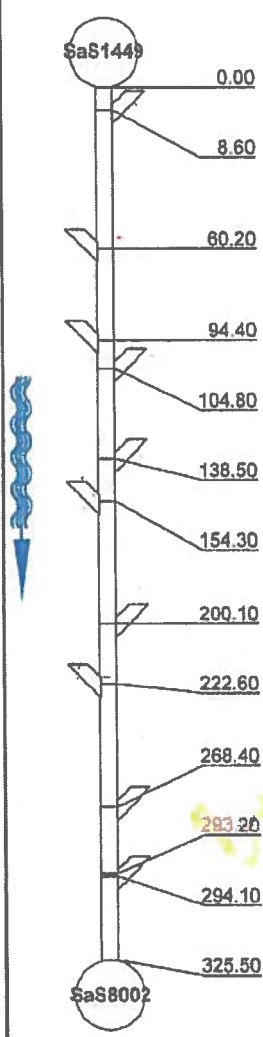
SaS1449						
	0.00	AMH	Upstream Manhole, Survey Begins, REMARK: SaS1449				
	8.60	TF	Tap Factory Made, at 09 o'clock, 6", within 8 inches of joint: YES, REMARK: Possible I&I from lead

60.20	TF	Tap Factory Made, at 03 o'clock, 6", within 8 inches of joint: YES, REMARK: I&I inside lead				
	94.40	TFA	Tap Factory Made Active, at 03 o'clock, 6", within 8 inches of joint: YES

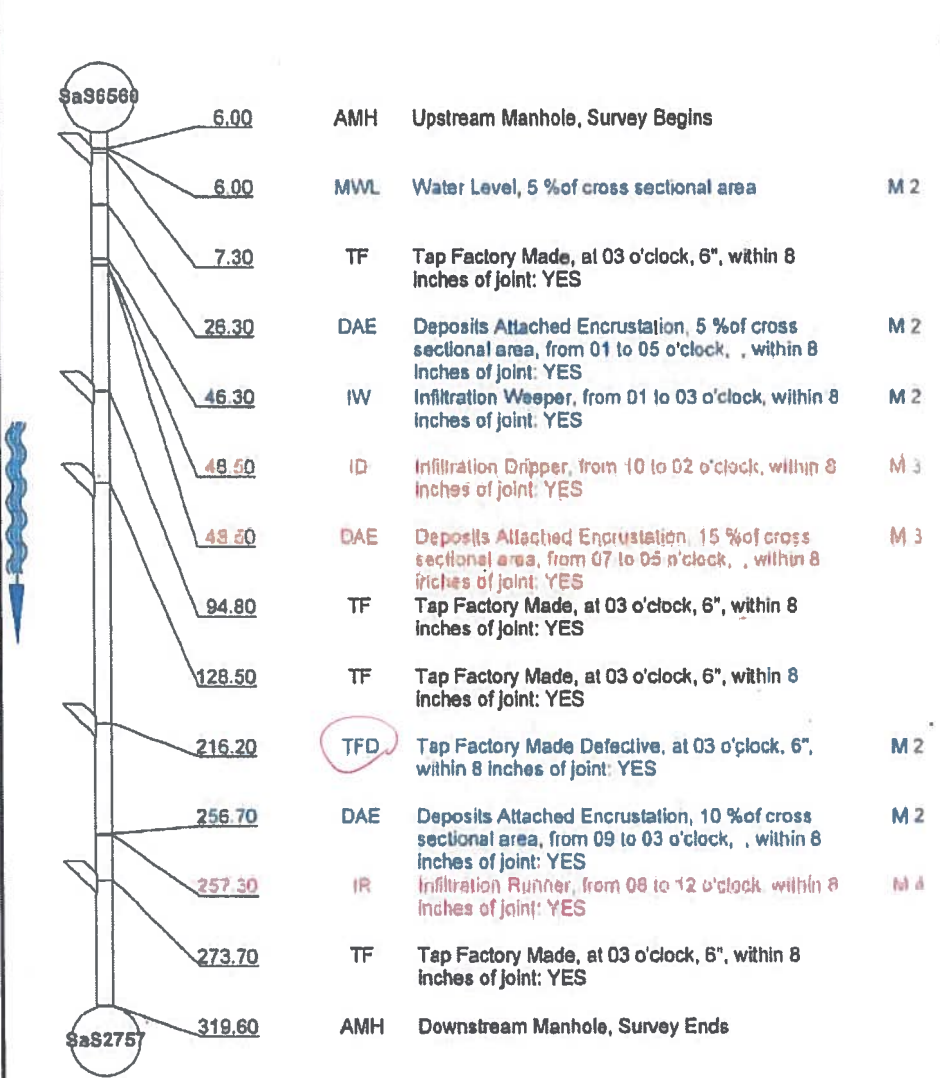
6.00	AMH	Upstream Manhole, Survey Begins				
	6.00	MWL	Water Level, 5 % of cross sectional area	M 2

7.30	TF	Tap Factory Made, at 03 o'clock, 6", within 8 inches of joint: YES				
	26.30	DAE	Deposits Attached Encrustation, 5 % of cross sectional area, from 01 to 05 o'clock, within 8 inches of joint: YES	M 2
