2018 ILLICIT DISCHARGE INVESTIGATIONS IN OAKLAND COUNTY'S PORTION OF THE ROUGE RIVER WATERSHED

FINAL REPORT

PREPARED BY:
OAKLAND COUNTY WATER RESOURCES COMMISSIONER

JANUARY 31, 2019

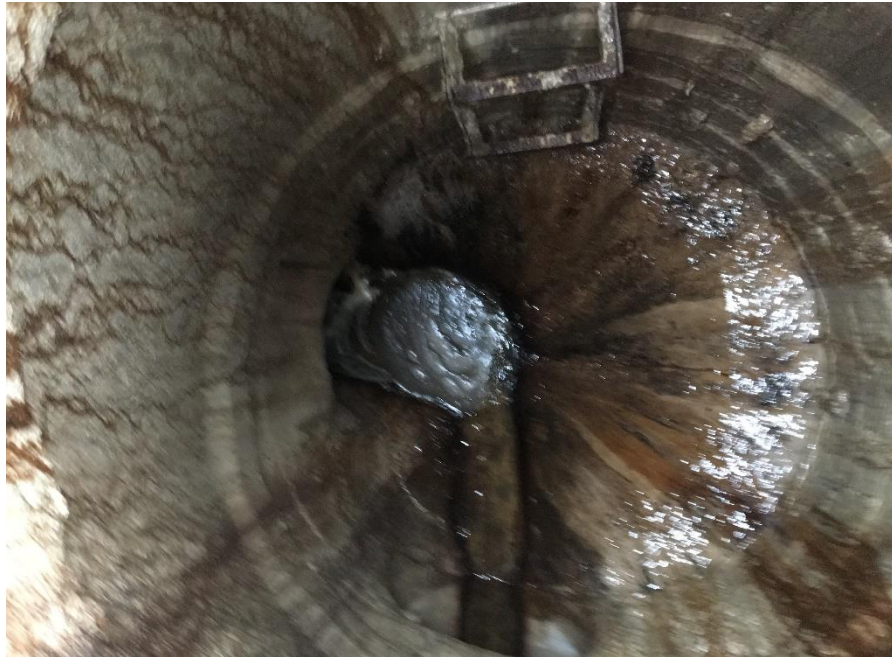
Results of *E. coli* sampling indicates that the drain is still experiencing elevated *E. coli* concentrations indicative of an upstream source of sewage contamination. *E. coli* concentrations at manhole 408 were at 27,837 CFU / 100 ML. An examination of the manhole showed light flow from the north and pooling of a brown material with suds. The manhole also has brown staining on the manhole floor, inlet pipe, walls and outlet. The manhole is an elbow for a north to east transition of flow in the drain and flow tends to pool at the outlet pipe for the manhole.

MH 408 . Flow from N. is pooled at elbow going E. Brown with suds, staining on MH wall

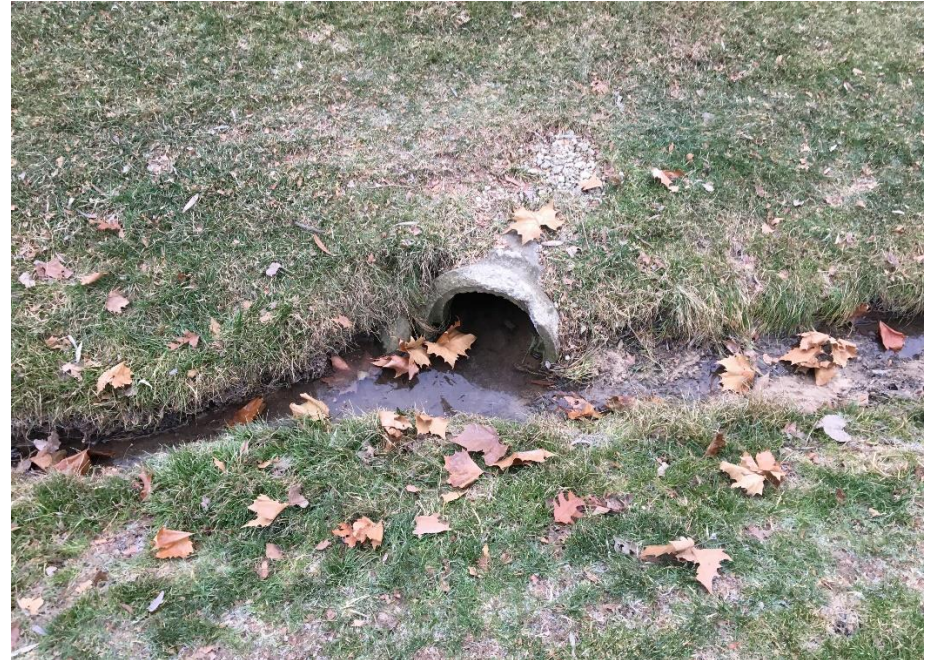
Drainage Ditch N. of MH 408. Flow is clear. Inlet pipe in ditch connected to MH 410.

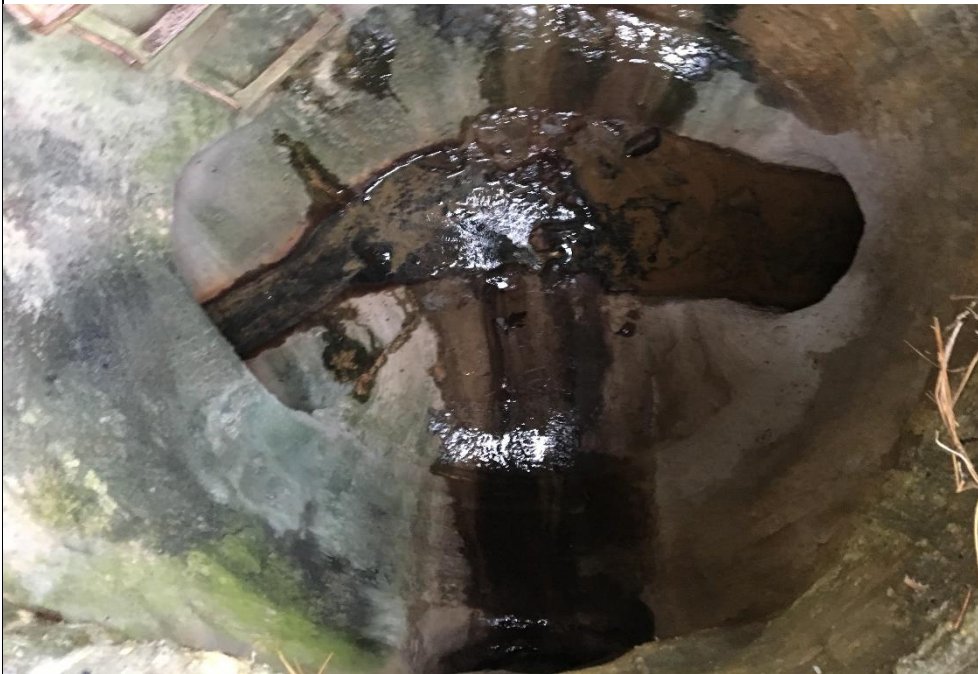
CB 13378- Flow from MH 408 to MH 410. Road dain Inlets N. & S. Low flow. No sample

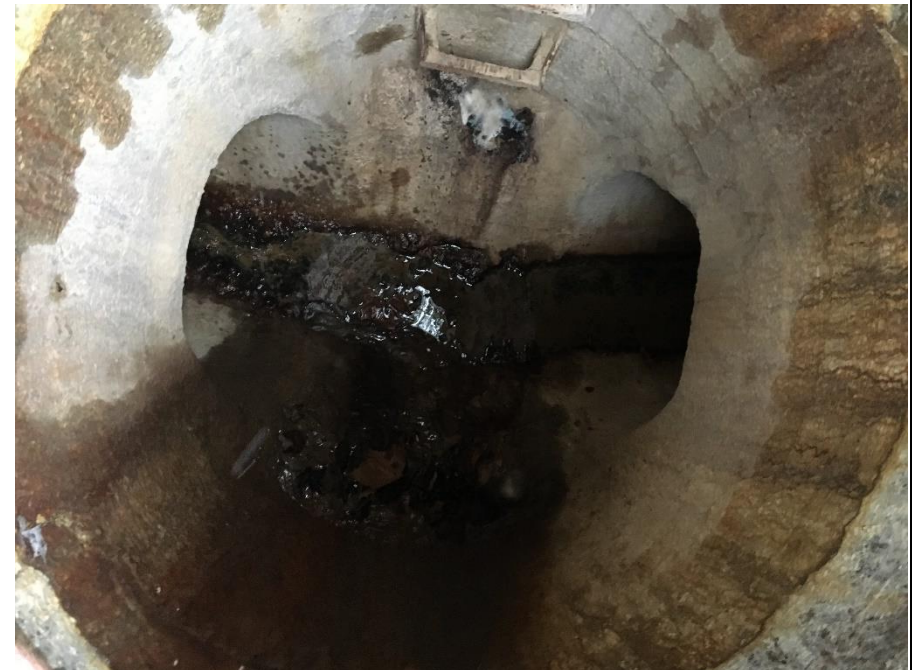
MH 410 – Connecting MH CB B 13378 to drain going E. Animal feces in MH. Sampled

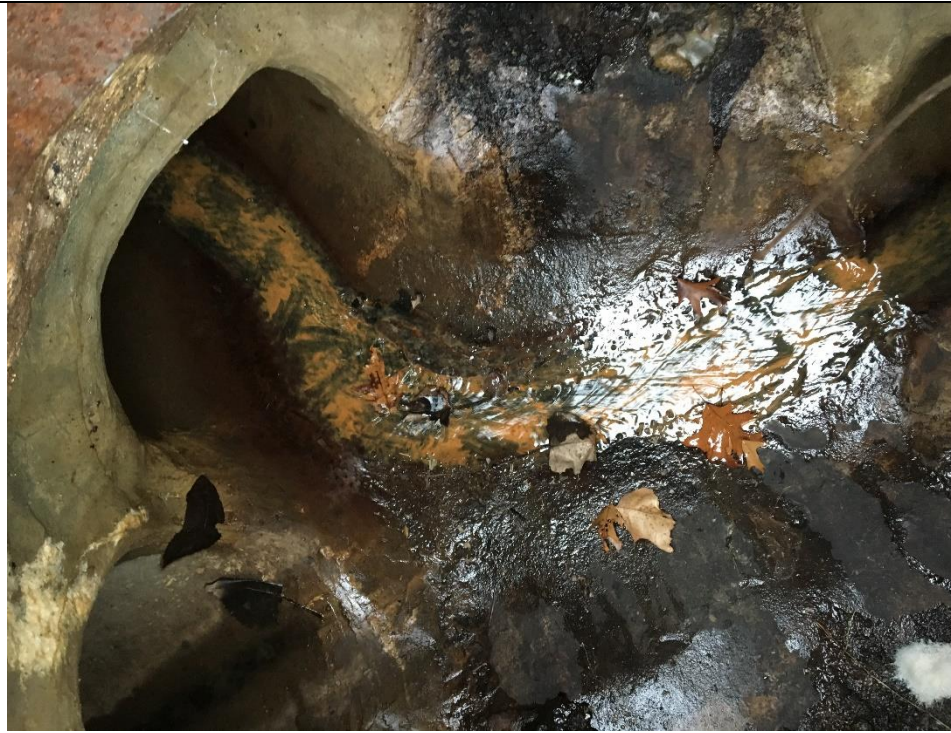
MH 407 flow from N. Rd drain inlet E. is dry w/ animal feces in MH. Sampled

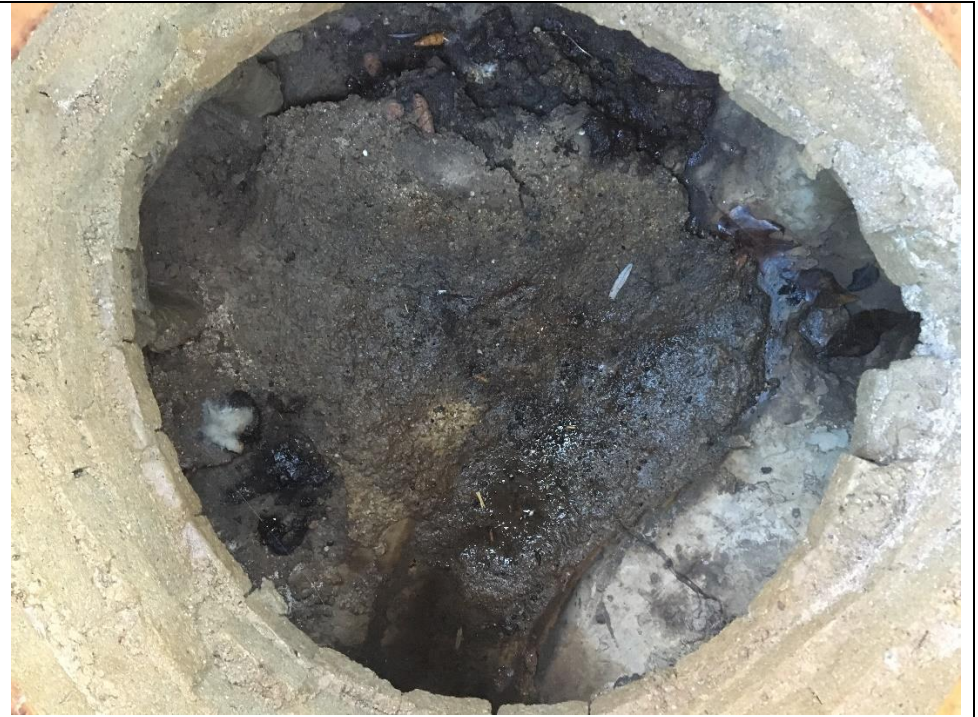
local storm MH for connected Rd drains on E. side of Charring Cross. Dry w animal feces

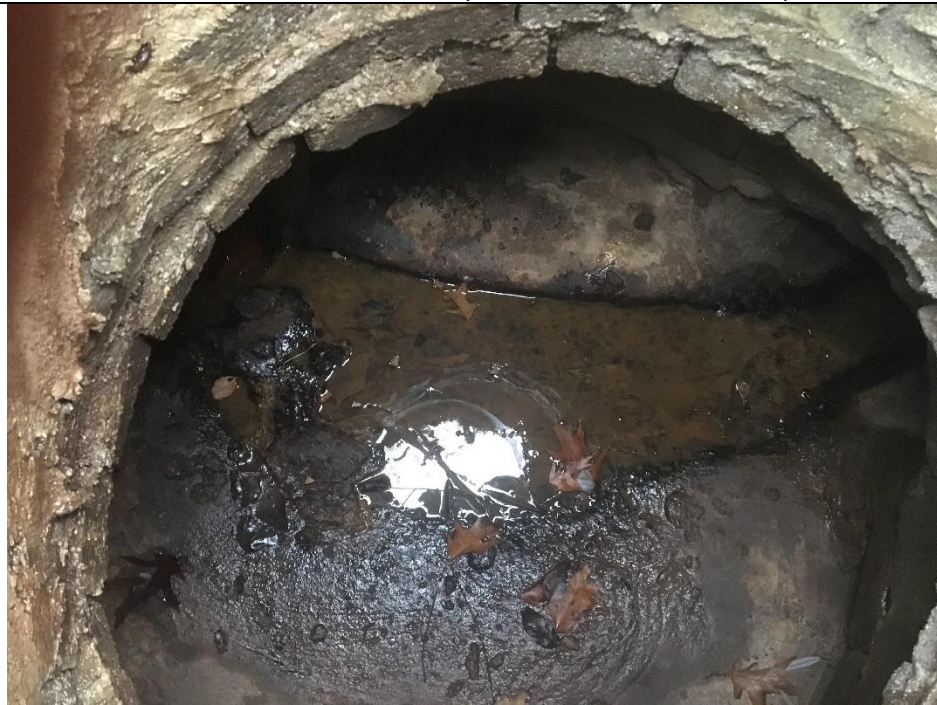
MH 7318 Connected to MH 407. Animal Feces on MH floor and channel. Sampled

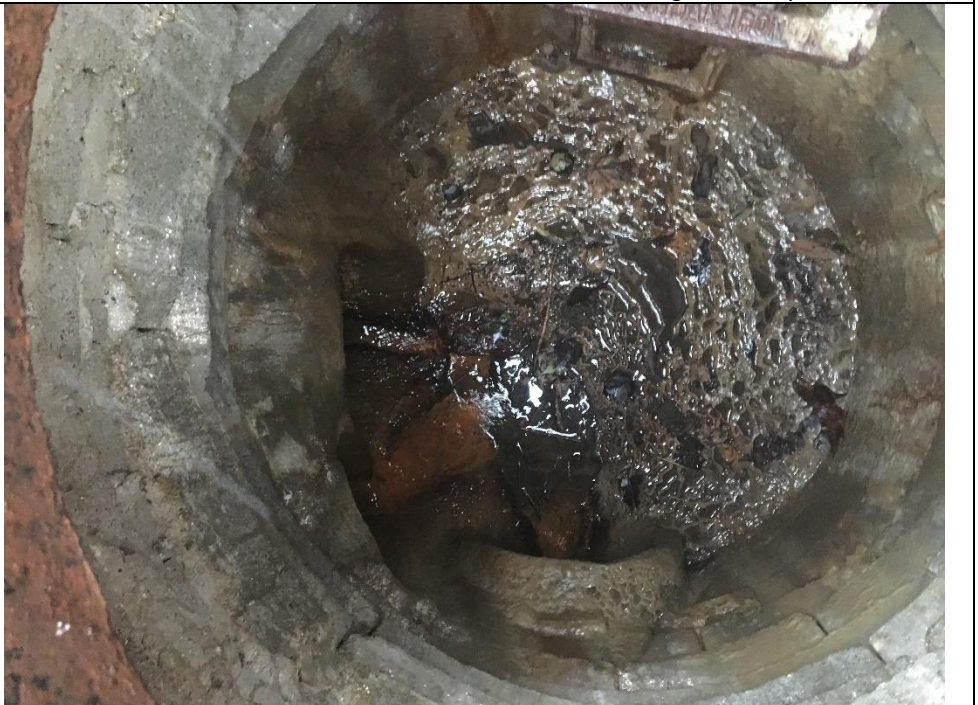
MH 7317. Elbow from W. to S. Possible sewage in MH. Sampled. Connected CB to the S.

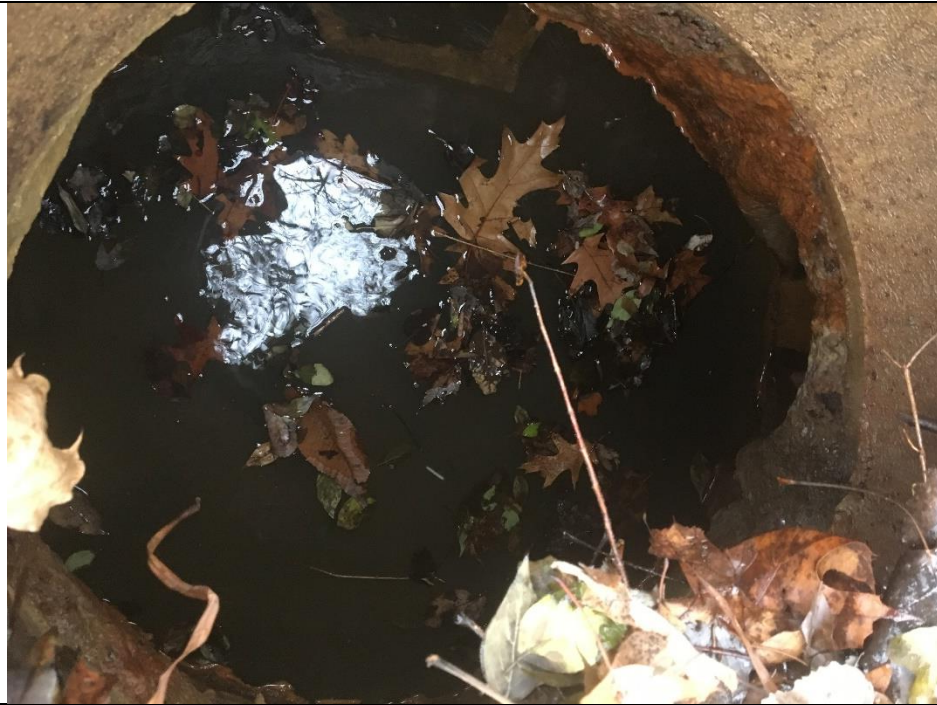
CB 13369 connected to MH 7317. Inlet flow from ditch line W. Looks clean. Sampled

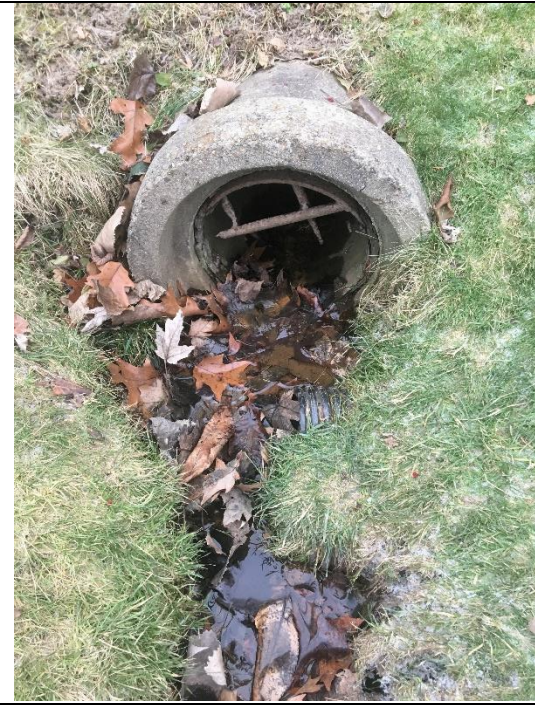
Inlet to CB 13369 w flow from drainage ditch to the W. Flow is clean

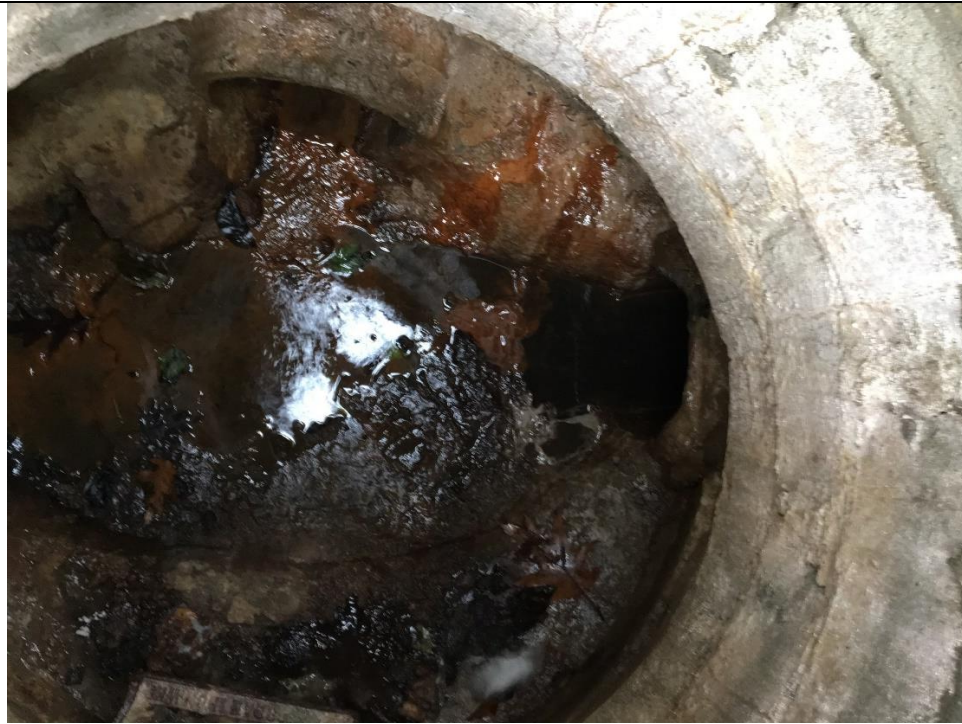
MH 7316. Terminus MH. Connects local drains W.& S. Sewage and animal Feces in MH

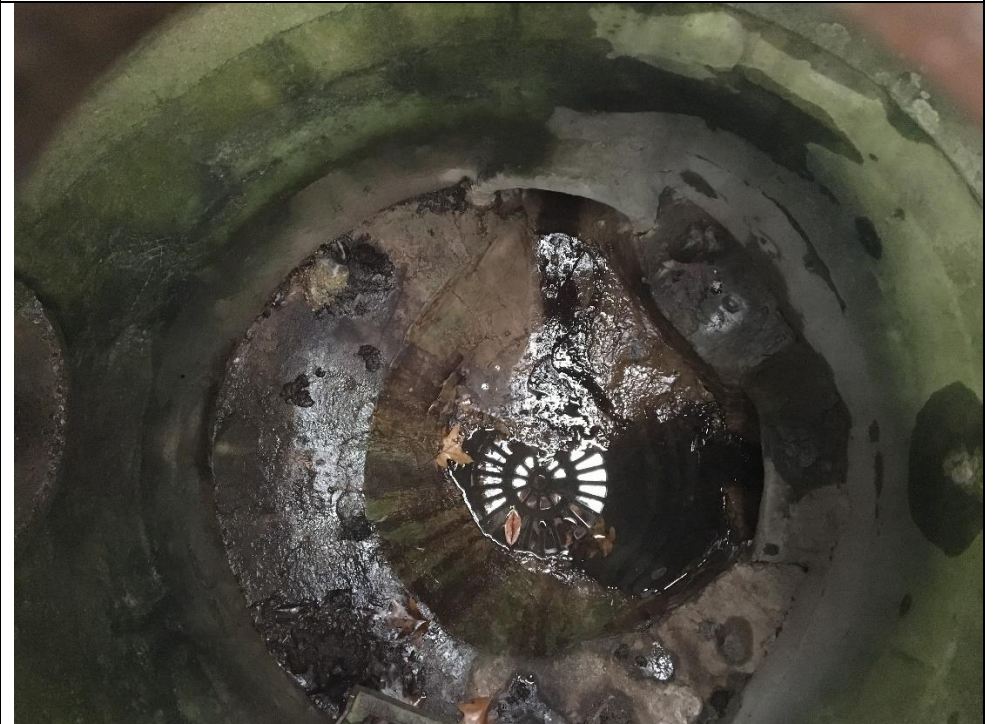
CB connects inlets for Whippers LN. & Hunt Master to MH 7316. Ponding at E outlet

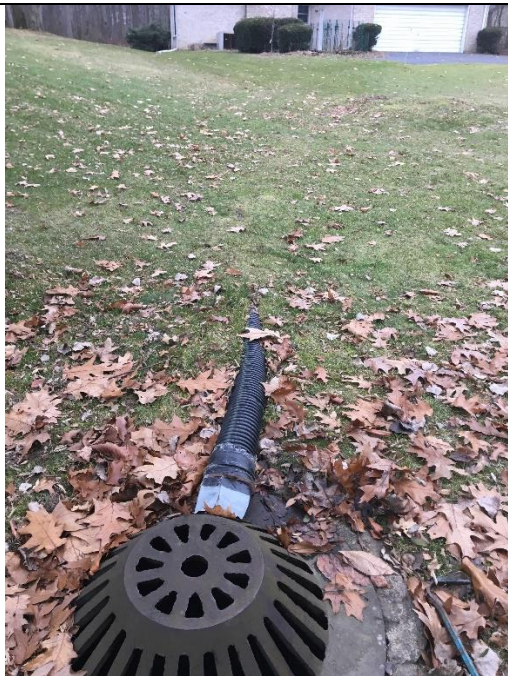
Plastic PVC drain from 482 Whippers LN connected to Back Yard CB Beehive. No flow.

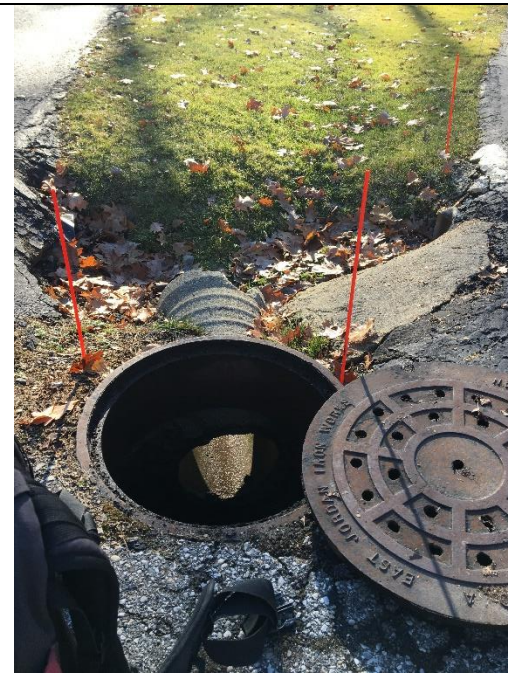
MH on Whippers Lane. Connects Rd drain ditches to drain. Water in sump. Sampled

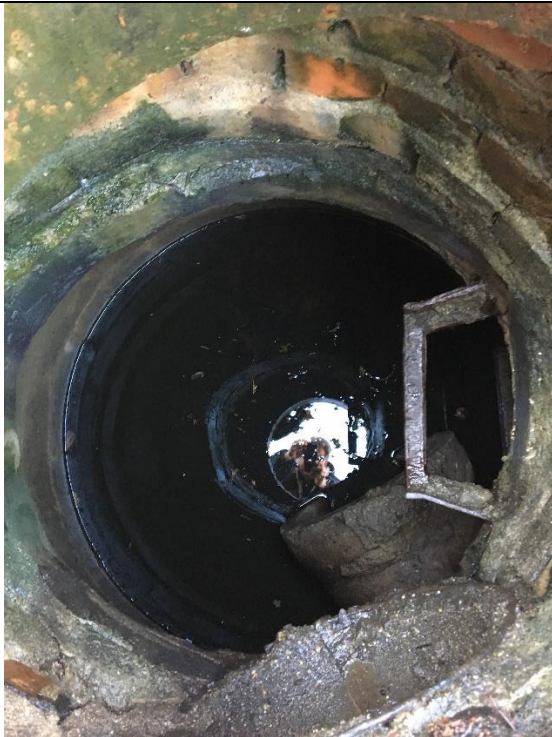
MH on Hunt Master. Connects Rd drain ditches to drain. Water in CB sump. Sampled

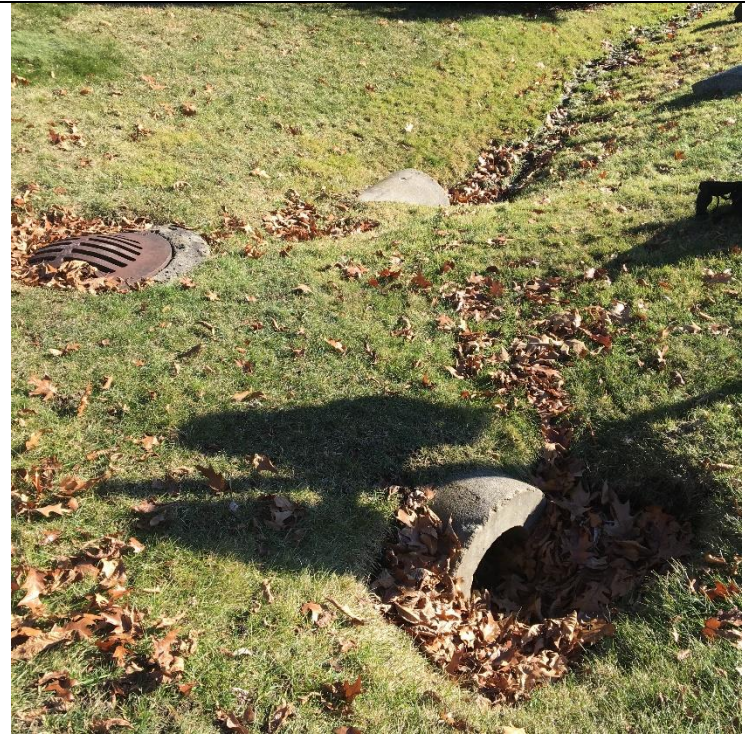
Beehive CB on Steeplechase. Connects Rd drain ditches. Flow in E. ditch line. Sampled

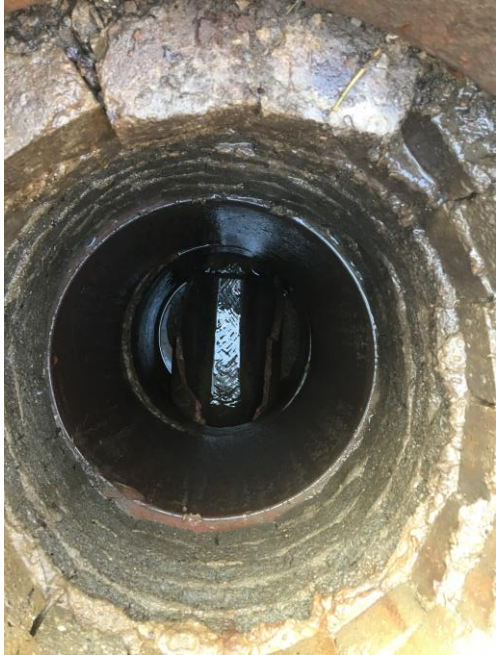
MH 417A located in Dover at Kensington. Connects to MH 417 on the CH Stevens Drain

The Road Commission for Oakland County (RCOC) was contacted. RCOC and Bloomfield Township are in the process of making arrangements to have the section of drain between manhole 417A and Dover 1 cleaned and CCTV inspected to locate any illicit connections to the drain. It should be noted that Bloomfield Township has indicated that all the properties in this area are on septic systems and sanitary sewer is not available.

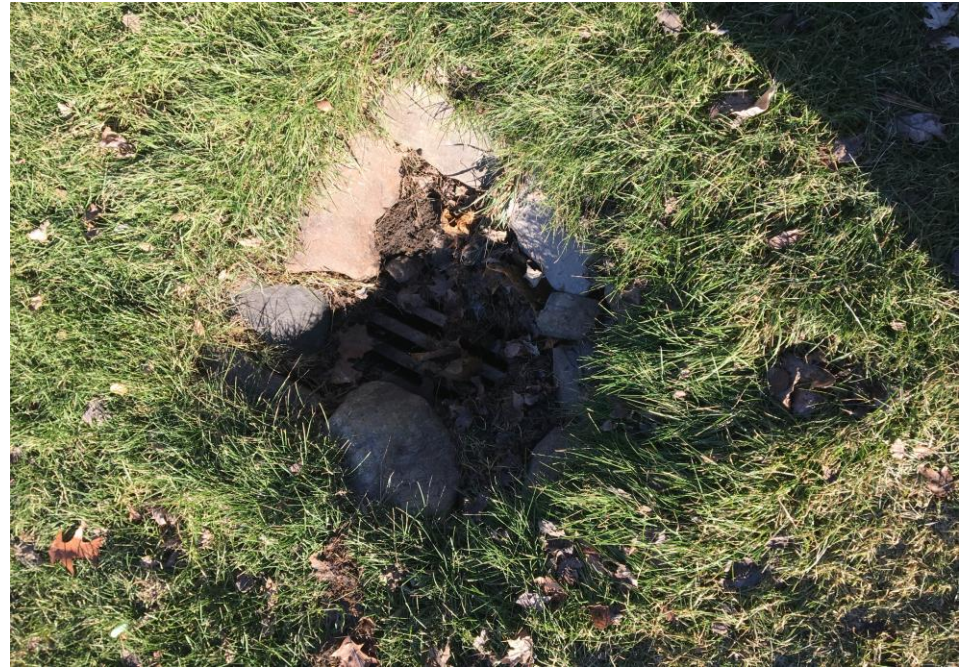
Dover 1 CB located W. of drive at 4810 Dover. Cover buried under landscaping rocks

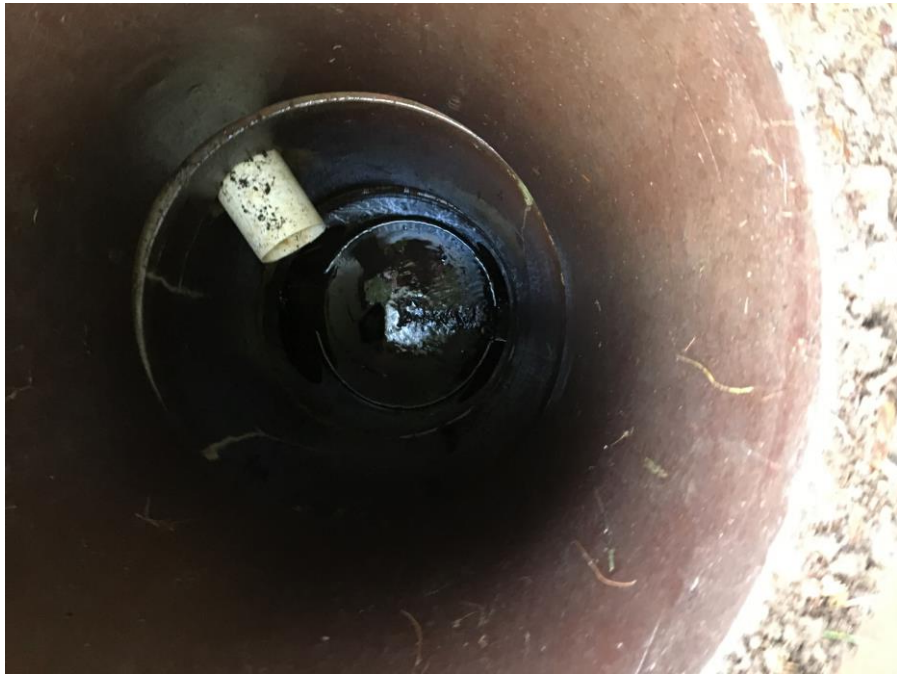
Dover 2 CB located W. of drive at 4790 Dover. 4" PVC to drain was dry. Sampled flow

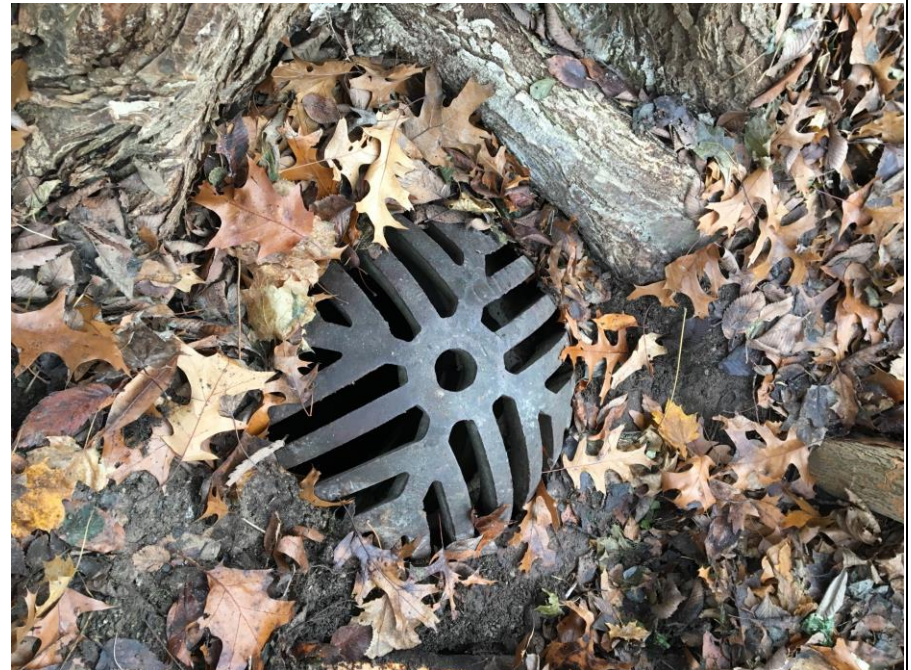
Dover 3 CB located E. of drive at 4725 Dover in woods. Beehive is locked in by tree roots

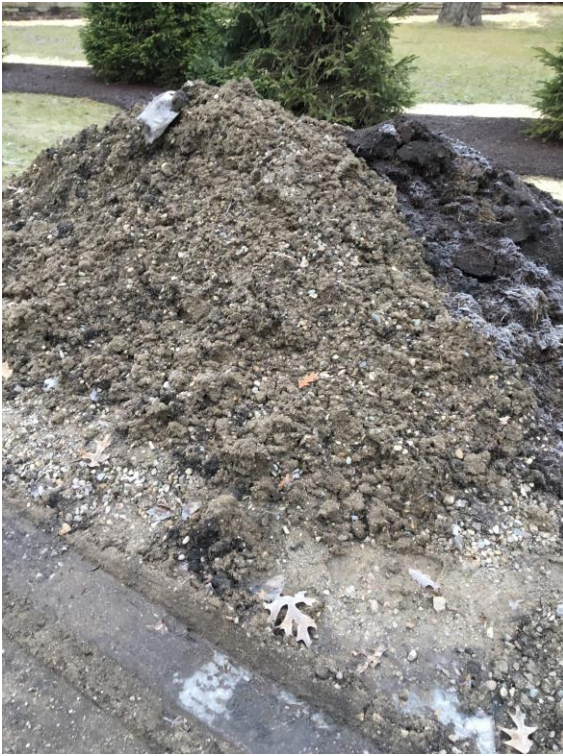
Soil pile from construction along road at 4525 Dover

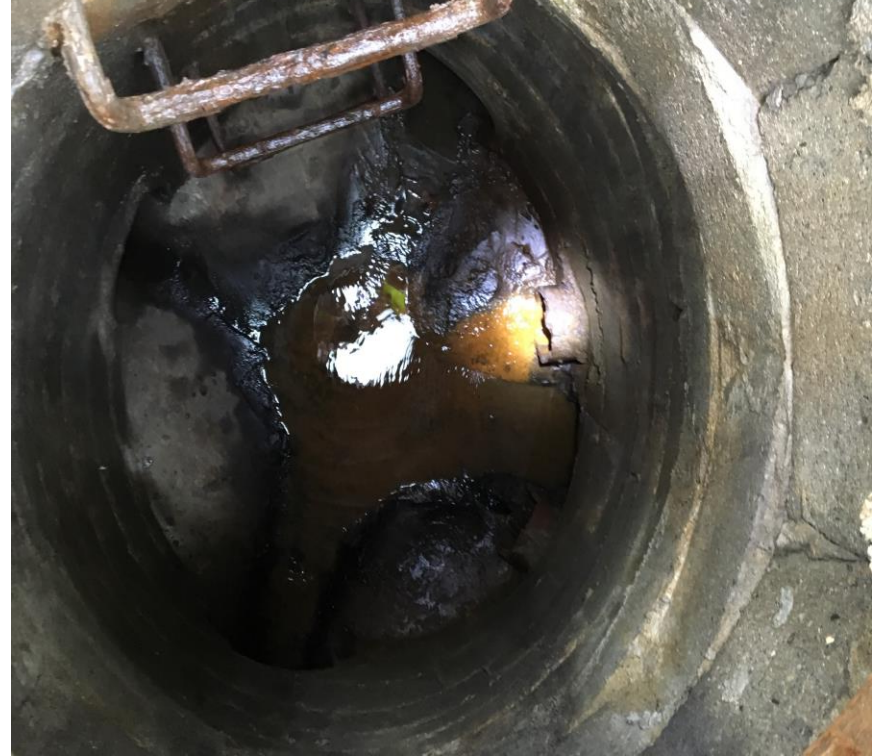
Dover 4 MH in Charring Cross at Dover. Rd rain Inlets E & W. Inlet. N with flow. Sampled

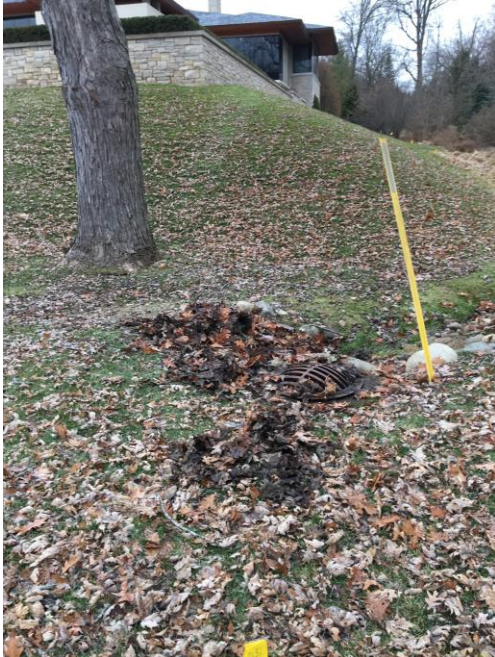
Dover 5 CB. N. of Charring Cross. Connect channel from pond to the N.

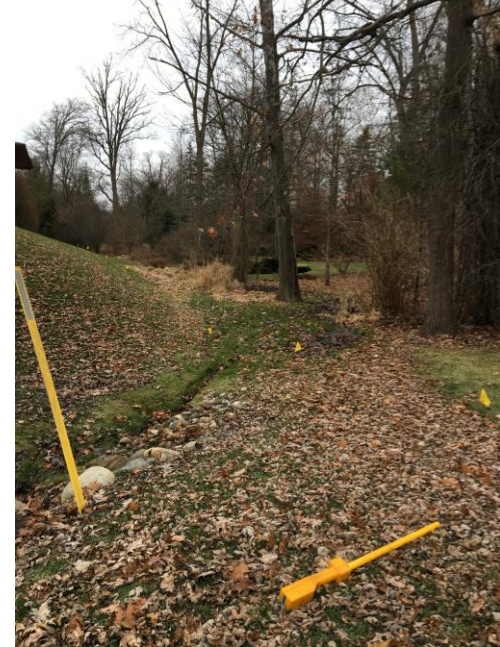
Flow channel connected to CB 5 from upstream pond S. of Wattles Rd. Sampled

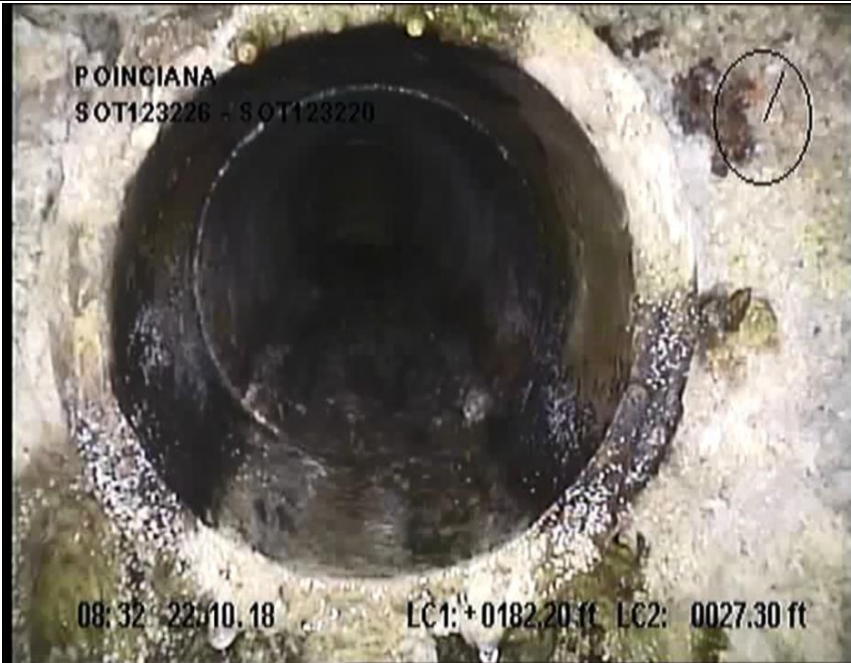
6" Clay Tile Tap 182.20 ft. S. of MH SOT123226 @ 21365 Poinciana

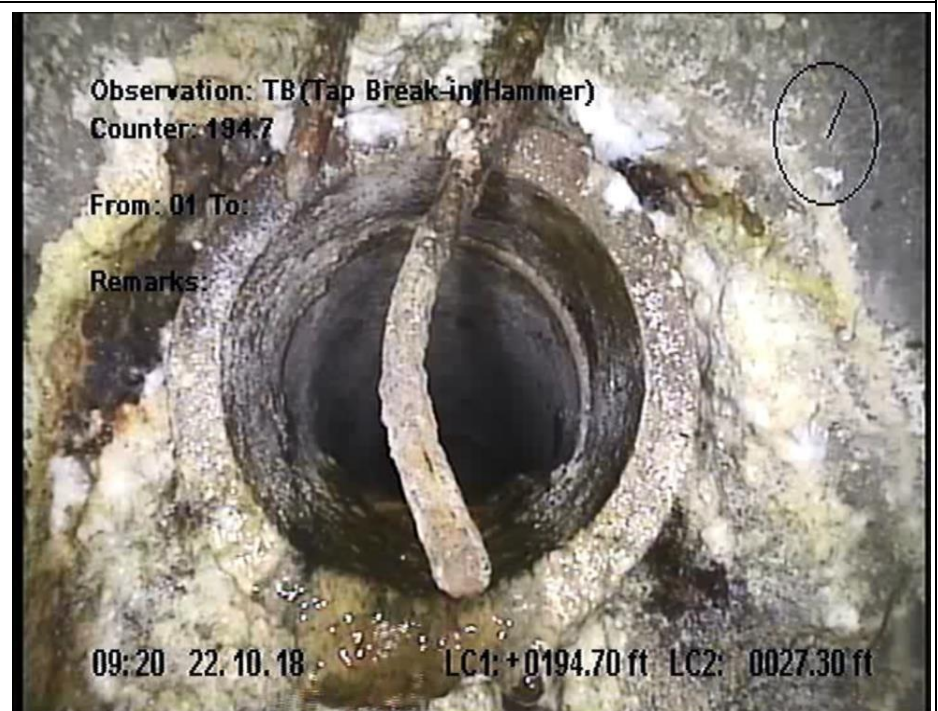
194.7 ft.	1 o'clock		TB	Tap Break in/Hammer	6"	Clay tile	w active flow
				228.0 ft.	12 o'clock		CL	Crack Longitudinal			
				262.5 ft.	1 o'clock	5 o'clock	DAE	Deposits Attached Encrusted

6" Clay Tile Tap 194.7 ft. S. of MH SOT123210 @ 21185 Poinciana w active Flow

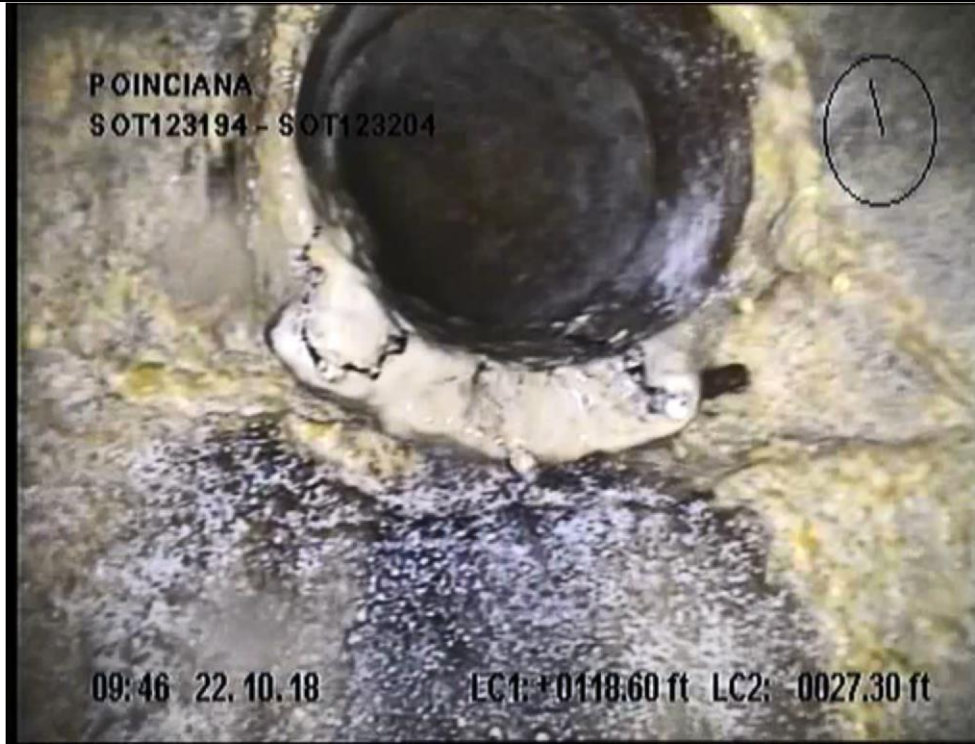
119.0 ft	11 o'clock		TB	Tap Break in/Hammer	6"	Clay tile	staining
				239.1 ft.	7 o'clock	5 o'clock	DAE	Deposits Attached Encrusted			
				249.8 ft.	12 o'clock		CL	Crack Longitudinal

6 "Clay Tile Tap 119.0 ft. N of MH SOT123194 between 21120 & 21130 Poinciana
