# **ILLICIT DISCHARGE INVESTIGATION OF THE US-16, LAW, AND FRACASSI DRAINS IN OAKLAND COUNTY**

## **FINAL REPORT**

**PREPARED BY:  
OAKLAND COUNTY WATER RESOURCES COMMISSIONER**

**JANUARY 17, 2014**

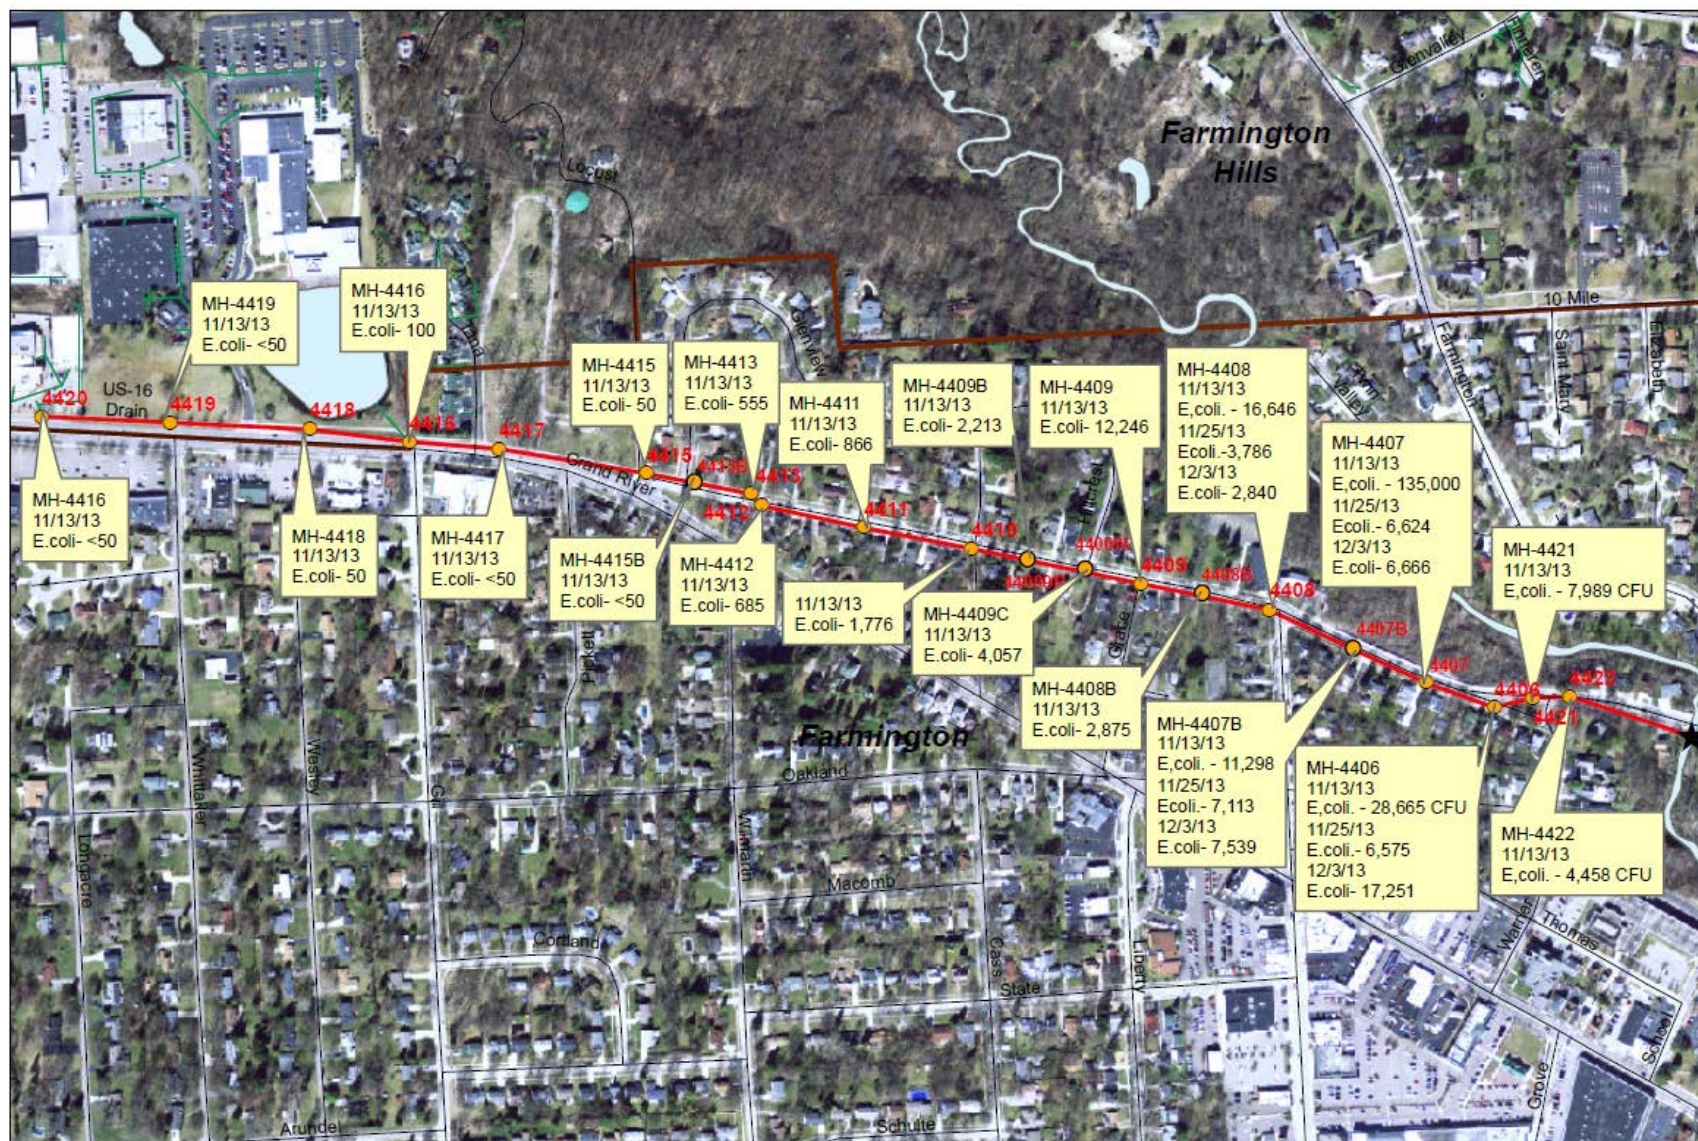
Figure 2: US-16 Drain Sampling Locations and Results

Examination and sampling of manholes west of the Grand River /Shiawassee junction (locations 4416-4420) indicates that flow is coming from the retention pond for the residential subdivision and commercial property on the north side of Grand River. Physical examination and sampling of manholes in this section of the Drain did not indicate any potential sewage contamination issues.

Examination and sampling from manholes on Shiawassee east of Grand River Ave. (locations 4406-4415) indicates that there is a high probability of intermittent sanitary discharges to this system at multiple locations. Although physical observations and *E. coli* sampling results did not verify any direct sanitary flow connections, consistent elevated bacteria levels and the presence of multiple sanitary overflow connections from the sanitary system paralleling the storm drain system (as witnessed in the manhole structures) indicates that there is a high probability of intermittent discharges of sanitary sewage from the sanitary sewer to storm drain. This most likely only occurs during times of peak sanitary flow in the system.

Manhole surveys discovered multiple connections from the sanitary sewer to the storm drain system which either have not been plugged or have been plugged and may be leaking (see notes for manholes 4406, 4408B, 4409C, 4410, 4413 and 4415 in Table 2, Appendix B for more details). Additionally, manhole 4407B has a sanitary house lead for the property running directly through it. The house lead may be damaged with sanitary sewage infiltrating through the wall of the brick manhole structure.

A table indicating the results of sampling and manhole surveys along with recommendations for inspections and repairs appears in Table 2, Appendix B. This information has been turned over to the City of Farmington for review. The City of Farmington Public Services will follow up with inspections of manholes along Shiawassee Road in order to evaluate the identified sanitary overflow connections and complete an examination of the storm and sanitary systems along Shiawassee in order to locate and eliminate any additional sanitary connections. (It should be noted that previous (March 2000) CCTV footage from the US-16 Drain is available for review). All sanitary overflow connections will be evaluated, plugged, or repaired as necessary to eliminate sanitary overflow into the storm drain system. The system will be monitored after the corrections have been completed.

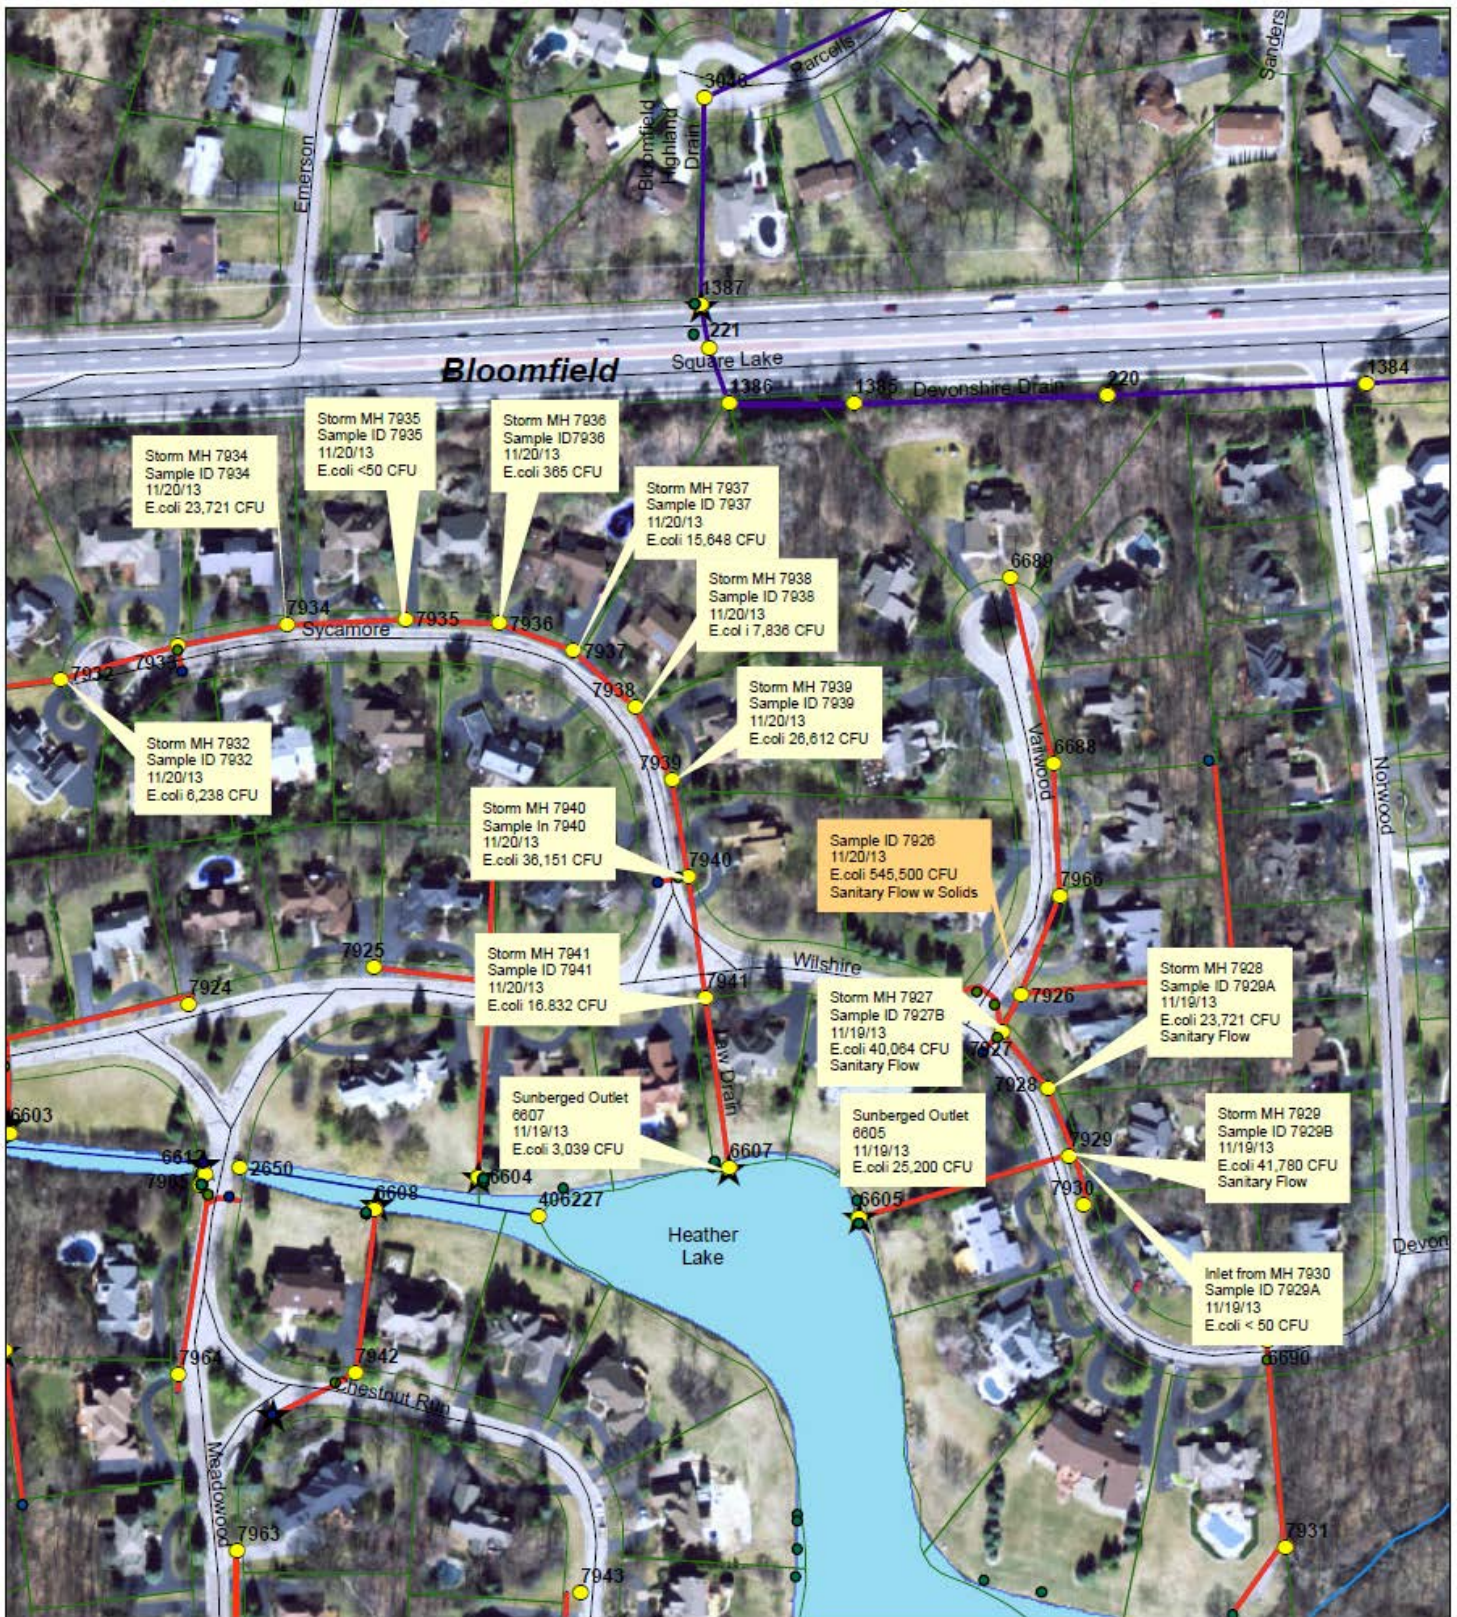
Figure 3: Law Drain Sampling Locations and Results

The enclosed drain system along Wilshire Dr., and Vailwood Ct. was examined for dry weather flow and evidence of sanitary sewage at the outlet (6605) and at upstream manholes (7930-6689). Dry weather flow and evidence of sanitary sewage (grey water, odor and toilet paper and solids) were found in the main channel flow at all manholes up to manhole 7966. A flush of sanitary sewage and visible solids were observed at manhole 7926 on November 20, 2013. Sampling of the flow for *E. coli* confirmed the

Video inspection of the system between MH 7966 to MH 6688 and MH 6688 to MH 6689 found a total of five connections from residential properties on the west side of Vailwood Ct. and along the cul-de-sac at the end of the street. These connections appear on the as-built drawings, so they may have been installed during construction of the drain. Active sanitary flow was observed in the two most downstream connections which tap the drain just north of MH 7966 and MH 6688. The remaining three connections did not have active flow but signs of sanitary debris at the outlets were observed.

Although *E. coli* counts were elevated at many locations, they were not high enough to indicate a direct sewage source and there was no physical evidence of sewage contamination. Dry weather flow is prevalent throughout the system. Properties on this street have many low lying areas with high groundwater levels and backyard drainage systems connected to the system.

A table indicating the results of sampling and manhole surveys and results of the CCTV inspections can be found in Appendices B and C. This information has been turned over to Bloomfield Township for review. Bloomfield Township Engineering and Environmental Services (EES) is in the process of contacting homeowners of suspect properties (See Appendix D). Dye testing will be used to confirm illicit connections to the storm drain and the availability of a sanitary sewer will be confirmed. It is anticipated that elimination of the illicit connections will be accomplished through enforcement of local plumbing and building codes and ordinances.

In addition, a CCTV inspection should be conducted between manhole 7926 and the outlet to determine the presence of possible illicit connections.

Additional sampling is necessary to isolate any potential sewage sources from groundwater / surface water flow influences.

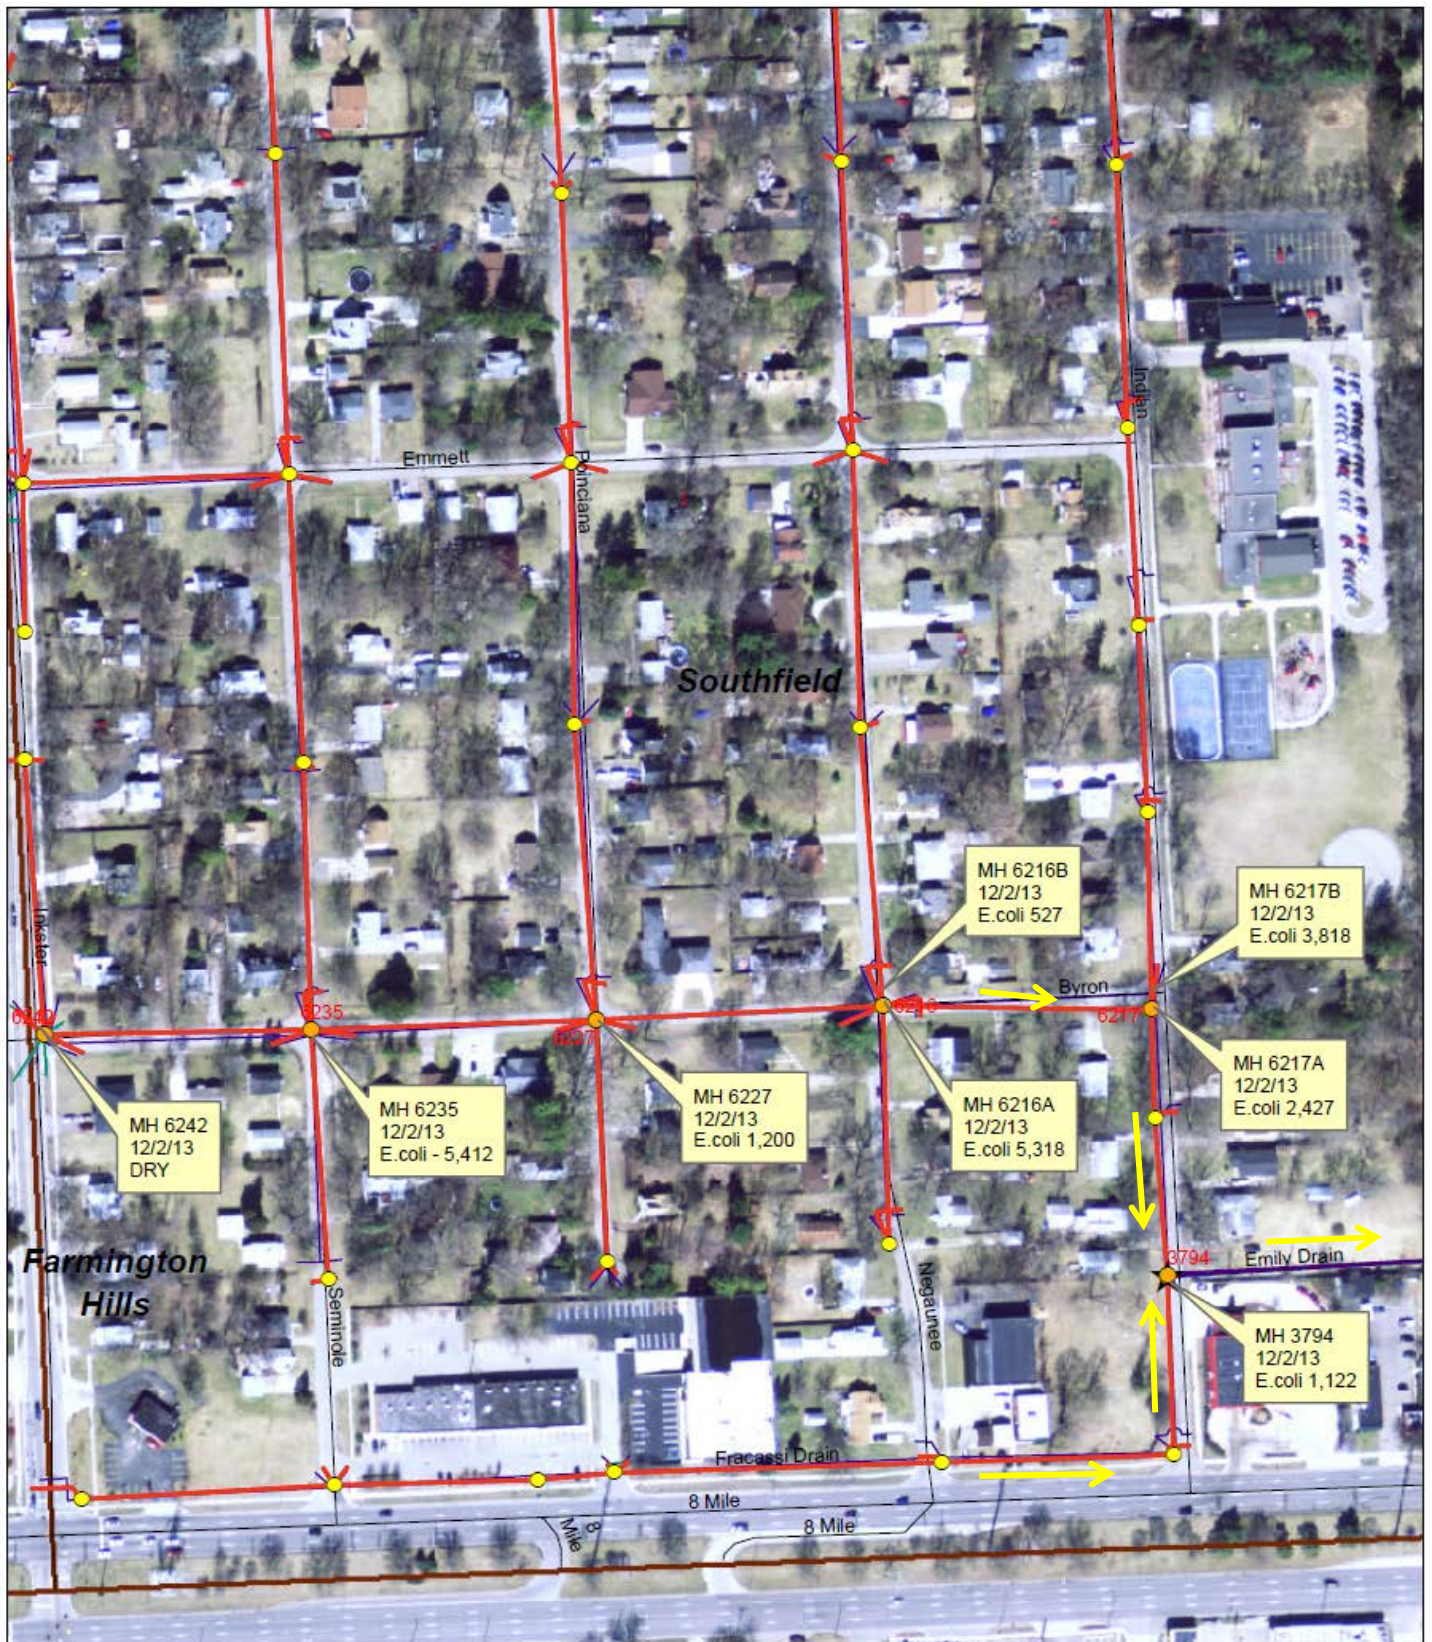
Figure 4: Fracassi Drain Sampling Locations and Results

Observational and sampling data from the outlet to the Emily Drain (MH 3794) and from manhole locations for laterals coming into the drain on Byron Street (6217-6236) indicate that there is continuous flow in the main channel of the drain from street laterals north of Byron Street except Inkster Road. The main channel of the drain is very deep making it difficult to sample and hard to ascertain flow and physical observations from street level. None of the samples collected had any physical indications of sewage contamination (color, odor, floatables, sheens, etc.). All of the manholes, except at Inkster Road, which was dry, had elevated *E. coli* concentrations. Although some results were greater than 1,000 cfu/100 ml (colony forming units per 100 milliliters), they were not high enough to indicate a direct sewage source. Based on these results, a decision was made not to collect additional samples or perform investigations of the connecting street laterals due to time and budget constraints of the grant.

Sampling data collected during the project period and historical sampling data suggests that the Drain may be receiving intermittent discharges of sanitary sewage from upstream sources, but it was difficult to isolate a particular segment of the Drain for advanced IDEP investigation. The depth of the Drain, continual dry weather flow volume, and the likelihood of an intermittent sanitary discharge source make it difficult to isolate specific drain laterals with potential sanitary sewage sources. A hydrologic flow study, additional sampling of the drain during peak sanitary flow and possibly other testing methodologies are recommended to distinguish between, groundwater, surface water, and sanitary sewage flow.
