# Danvers Pond Dam Removal and Stream Restoration Project

## Great Lakes Restoration Initiative Grant Final Report

US EPA Contract Number E-00639

December, 2012

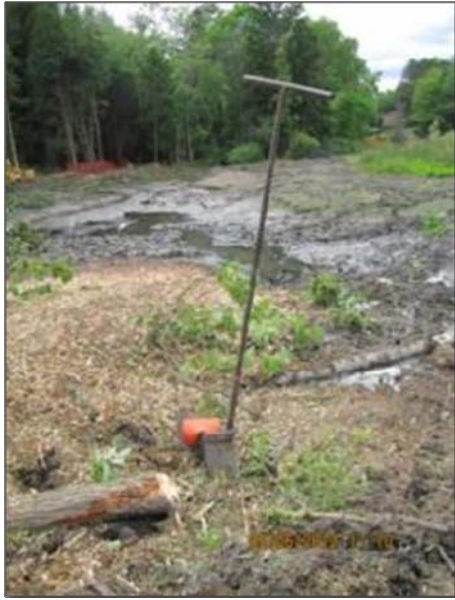
**June, 2012-** The existing bypass valve was found and opened and the impoundment water level was lowered. During design, the existing bypass valve was known to be in place, but its functionality was unknown. After the water was lowered, the existing island and deposited sediments upstream of the dam within the center of the impoundment acted as a barrier, separating the north half of the pond from the south half. The active flow of the stream continued through the north half of the pond and over the north end of the dam. Efforts were then concentrated on dewatering low-lying areas in the south half of the pond. The contractor used a well point to help with the dewatering of the sediments on the south side of the pond.

**Existing bypass valve opened**

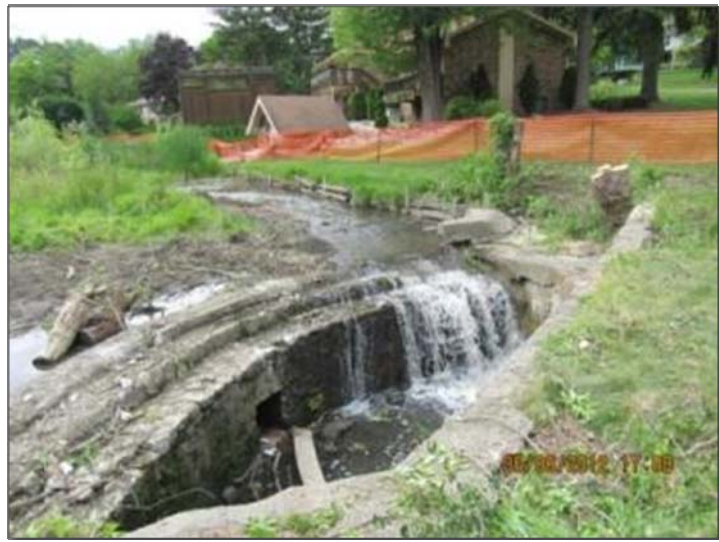
**Flow through north side of pond and over dam**

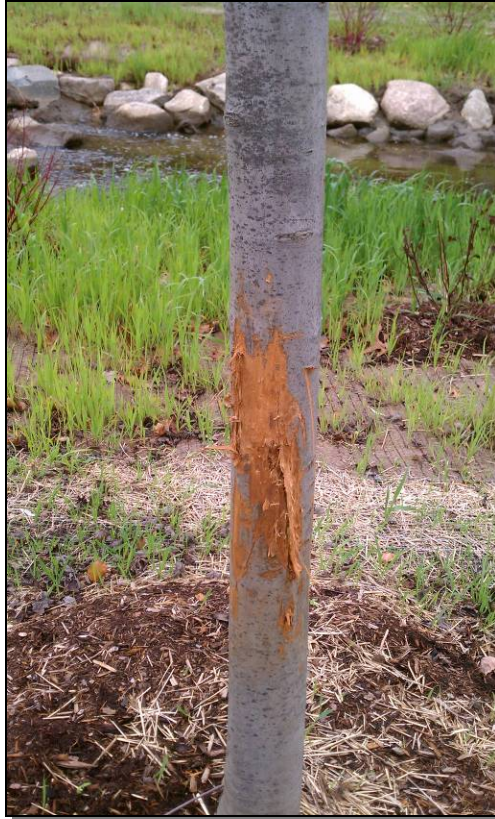
- Deer- Deer were observed at the site. Tree damage due to deer activity was observed. (See photos below.) Also, deer droppings and deer tracks were observed at multiple locations throughout the site.

**Damage to Maple Tree due to Deer Activity**

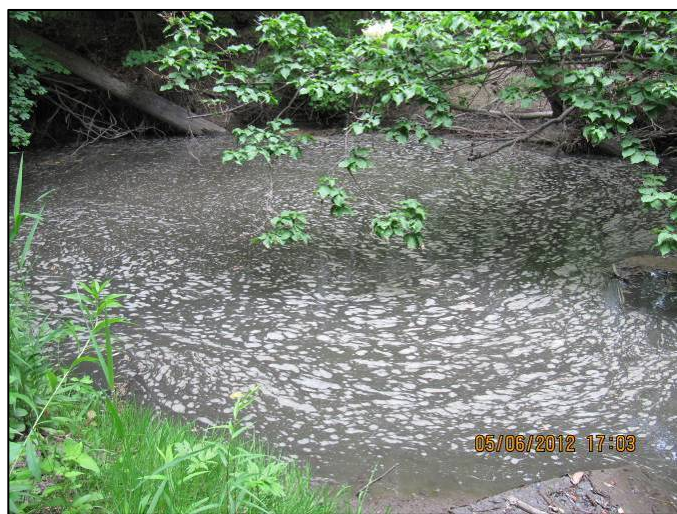
**June 5, 2012:**  
Swirling caused by turbidity barrier

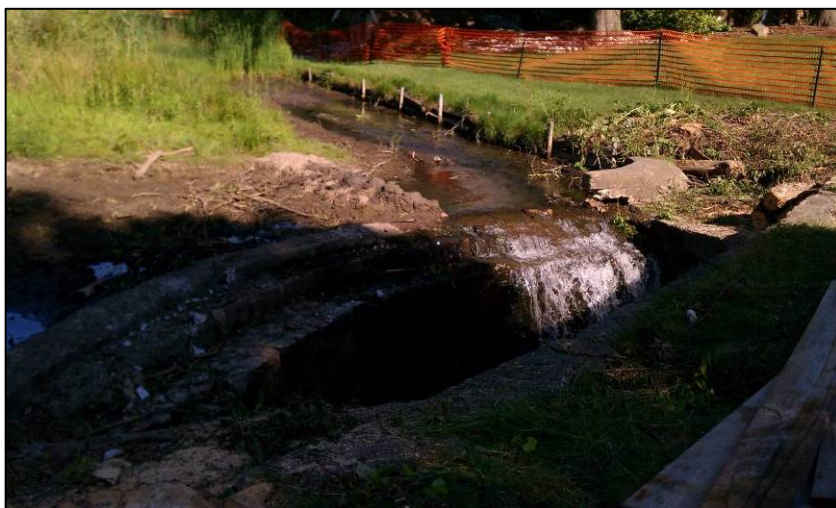
**June 7, 2012:**  
Dam, note water running over north  
part of dam

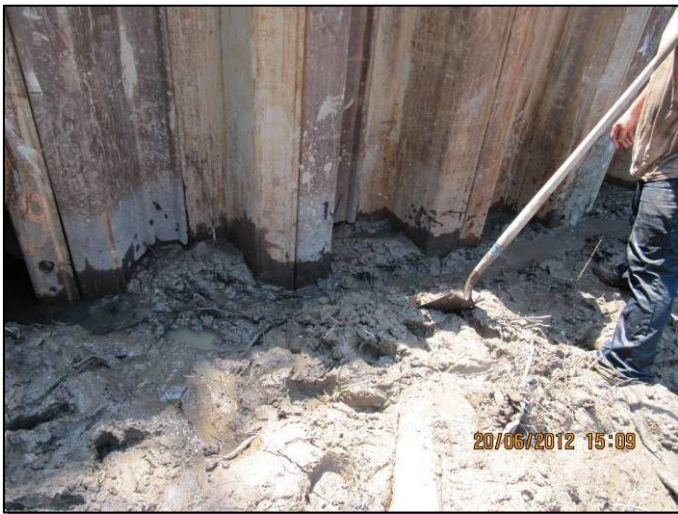
**June 14, 2012:**  
Plugging leaks in temporary dam

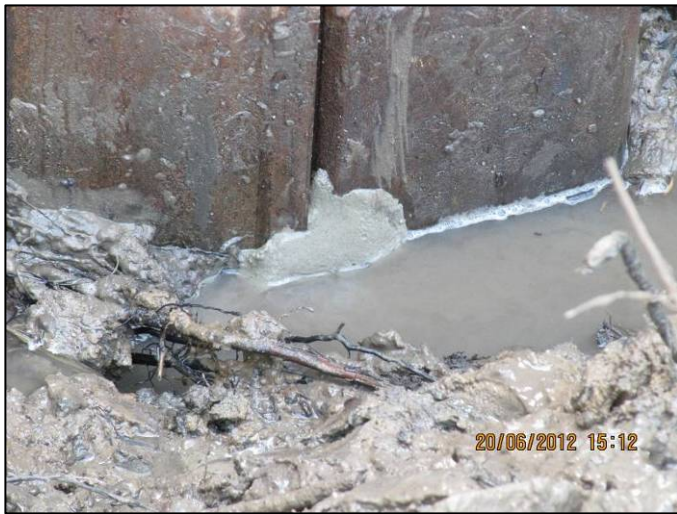
**June 20, 2012:**  
Plugging leaks in temporary dam – close up
