2021 Habitat Sites Report

Living Shoreline and Cuttle Creek

Report prepared for: City of Marysville
Projects: Living Shoreline and Cuttle Creek
Report prepared by: Friends of the St. Clair River
Funding provided by: EGLE
Report date: March 28, 2022

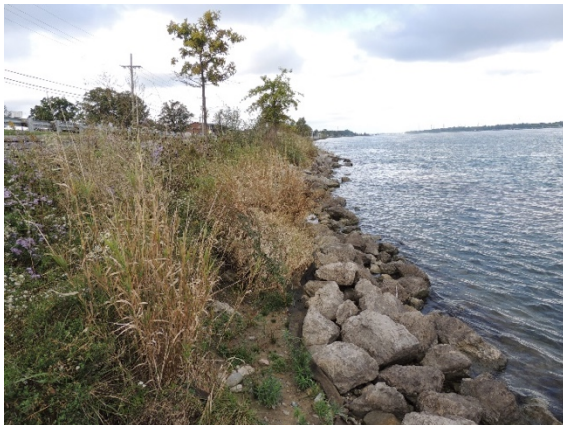
Marysville Living Shoreline facing north

On the south end of the site native vegetation dominates. Native species present include asters, goldenrod, coneflower, Culver's Root, bee balm, sumac, penstemon, coreopsis, bluestem, jewelweed, boneset and milkweed. The native trees and shrubs along the walkway appear to be thriving and include cottonwood, dogwood, ash and willow. Up to approximately 25% of the area is covered with invasive Phragmites. Invasive species include *Phragmites*, Black Locust (*Robinia pseudoacacia*), teasel (*Dipsacus* sp.) and Purple Loosestrife (*Lythrum salicaria*).

The shoreline has been stabilized with additional rock to protect against high water and erosion. There is some erosion behind the seawall and rock face despite the additional rock that was added.

The vegetation bordering the walkway has been mowed. Woody debris is caught in the rocks. It does not appear that invasive Phragmites or other invasive plant species are being controlled.

Recommendations: The site would benefit from invasive species control. Mowed edges can be replaced by a low growing native ground cover, or mower deck could be raised or be mowed less frequently. Eroded areas should be backfilled and possibly armored with more rock.

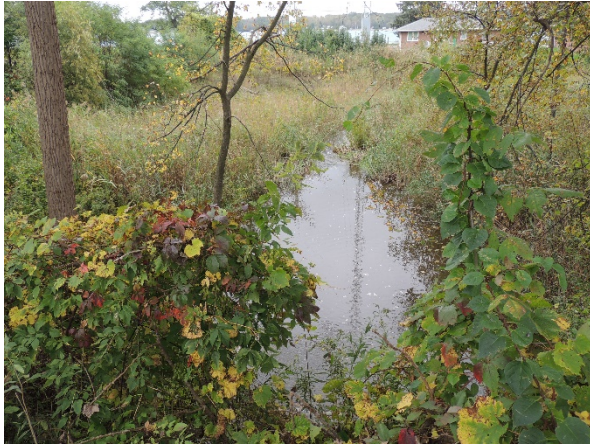
Cuttle Creek @ bridge 1, east view

At the first bridge the bank edging the creek is steep in this area. Invasive *Phragmites* is encroaching to the edge of the creek. Native species Staghorn Sumac (*Rhus typhina*) and grapevine are proliferating near the bridge. Trees dominate this area including cottonwood, elm, boxelder and pear with invasive Black Locust (*Robinia pseudoacacia*). Native Virginia Creeper (*Parthenocissus quinquefolia*) is present on most trees as well as wild grape vine (*Vitis* sp.). At the second bridge on the south side

At the first bridge there is a steady flow of clear water with some riffle. This part of the creek is shaded by mature trees. At the second bridge the water is clear and flowing with an active riffle area west of the bridge and a less active flow to the east. To the west of the bridge a high-water mark on the adjacent vegetation shows that the water level has dropped since summer. The creek bottom is stone with little sedimentation. At the third bridge there are large boulders in the creek, a rocky bottom with a riffle area. There is some woody debris across the creek. A red tail hawk was seen perched in a tree. At the fourth bridge the stream is narrow with vegetation encroaching on the east side and a small riffle area. On the west side the flow is slower with more sediment and

Recommendations – Management of invasive *Phragmites* is needed, especially in the areas where it is starting to encroach into the stream. While cutting back shrubbery around the bridges some invasive species, like multiflora rose, could be removed at the same time.

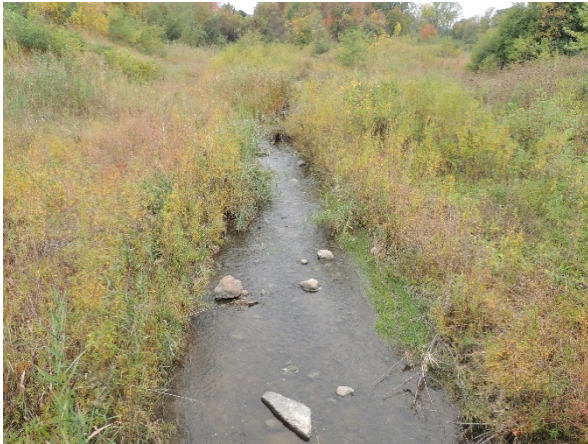
Cuttle Creek @ bridge 2, west view

native plants dominate including coneflower, asters, thistle, goldenrod, bluestem, Indian Grass (*Sorghastrum nutans*). Invasive plants in this area include invasive *Phragmites*, Canada Thistle (*Cirsium arvense*), and teasel (*Dipsacus* sp.). On the north side invasive *Phragmites* has encroached to the creek's edge with some native plants present.

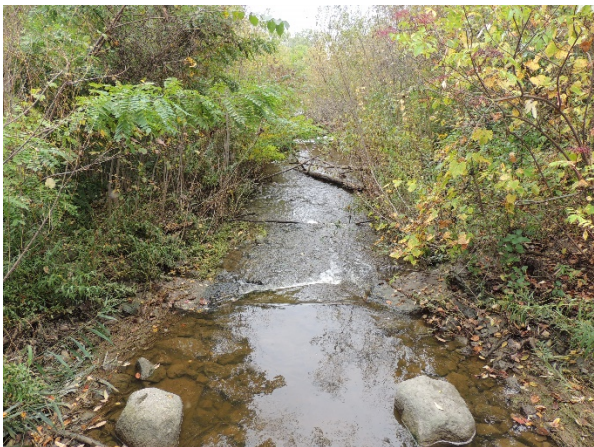
Cuttle Creek @ bridge 3, east view

At the third bridge species present include button bush and swamp white oak, elderberry and other mature trees and shrubs. Invasive species present include multiflora rose and burning bush with phragmites growing under the bridge. At the fourth bridge to the east invasive *Phragmites* has encroached to the edge of the creek and overarching the creek in some areas. Pond weed was observed in the creek. On the west side near the bridge were cattails, grapevines and dogwood. Further west phragmites have encroached to the edge of the creek. Invasive narrow leaf cattail was also present. At the fifth bridge to the east phragmites dominates almost to the fourth bridge. Native plants include dogwood, willows with some aster, cattails and button bush. Invasive species include multiflora rose and purple loosestrife with phragmites dominating further west.

There does not appear to be any management of invasive species. Interpretive signs at the second and fifth bridges are in good condition but should be cleaned. At the third and fourth bridges some shrubbery has been cut on the adjacent hillside and a lot of woody debris remains.
