Annette DeMaria, P.E., PMP
Executive Director

SUBJECT: 2022 IDEP Investigation Summary

SUBJECT: IDEP Investigation Results: Outfall BV51 (Sleepy Hollow Lane)

SUBJECT: IDEP Investigation Results: Outfall L1619

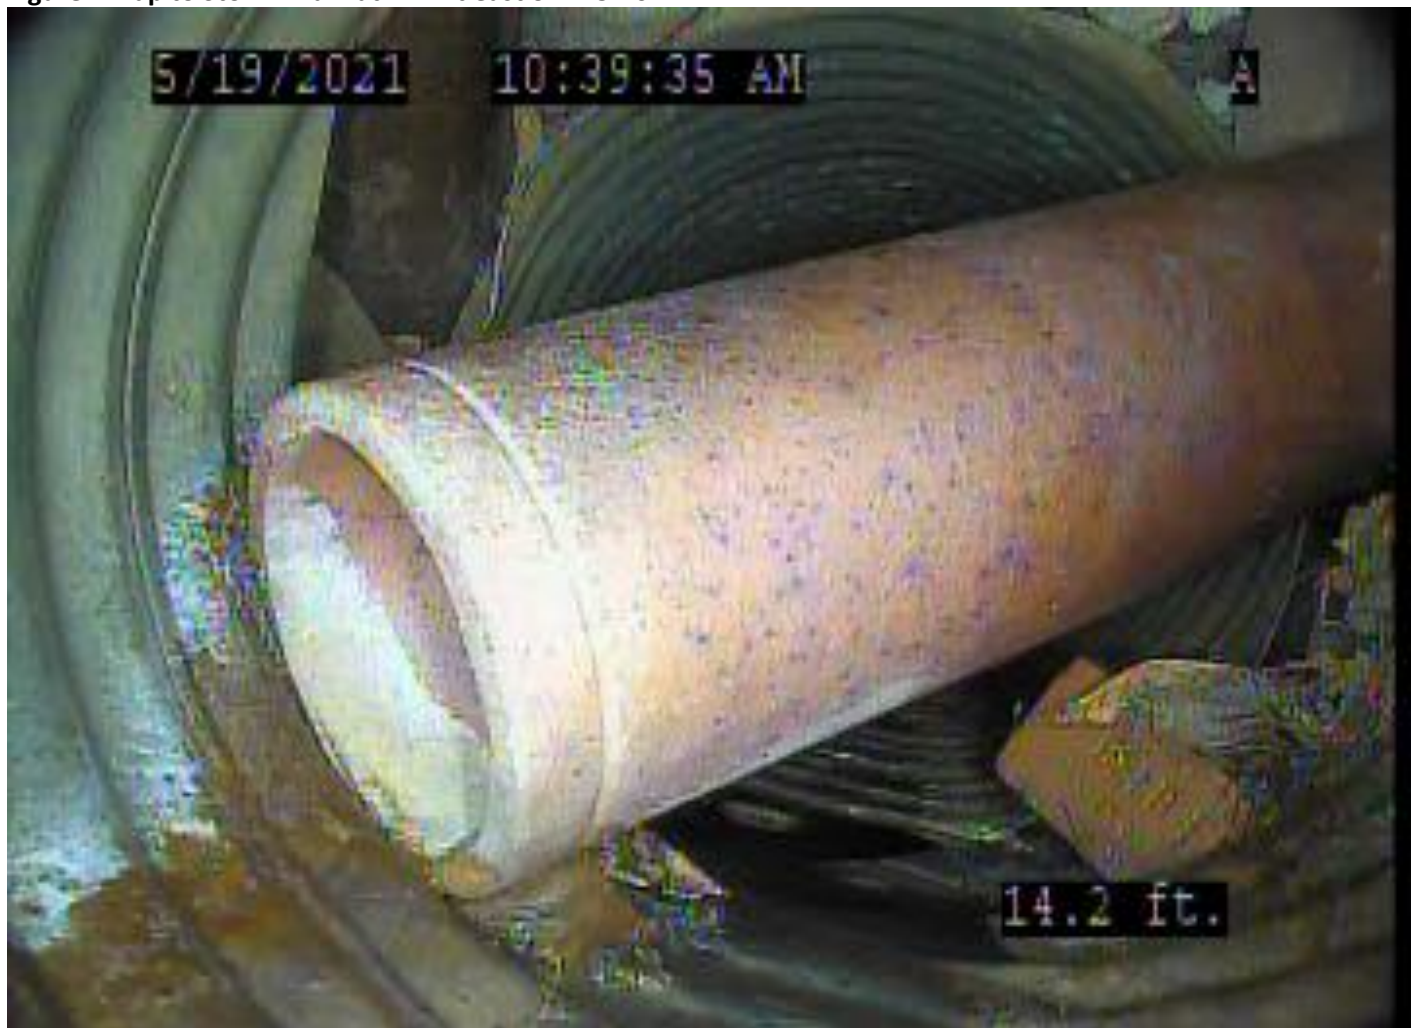
ARC staff coordinated with the Village of Beverly Hills and OCWRC to televise the remainder of the storm drain on July 26, 2022. The drains from BV51-1 to BV51-2, and the drain from BV51-3 to BV51-2 were televised. BV51-2 is buried. No possible illicit connection was identified.

Figure 2. Tap to Storm Drain at 14.2 ft east of BV51-0

Work to date indicates that no illicit connection has been identified upstream of BV51. The manhole at BV51-2 is buried. We recommend digging up BV51-2 to be able to further investigate it and sample the manhole.

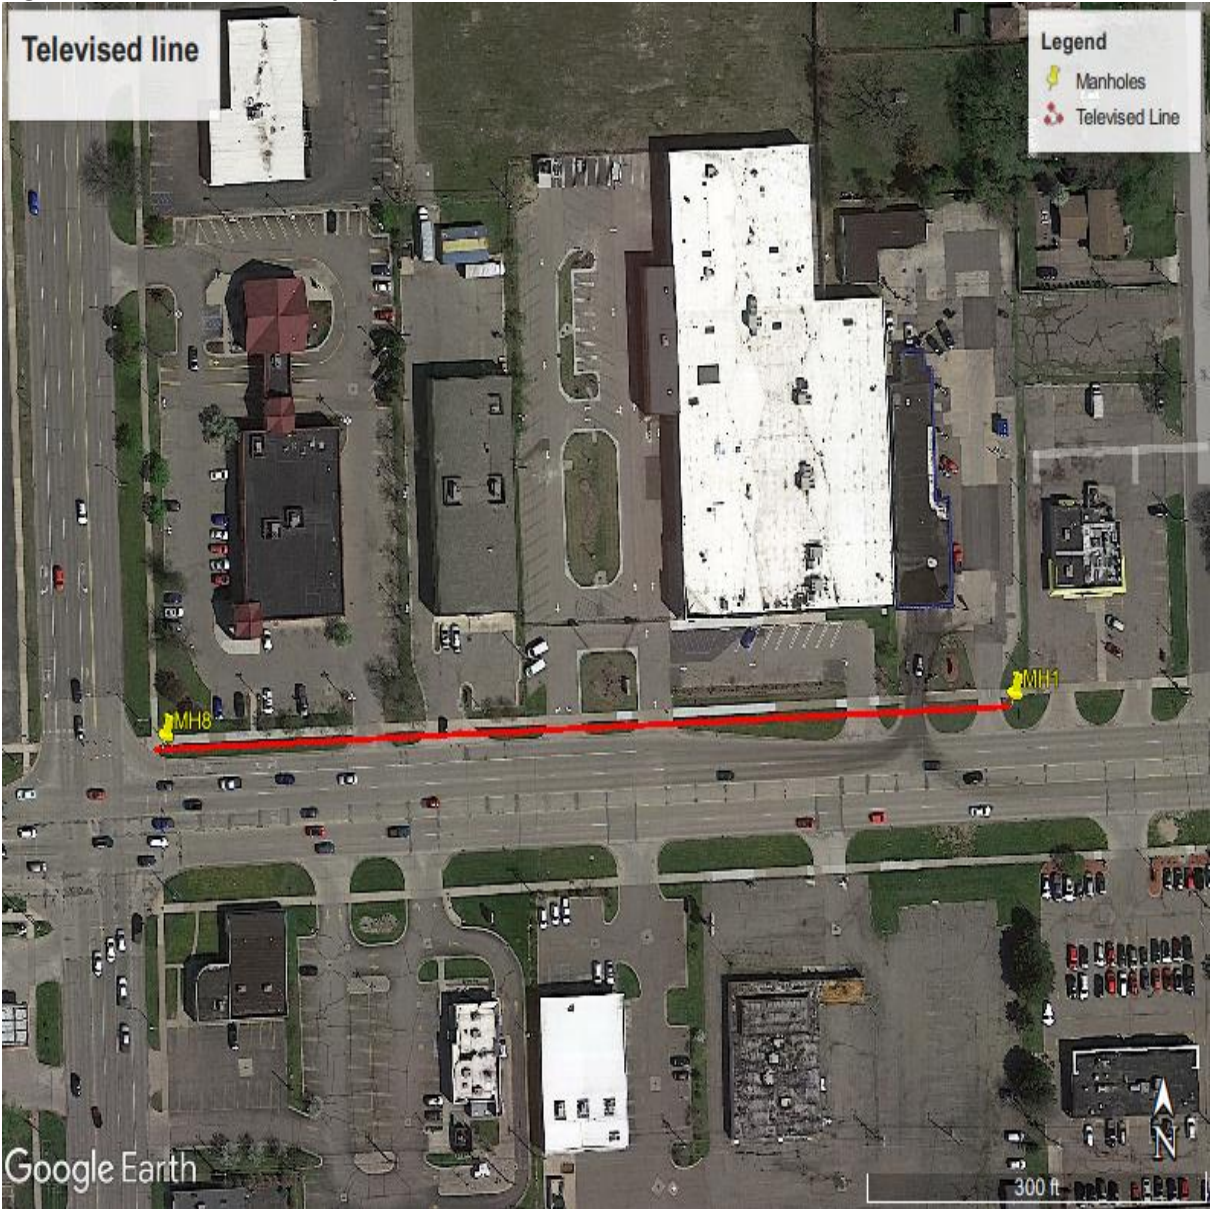
Figure 2. Televised Line Map

ECT worked with a televising crew on December 21, 2022 to televise the line starting at the manhole by the Chicken Shack along Seven Mile Road and ending at Middlebelt Road (Figure 2). Eight manholes were encountered along this section of pipe. No taps were found between manholes and the line ended at a 12" pipe that was bulkheaded. Inlets in the manholes appear to connect to catch basins along Seven Mile Road and to the parking areas of the businesses to the north of the storm drain. The CCTV report is included as Attachment A.

The source of the elevated *E. coli* at this outfall remains unclear. Additional inspections of catch basins and their connections along Seven Mile Road, upstream of the Chicken Shack are recommended.

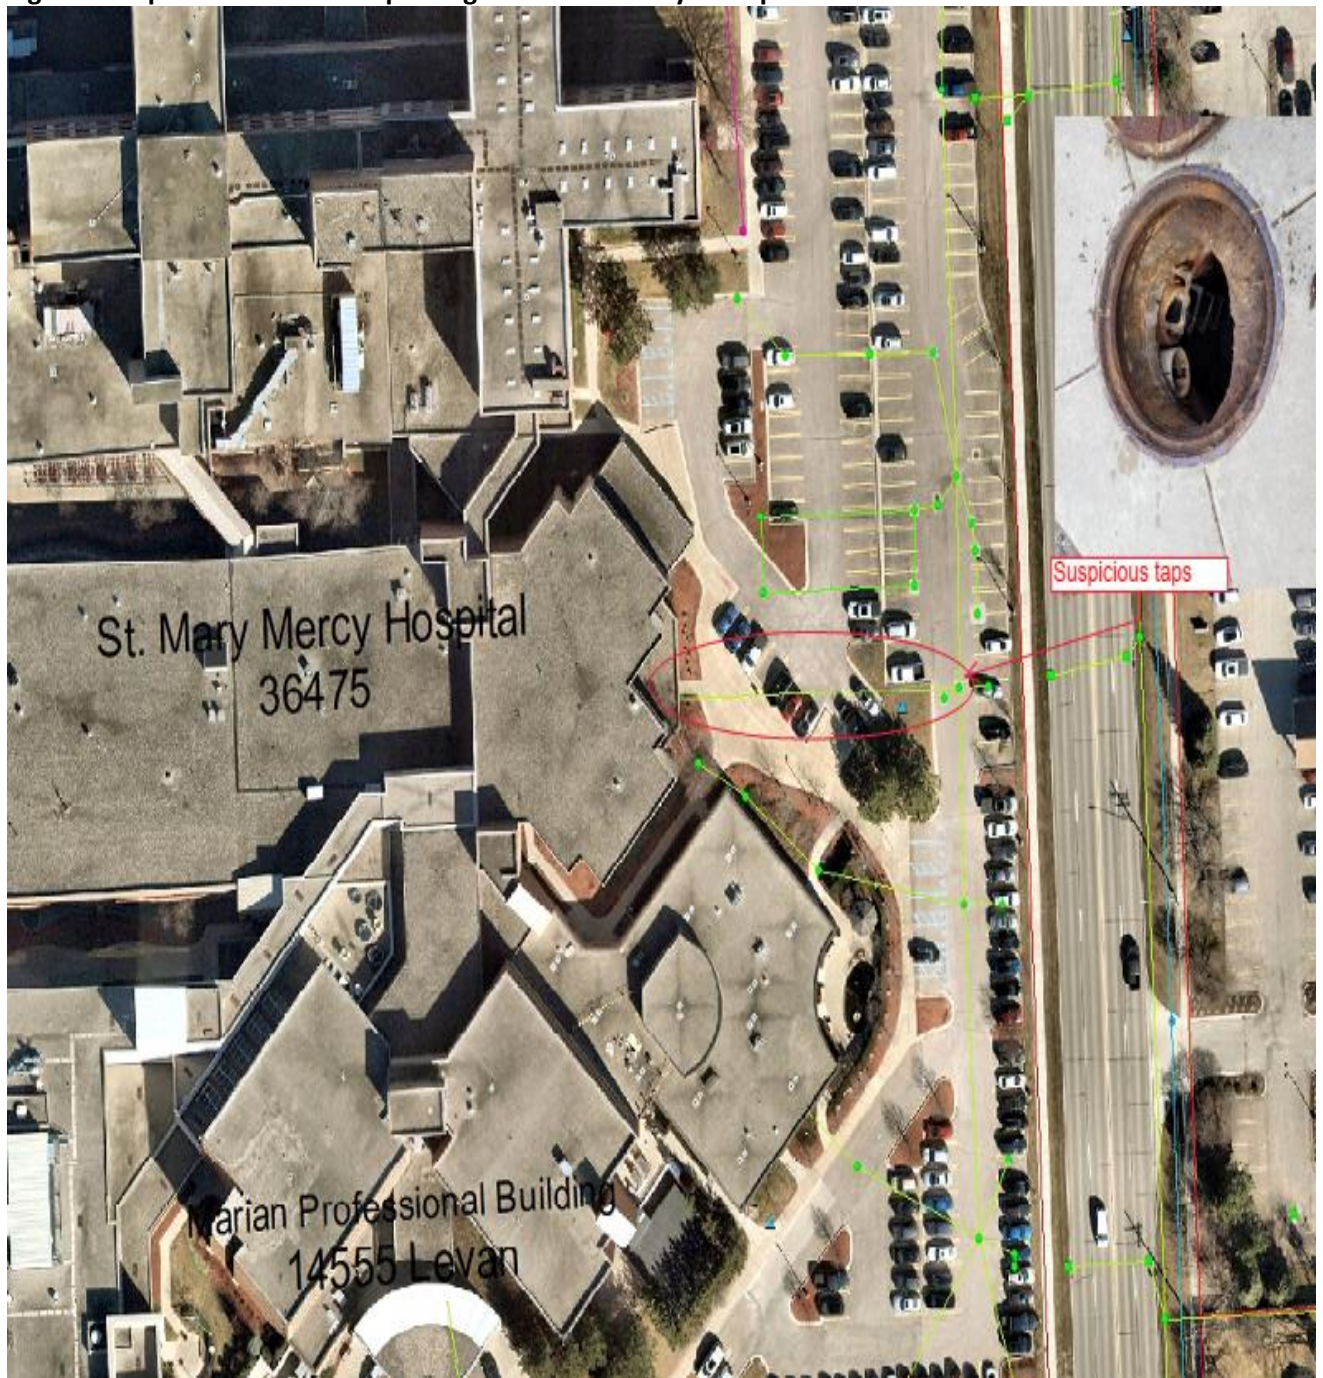
Inspections of manholes and review of utility drawings for the Hospital parking lot revealed a suspicious tap to the storm drain (Figure 2). Representatives from the Hospital cooperated with the City of Livonia and dye tested the area of the hospital closest to the tap. It was found that a section of the old emergency room had an illicit connection to the storm drain, which was subsequently corrected.

Figure 2. Tap to Storm Drain in parking lot of Saint Mary's Hospital

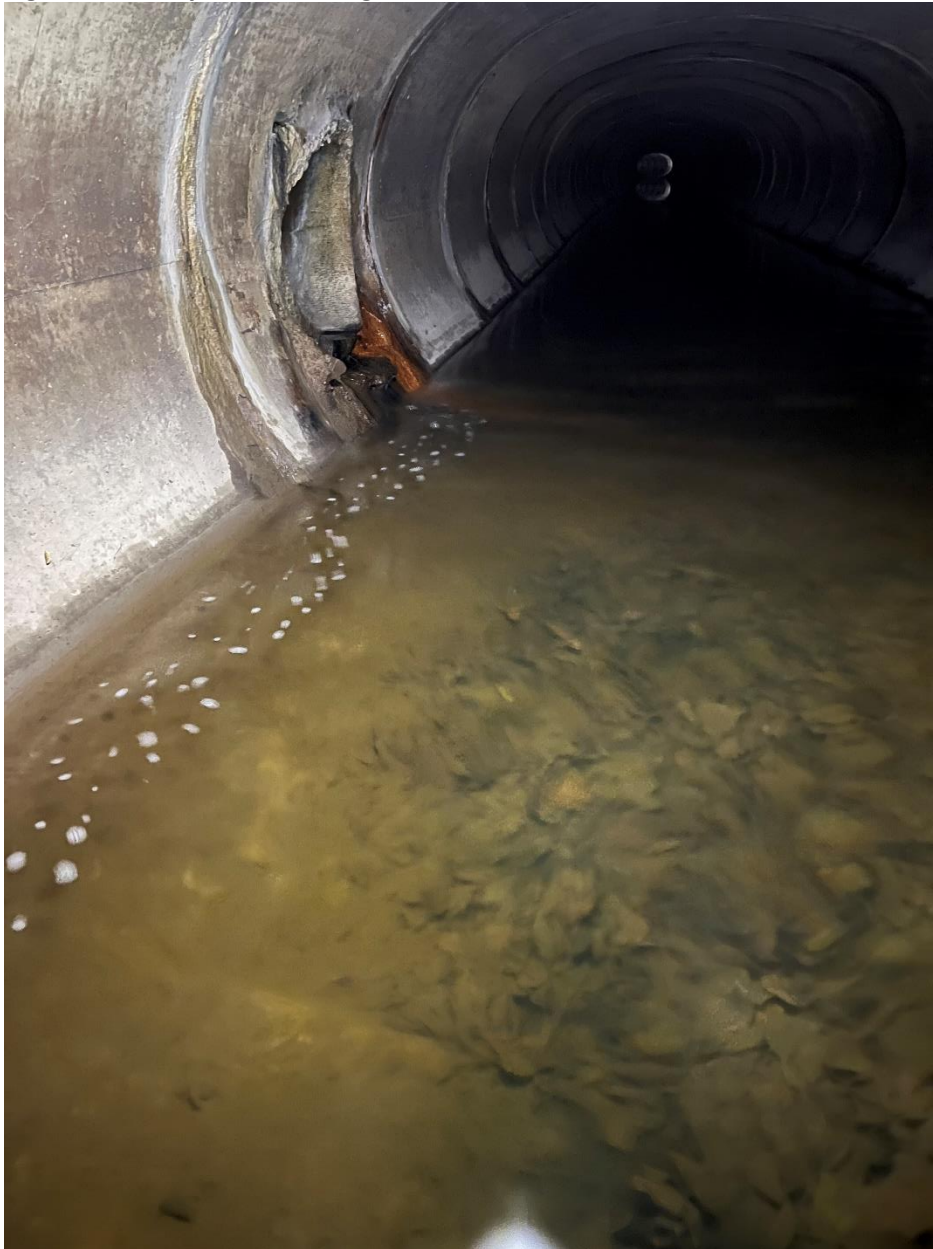
ECT resampled the outfall on November 3, 2022 to confirm that the corrected illicit connection had effectively reduced the *E. coli* levels coming from the outfall and found *E. coli* levels of 10 MPN/100 ml. However, during this sampling, bubbles that looked like soap were observed coming from the outfall (Figure 3). A test for surfactants was conducted in the field and surfactants level of 2.0 ppm was found. This indicates that although the *E. coli* source has been effectively eliminated, an additional pollutant source appears to be present that has been contributing surfactants to the river. Follow-up investigations were conducted later in November 2022. Surfactants levels of 2.0 ppm were consistently found in manholes in the hospital parking lot upstream of the outfall leading to the southern section of the parking lot. Due to a car being parked over a manhole, the investigation was not completed, and additional investigation is needed to narrow down the source of the surfactants.

Figure 3. Bubbly water coming from the outfall

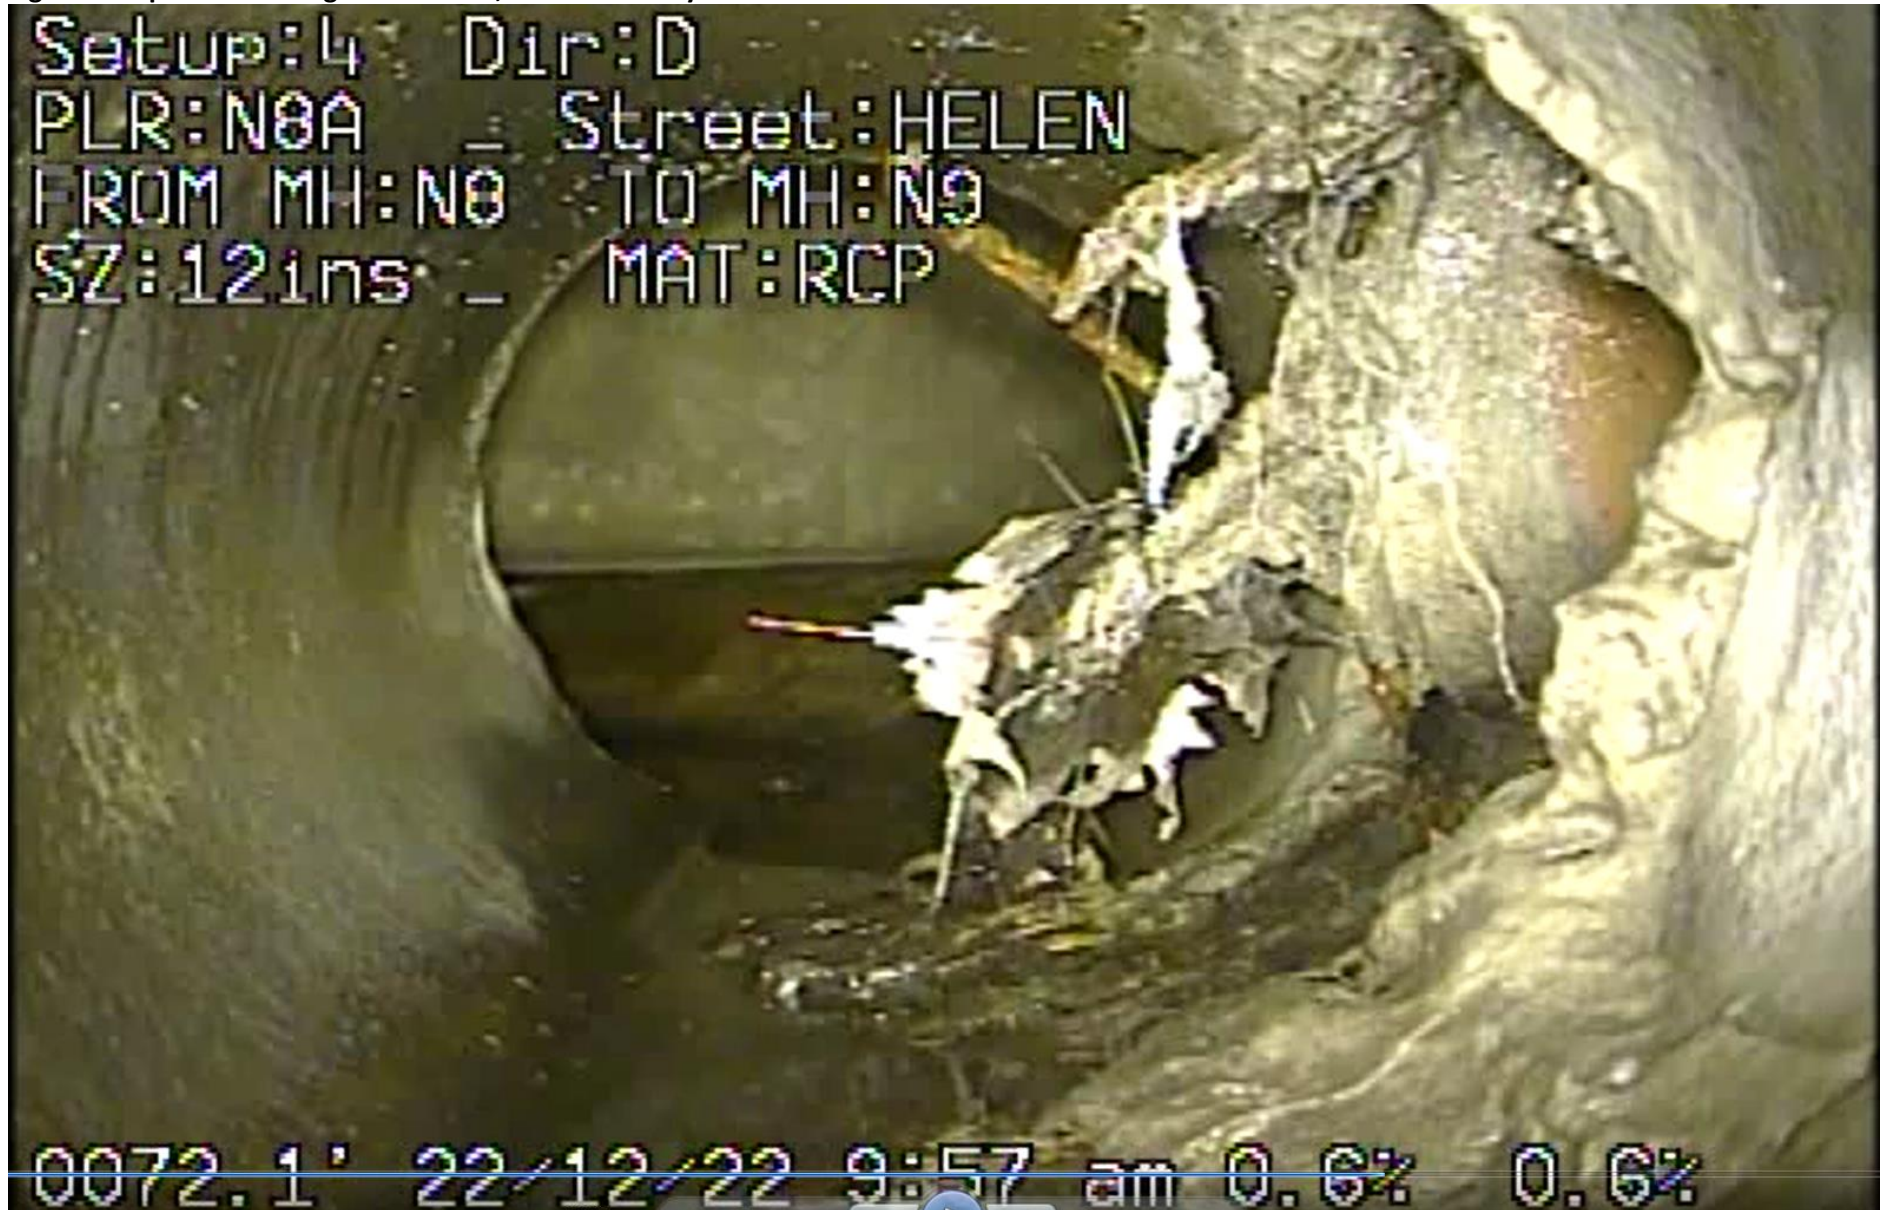
Based on the sample results from 2020 and 2021, ARC staff had the drains along Helen Street and Tromley Street televised in December of 2022. Although excessive sediment was found in the storm drain on Tromley Street, no evidence was found of illicit connections. On Helen Street, a tap was identified coming from the east side of Helen Street, south of the intersection with Cherry Hill Road (Figure 1).

Figure 2. Tap in drain along Helen Street, south of Cherry Hill Road

It is unclear whether the tap that was identified is an illicit connection or draining stormwater. Therefore, additional sampling immediately downstream of the tap is recommended to test for *E. coli* and human *Bacteroides*. If elevated levels are found, then dye testing the nearby apartment building may be the recommended next step.
