2021 Port Huron Habitat Site Report

Pine Grove Park and Kiefer Park

Report prepared for: City of Port Huron Projects: Pine Grove Park and Kiefer Park Report prepared by: Friends of the St. Clair River Funding provided by: EGLE Report date: March 28, 2022

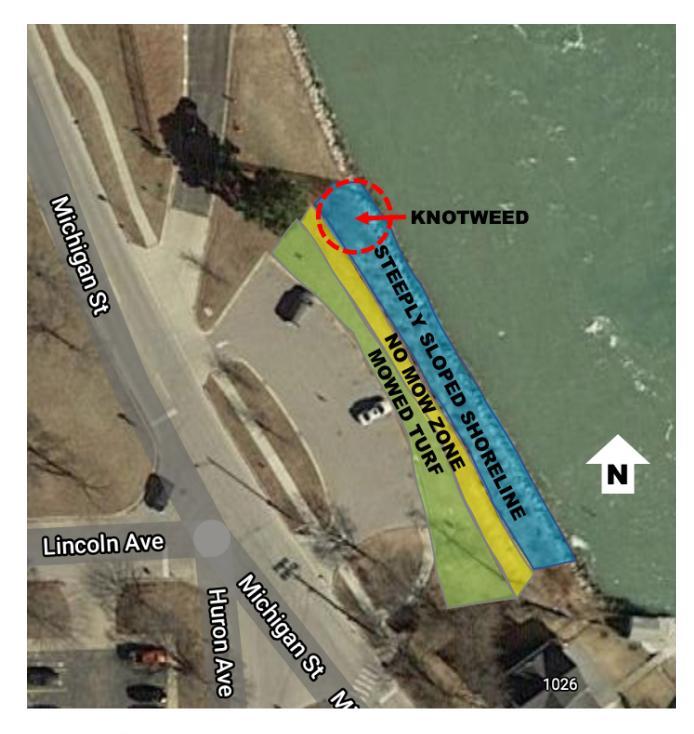
Port Huron – Pine Grove Park Shoreline fish & wildlife habitat Site sketch – management zones Friends of the St. Clair River – www.scriver.org

VEGETATION – Score: POOR

The street level area is kept mowed as well as the top 3 to 4 feet of the slope to the water's edge. On the steeply sloped portion adjacent to the river, native plants dominate, especially Indian Grass (*Sorghastrum nutans*). Non-native chicory and daisies and native milkweed were also observed. Opportunistic, native wild grape vine (*Vitis* sp.) and Virginia Creeper (*Parthenocissus quinquefolia*) are engulfing most of the trees. On the north end of the site there is a dense patch of invasive Japanese Knotweed (*Fallopia japonica*) which appears to be overwhelming the native trees.

Recommendations – Re-establish a no mow zone on the top three to four feet of the slope. Plant a low growing native ground cover in this area to help prevent erosion. Virginia Creeper is a native plant valued by wildlife and is already present on the site. Virginia Creeper can be trained to grow as a large-scale groundcover. Training involves cutting the vines to the ground where they are climbing trees, shrubs or other desirable native species, while allowing it to grow across the ground. Manage Japanese Knotweed in this project by herbicide application by a qualified contractor. Wild grape vine is an aggressive native species and should also be removed from trees and shrubs, and possibly treated with herbicide at the same time as Japanese Knotweed. Installing and repairing erosion control webbing will reduce erosion on the paths.

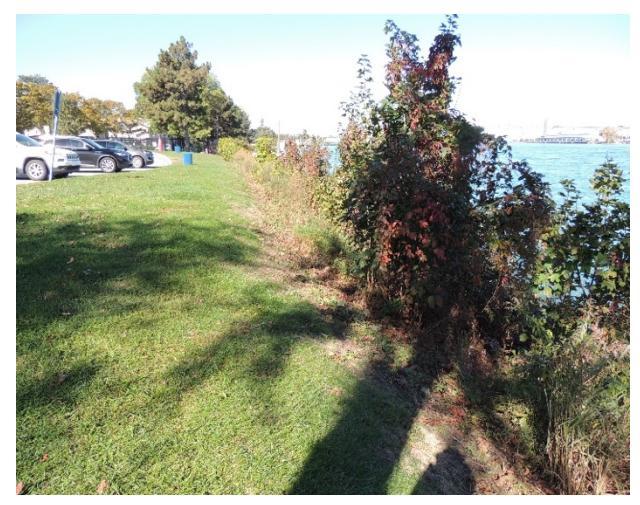
A view of the site from the south end showing the top of the slope is now bare soil and is eroding rapidly.

In some areas water is adjacent to the soil bank with no rock interface. Erosion of the upper slope has increased dramatically since last year. The plastic grid in place to prevent erosion is exposed and is breaking down.

Signage needs updating due to minor water damage. A tree has been cut down with only the stump remaining. Mowing of the grass on the upper 3 to 4 feet of the slope is increasing erosion on upland portion of the site.

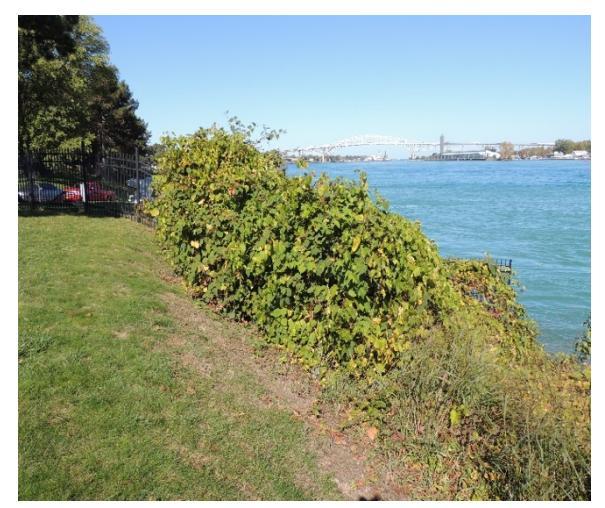
Invasive Japanese Knotweed covering trees at the north end of the site. Erosion can be seen in the foreground at top of slope.

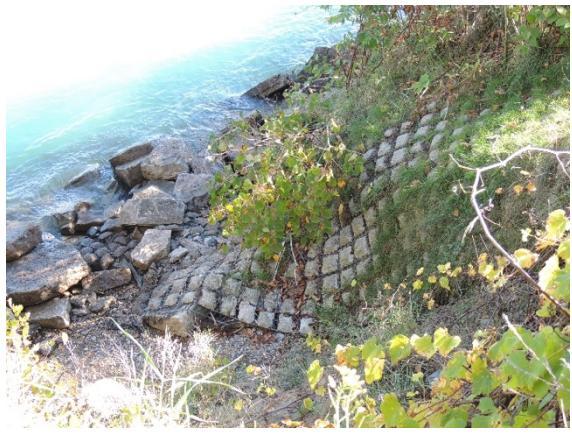
North end of the site showing the erosion undercutting the concrete erosion mat.

There is severe erosion on the north end of the slope. The concrete erosion control structure has been undermined near the water's edge. There has been severe erosion all along the bank/water interface. There is some erosion on the south end, but the grassy slope and concrete barrier has helped to reduce that.

Recommendations – There is a need to reinforce eroded areas especially at the north end. Invasive species control would also be helpful to support project intent of providing wildlife habitat.

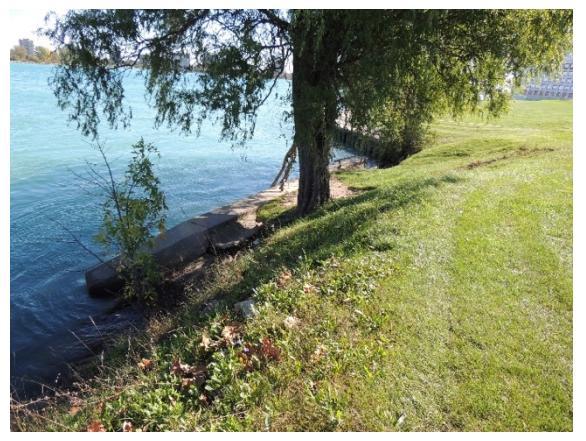
South end of the site with grassy slope, concrete barrier and debris hanging from the tree.

Debris was observed on the ground, including food wrappers, plastic bottles etc. even though garbage cans are present. Woody debris and ropes have been suspended from a tree at the south end.
