2017 ILLICIT DISCHARGE INVESTIGATIONS IN OAKLAND COUNTY'S PORTION OF THE ROUGE RIVER WATERSHED

FINAL REPORT

PREPARED FOR:
ALLIANCE OF ROUGE COMMUNITIES

PREPARED BY:
OAKLAND COUNTY WATER RESOURCES COMMISSIONER

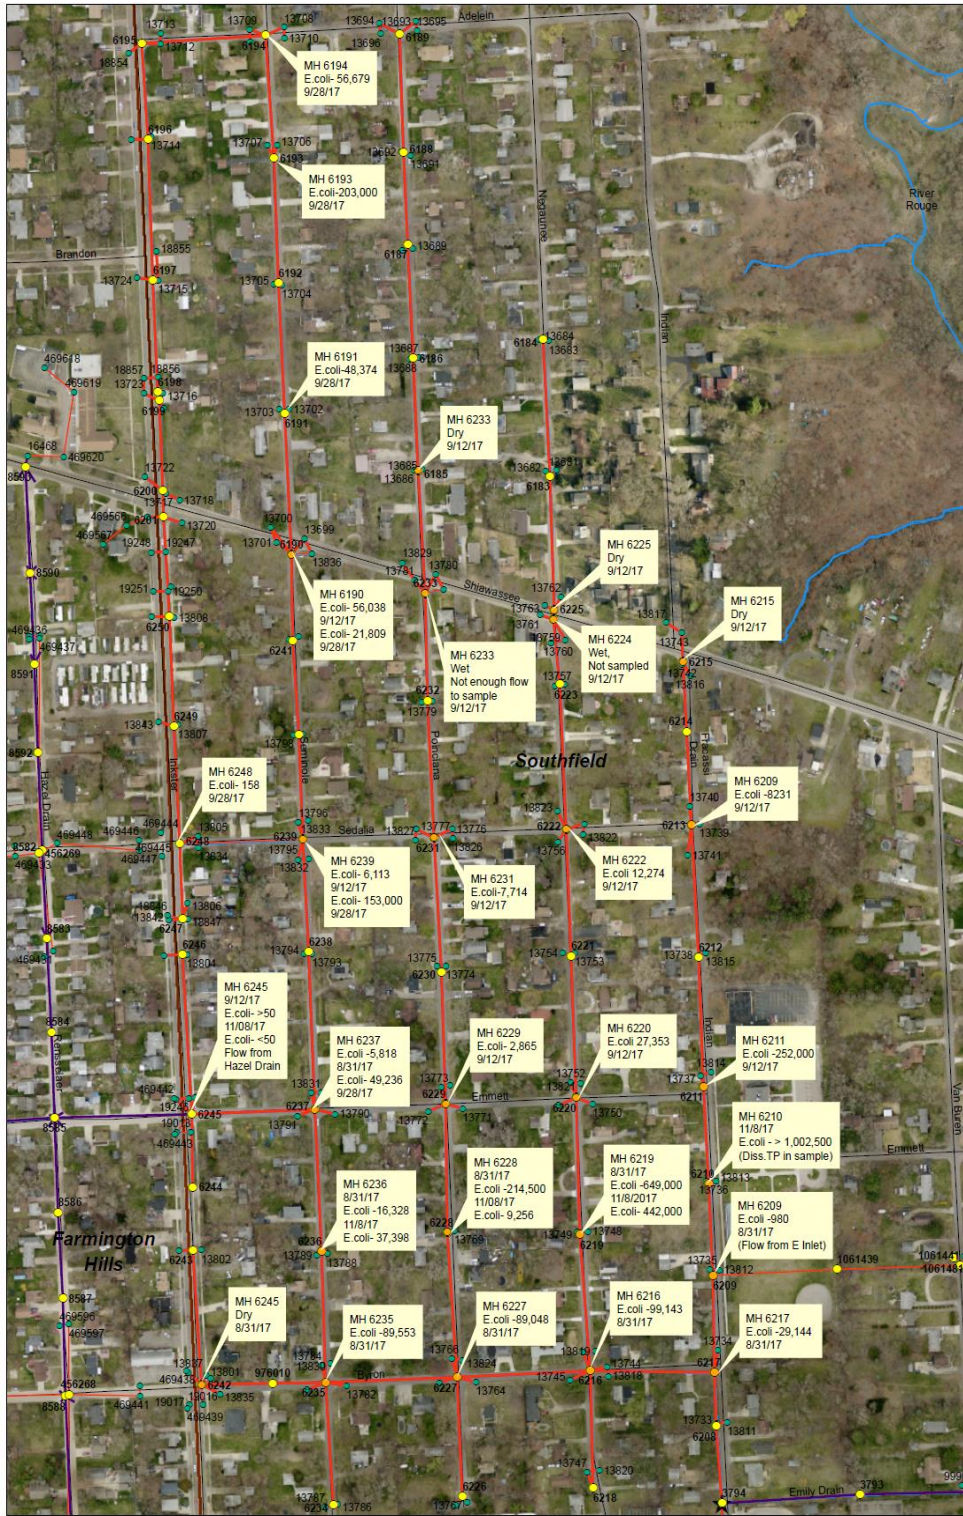
Figure 3: Fracassi Drain 2017 *E. coli* Sampling Locations and Results.

Manhole inspections and sampling indicate continue dry weather flow and high concentrations of *E. coli* in the drain on Indian Street south of the Shiawassee Road that is indicative of sanitary sewage. The highest concentrations, greater than 1,002,500 CFU/100 ML were found at MH 2610 just south of Emmet St. across from the John Grace Community Center. Visible observations at this MH also indicated the possible presence of dissolve toilet paper. A CCTV inspection of this section of drain between MH 6210 and 6211 found a connection of a 6-inch clay tile pipe inlet to the drain from the east in line with the south end of the John Grace Community Center Building. WRC met with the City of Southfield and arrangements were made to dye test the Community Center. Dye testing of the Community Center verified that bathrooms and connected fixtures along the front (west) side of the building located in the north, central and south end of the building and upstairs are connected to the sanitary sewer on Indian. However, dye testing of the bathroom and the kitchen in the southeast corner of the building along with

Manhole inspections and sampling of dry weather flow indicate high *E. coli* concentrations in the drain south of Shiawassee Rd to Byron St. with the highest concentration of 649,000 CFU/100 ML at MH 6219 south of Emmet Street. Cleaning and CCTV inspection of the storm drain on Negaunee Street began in 2017. Sections of the drain from MH 6224 south of Shiawassee Road to MH 2221 south of Sedalia Street were completed during the project period. No connections to the drain were found during CCTV inspection of these sections. Additional CCTV inspections of sections south of this point to Byron Street are expected to be scheduled in 2018.

Fracassi Drain, 2017 IDEP Project E.coli Sampling, Southfield

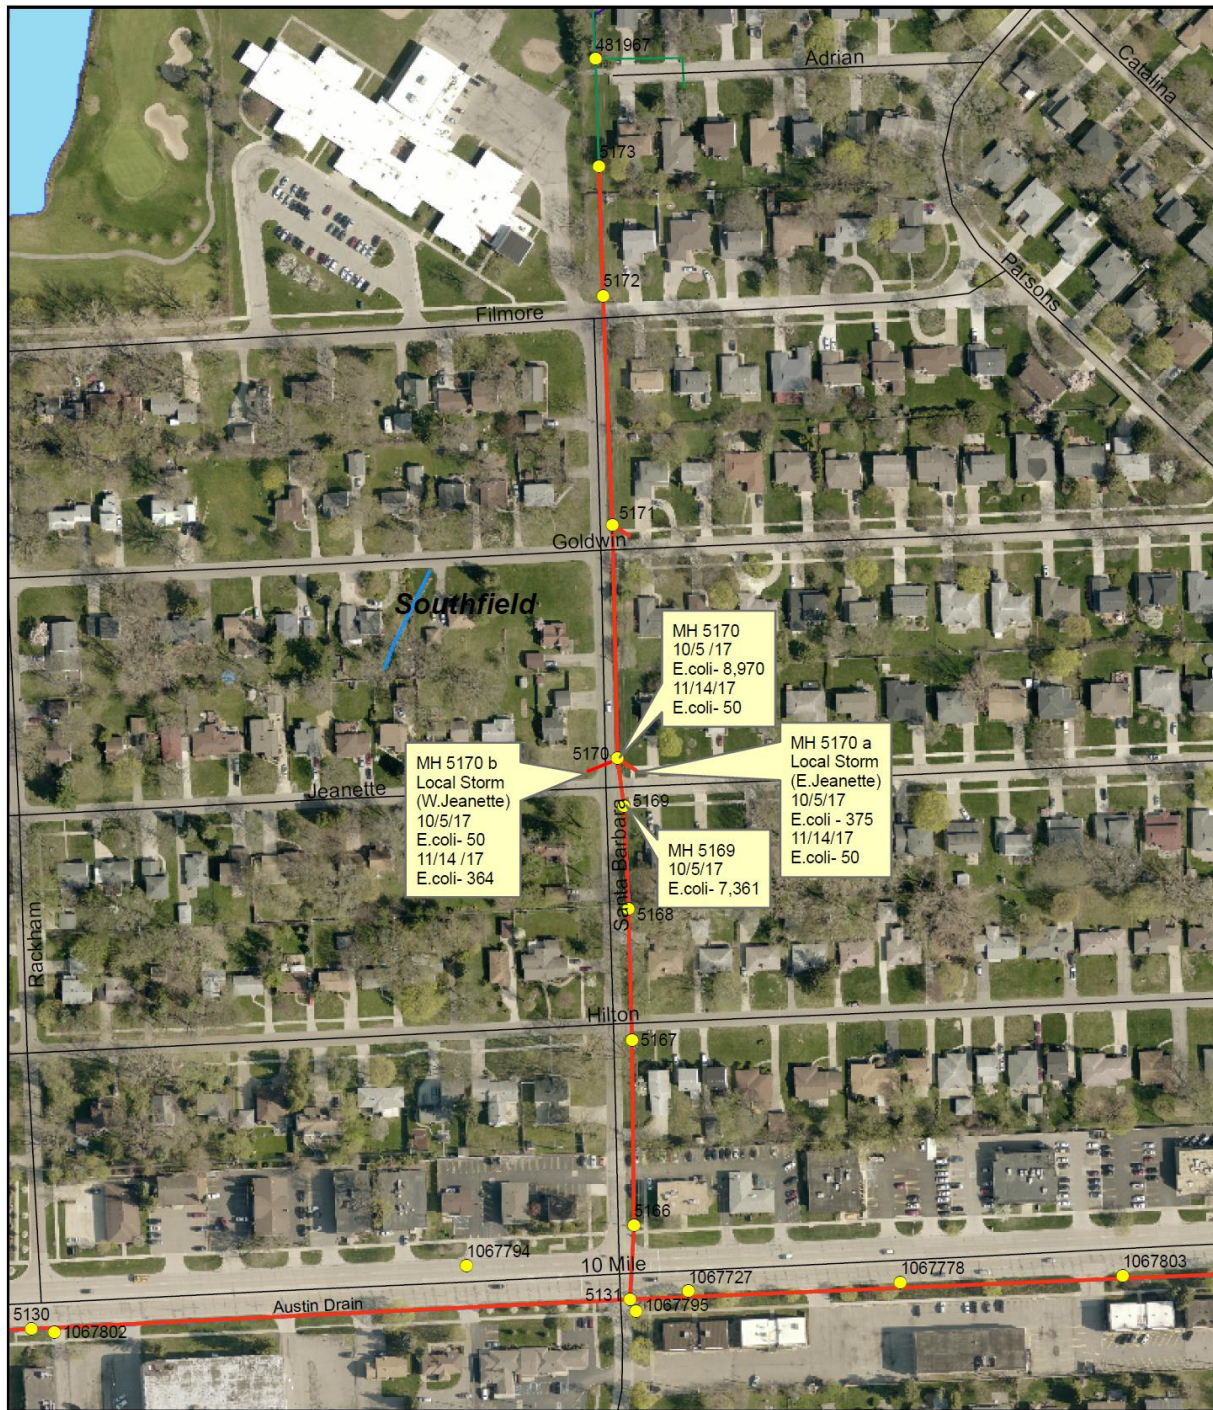
Figure 5: 2017 Austin Drain Sampling Locations and Results

Austin Drain, E.coli Sampling Map 10/5/17 & 11/14/17 Southfield

- No additional advance IDEP Investigations are recommended at this time.
- Additional DWS data is needed to evaluate the drain for upstream illicit discharges and investigations. It is recommended that WRC collect additional dry weather screening data under their IDEP Program at the drain lateral on Santa Barbara Street in 2018.

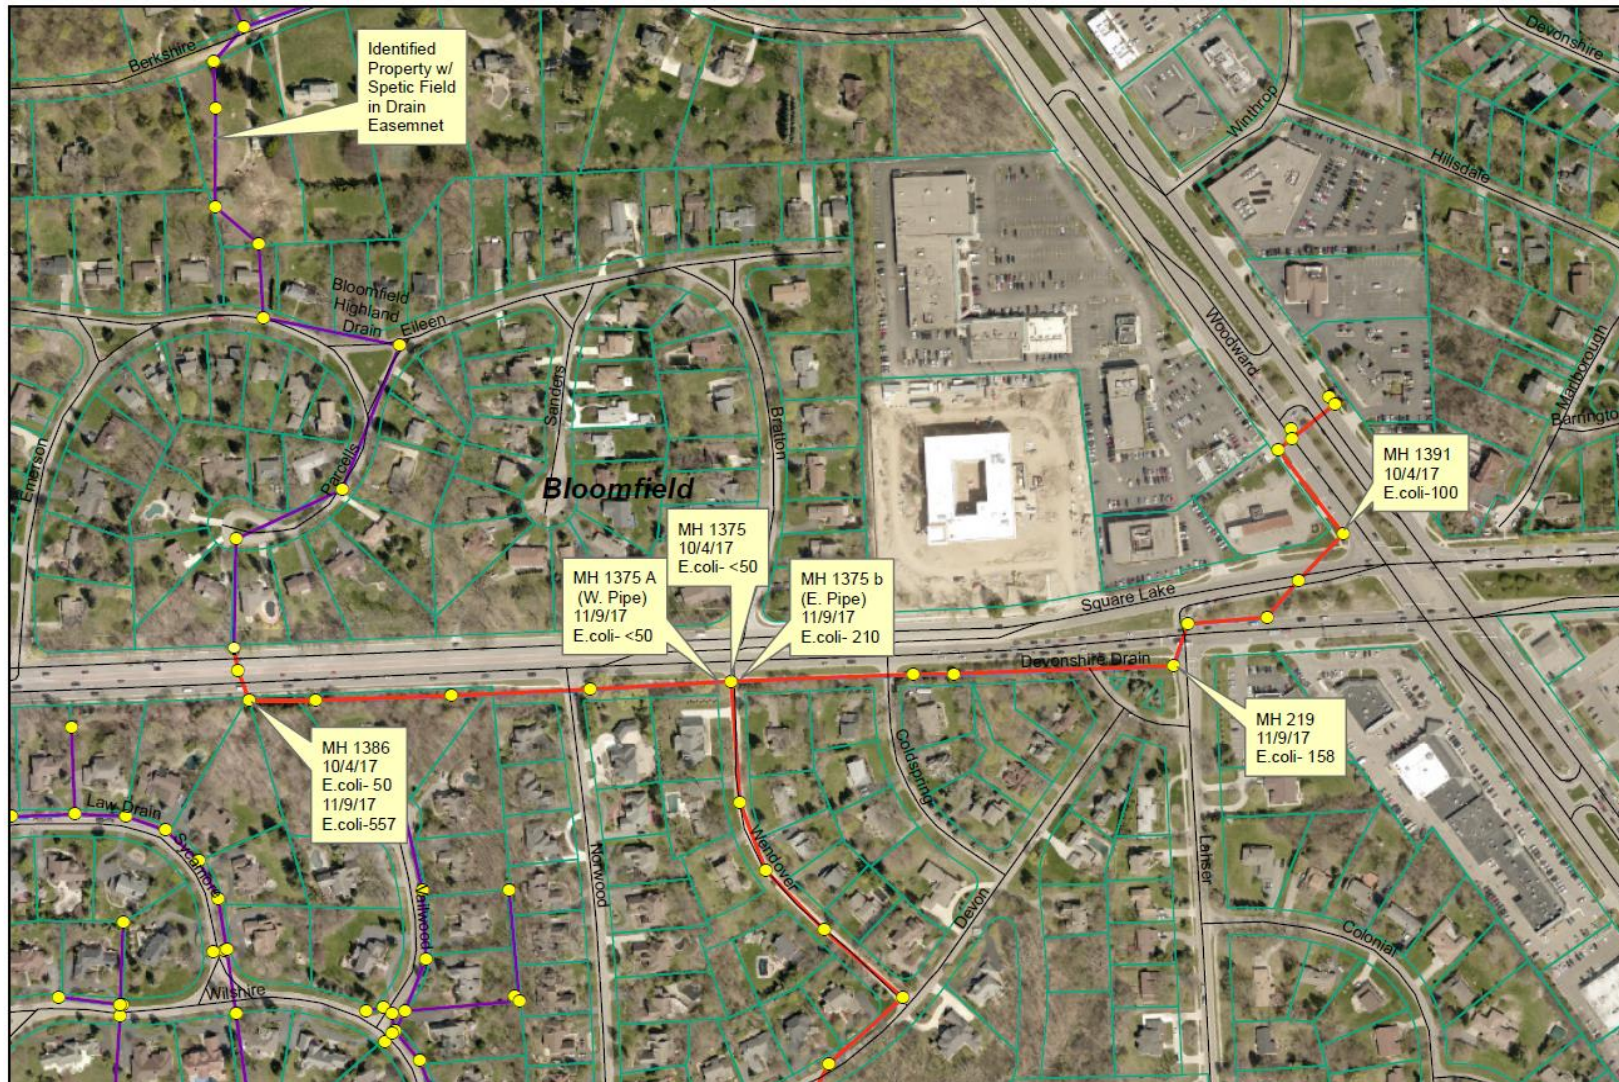
Figure 6: Devonshire Drain Sampling Locations and Results

**Devonshire Drain,
E.coli Sampling, 10/4 & 11/9 2017
Bloomfield Twp.**

- No additional sampling or investigation of the drain is recommended at this time.
- The drain will be put back on the list for periodic dry weather screening by WRC under their IDEP Program beginning in 2018.
- Follow up with the Oakland County Health Department on the status of the permit for new construction for the septic system located at 127 S. Berkshire in 2018 is recommended.

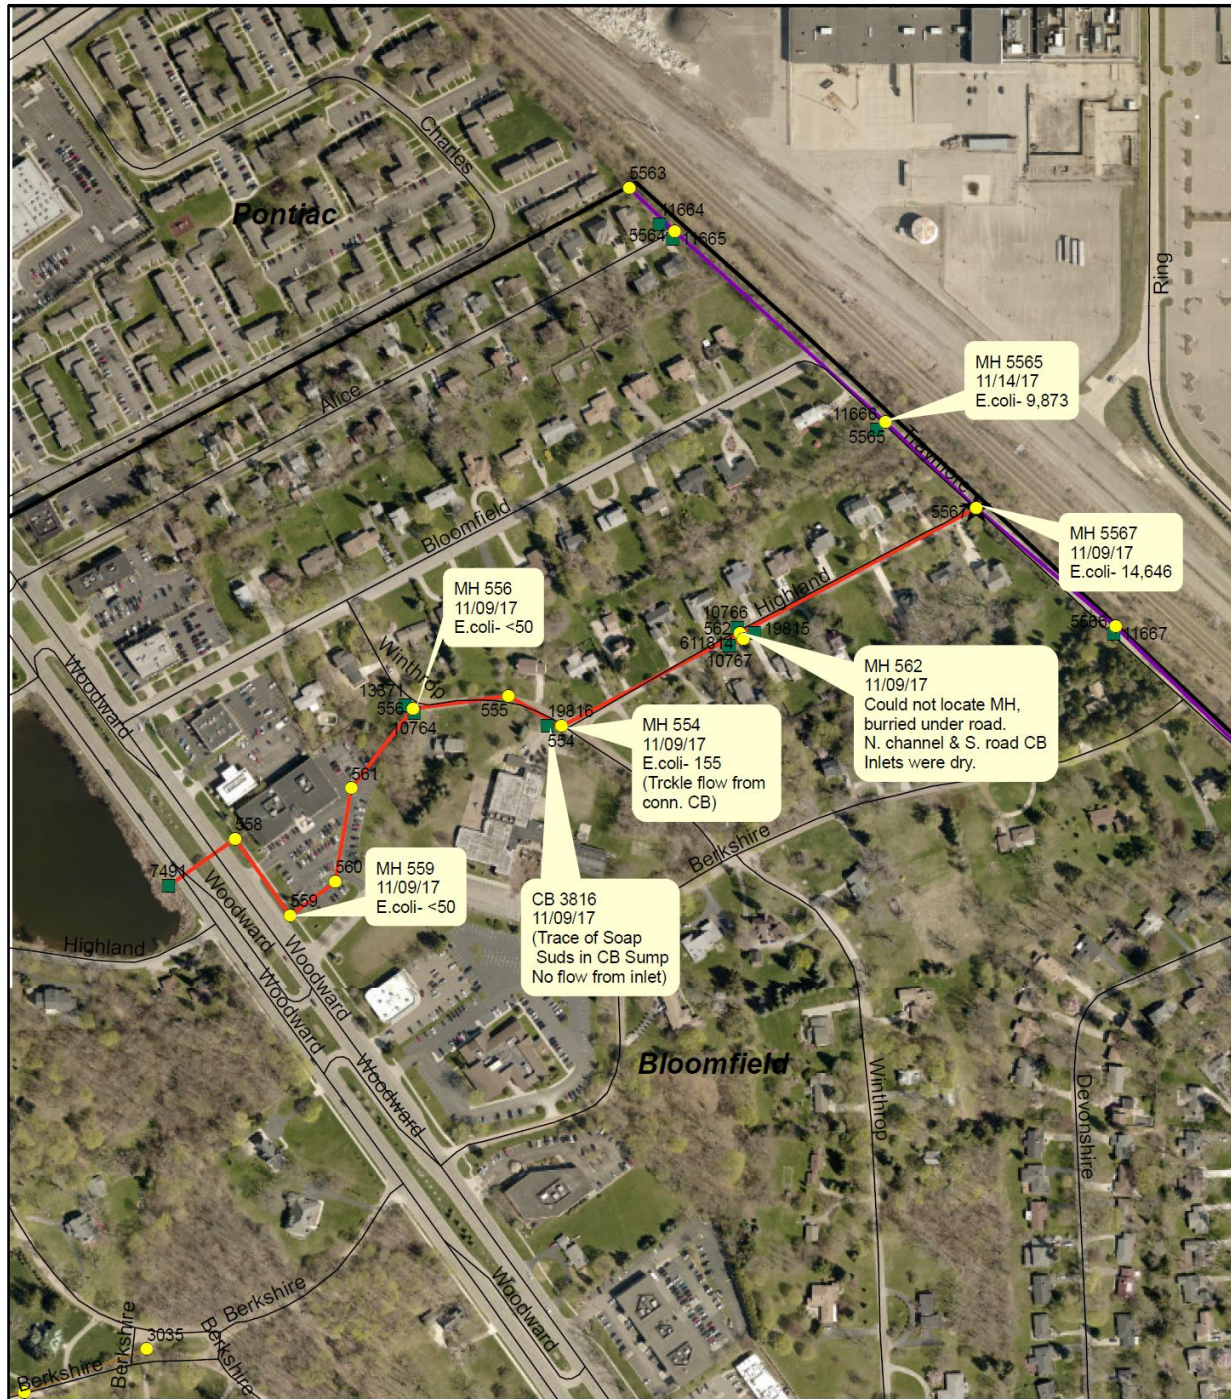
Figure 7: Claude H. Stevens Drain No. 1 Sampling Locations and Results

drain was found. A trickle flow observed at MH 554 from a connected catch basin located in driveway off Winthrop for the Rectory at St. Georges Orthodox Church and School. Inspection of the catch basin found a residual trace of soap suds in the catch basin sump. No flow was observed in the connected property drain inlet. A survey of the Church and School parking lots did indicate any activities that would contribute to soap suds in the catch basin.

**Claude H. Stevens No.1 Drain
Investigation & Sampling Results, 11/9 & 11/14 2017
Bloomfield Twp.**

- No additional sampling or investigations of the C. H Stevens No. 1 Drain are recommended at this time.
- Follow up with WRC Drain Maintenance and Bloomfield Twp. on buried manhole cover and possible flooding issues at MH 652 is recommended.
- Follow up with Bloomfield Twp. on soap suds issue in the catch basin for St. George's Church and School Property is recommended.
- Additional follow up sampling on the Hamlin Drain in 2018 is recommended.

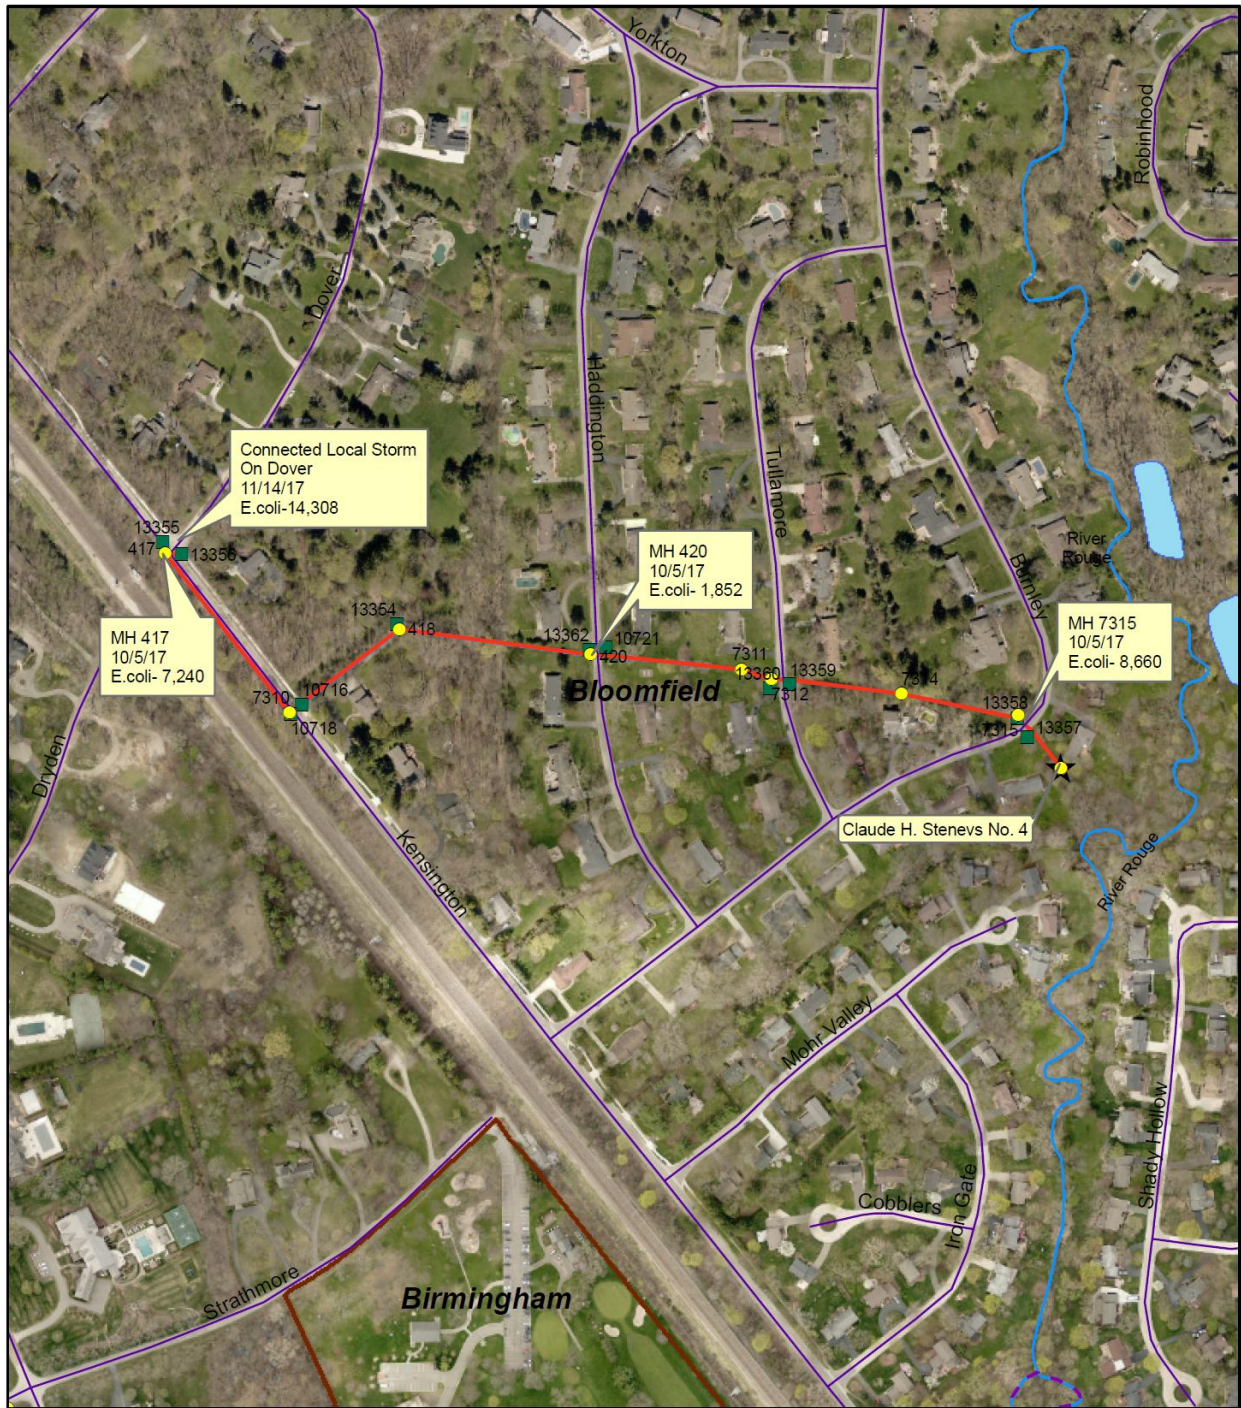
Figure 9: Claude H. Stevens No. 4 Drain Sampling Locations and Results

In 2017 the drain was sampled for *E. coli* at four (4) locations including; MH 3375 near the outlet of the Drain on Burnley Street, at MH 420 on Haddington Street and at MH 417 in Kensington Rd. A connected MH from a local drain system on Dover Street was also sampled. A map of sampling locations and results is included as Figure 9. A table of sampling results is included in Appendix C.

All MH locations showed *E. coli* concentrations greater 1,000 CFU/100 ML. Sampling of the upper terminus of the drain at MH 417 in Kensington Road showed *E. coli* concentrations of 7,240 CFU/100 ML. Examination of this manhole showed connections for catch basins picking up road drain ditches on the northeast and southeast corners of Kensington Road and Dover Street. An additional inlet with a connecting MH in Dover Street was also identified. The inlet exhibited dry weather flow was found to be from a 6-inch clay tile crock drain under the center of the street. Sampling of flow in the connected drain showed *E. coli* concentrations of 14,308 CFU/100 ML. This drain system is not connected to the

**Claude H. Stevens No. 4 Drain
E.coli Sampling Results 10/5 & 11/4 2017
Bloomfield Twp.**

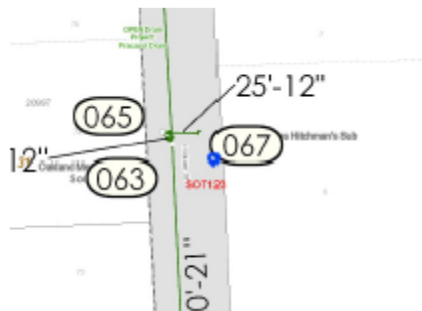
Photo	Not Applicable
Sample	Not Applicable
Results	Not Applicable
Comments	Front and upstairs bathrooms on the W. side of the building are connected to the sanitary sewer on Indian St. Connections for kitchen, bathroom, utility room and basement floor drains is unknown. Dye was not found in the sanitary or storm drain systems for the property. Follow up investigation is needed.

Diagram of John Grace Elementary School Sanitary Sewer Plan.
