**Office of the Great Lakes, Areas of Concern Program  
Michigan Department of Environmental Quality  
Statewide Aesthetics Assessment Findings for Impaired AOCs**

Muskegon Lake, Clinton River, Rouge River  
and Detroit River Areas of Concern

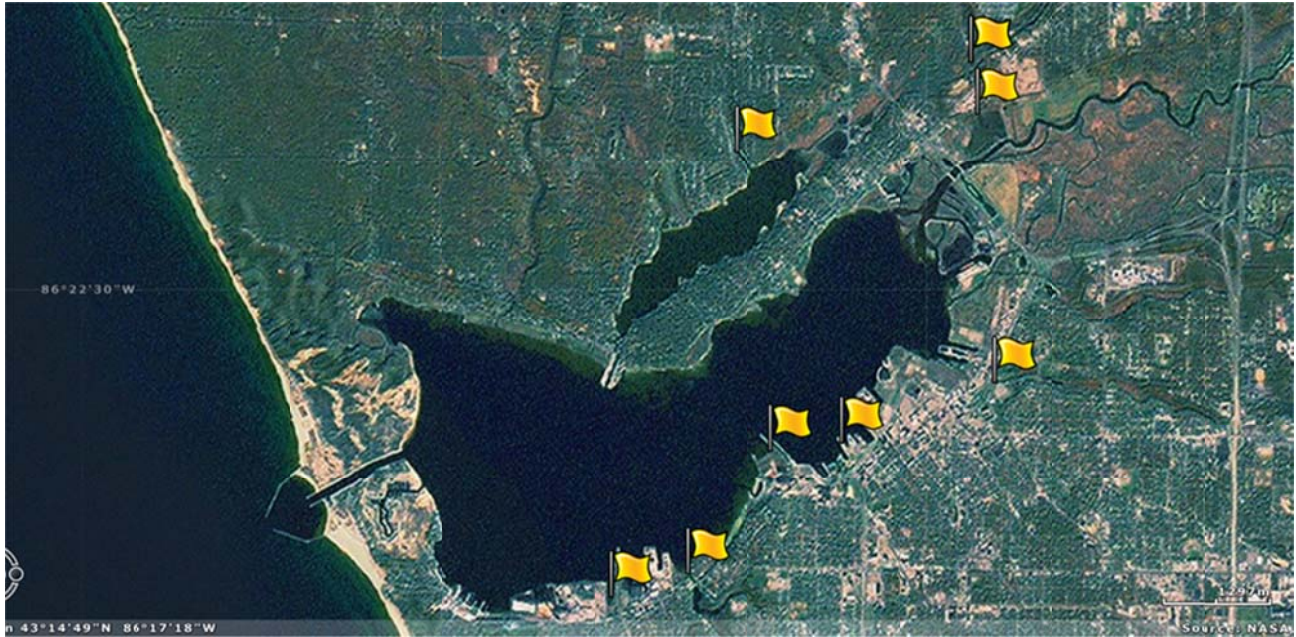
**Figure 1. Muskegon Lake Aesthetics Monitoring Locations.**

**Muskegon Lake** was assessed on July 12 and November 29, 2011, see Figure 1 for locations. Eight sites were assessed around Muskegon Lake. Staff identified the ongoing oil leak in Fenner's Ditch, which feeds Bear Lake, and petroleum odors and oil films near Bear Creek and adjacent to Celery Lane, near the Zephyr site (determined by the DEQ to be a "facility" under Part 201, Environmental Remediation, of the Natural Resources and Environmental Protection Act, 1994 PA 451, as amended) as potentially impairing designated uses. Also noted was abundant trash in a small area of Ryerson Creek, resulting from a backed up culvert near the farmers market. Since the assessments, the Ryerson Creek culvert was replaced and its elevation adjusted to restore stream flow, which also appears to be alleviating the accumulation of trash. DEQ AOC staff conclude the Muskegon Lake AOC continues to be aesthetically impaired, due to petroleum contamination at the Fenner's Ditch and Zephyr sites.

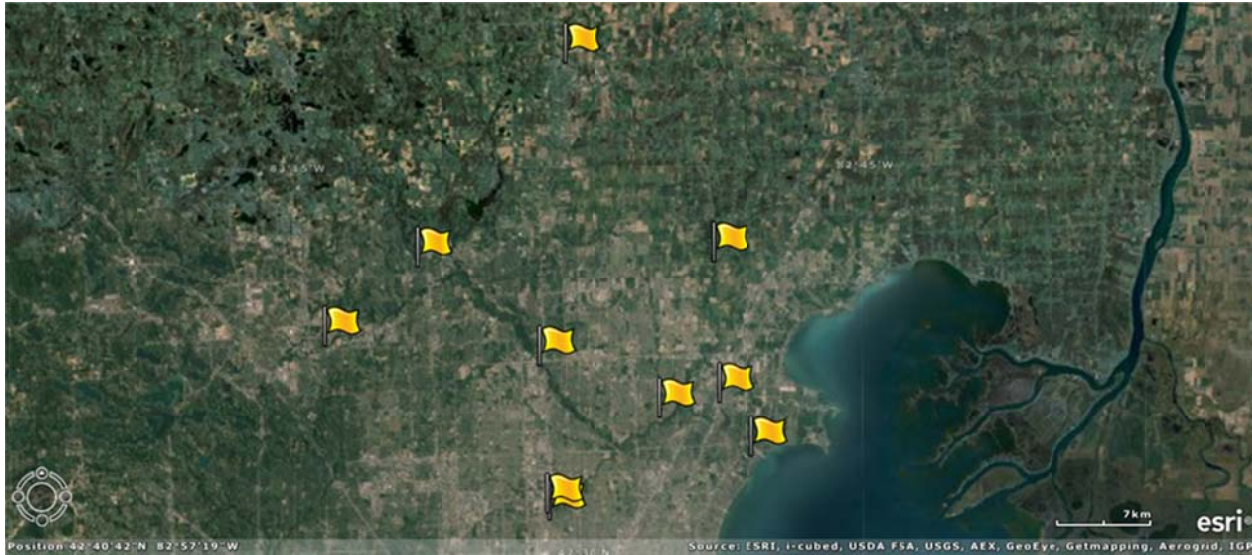
**Figure 2. Clinton River Aesthetics Monitoring Locations.**

The **Clinton River** was assessed on July 27 and November 16, 2011. See Figure 2 for locations. Ten sites were assessed in the Clinton River watershed during the initial round of monitoring. Although there are dissolved oxygen and *E. coli* Total Maximum Daily Loads (TMDLs) in place for specific parts of the Clinton River AOC, there was no evidence of potential aesthetic impairments observed, outside of a small amount of debris in one limited area. Evidence of wildlife habitat was observed, along with minnows, shore birds, aquatic insects, crayfish, etc. One person was observed paddling a kayak in the Clinton River in downtown Mt. Clemons and children were seen playing in Paint Creek, a tributary of the Clinton River, at the City of Rochester municipal park. In the days immediately following the conclusion of the first cycle of monitoring, information came to the attention of AOC staff regarding a potentially aesthetically impaired site in the AOC, of which staff were not previously aware. On September 21, 2011, the DEQ AOC Coordinator visited the St. Lawrence Cemetery on Auburn Road, in Macomb County and took a number of photographs showing an inactive landfill behind the cemetery, on the banks of the Clinton River. Over time, the banks have eroded, exposing landfill debris and leachate seeps. Some of the debris continues to fall into the river, and water of unnatural characteristics had been observed discharging into the Clinton River. This site was added to the list of monitoring locations for the second round of assessments.

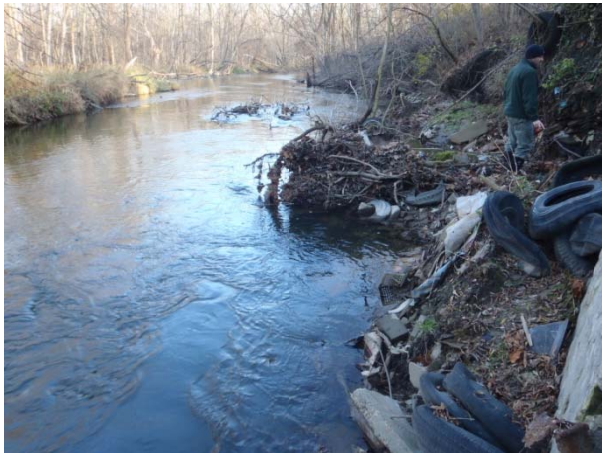
During the November 16, 2011 assessment, additional photographs of the landfill area were taken showing a six to eight foot vertical wall of landfill debris sloughing into the river (Figure 3). The debris found in the immediate area included: car bodies, a transmission, a motorcycle frame, a clothes dryer, scores of tires, glass bottles, plastic toys, bicycle parts, plastic bags, wood debris, and other various forms of trash. In terms of water quality, discolored water was observed seeping out of the exposed river bank and into the river (Figure 4). However, surface samples of river water that were collected adjacent to the site did not exhibit unnatural color, but petroleum odors were present, as were oily sheens and biofilms.

**Figure 3. St. Lawrence Cemetery Property, 11-16-11**

The site was immediately referred to the DEQ's Water Resources Division and Remediation Division for further investigation and follow up. On September 1, 2011, water and sediment samples were collected from the site for analysis. The water samples exceeded aquatic life values developed for both mercury and copper. The sediment samples did not exceed available screening value concentrations. A meeting has been scheduled with the landowners, regulatory authorities and other stakeholders to begin the process of determining how best to proceed with site remediation. It is the professional opinion of AOC program staff that due to ongoing, persistent conditions at the St. Lawrence Cemetery site immediately adjacent to the Clinton River, the aesthetics beneficial use in the Clinton River AOC remains impaired.

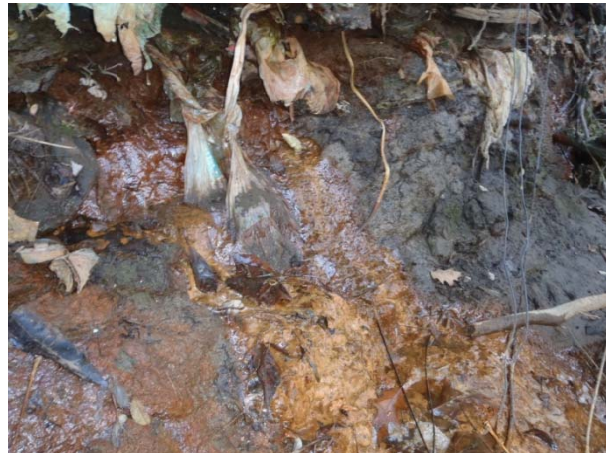
**Figure 4. Landfill Leachate, 11-16-11**

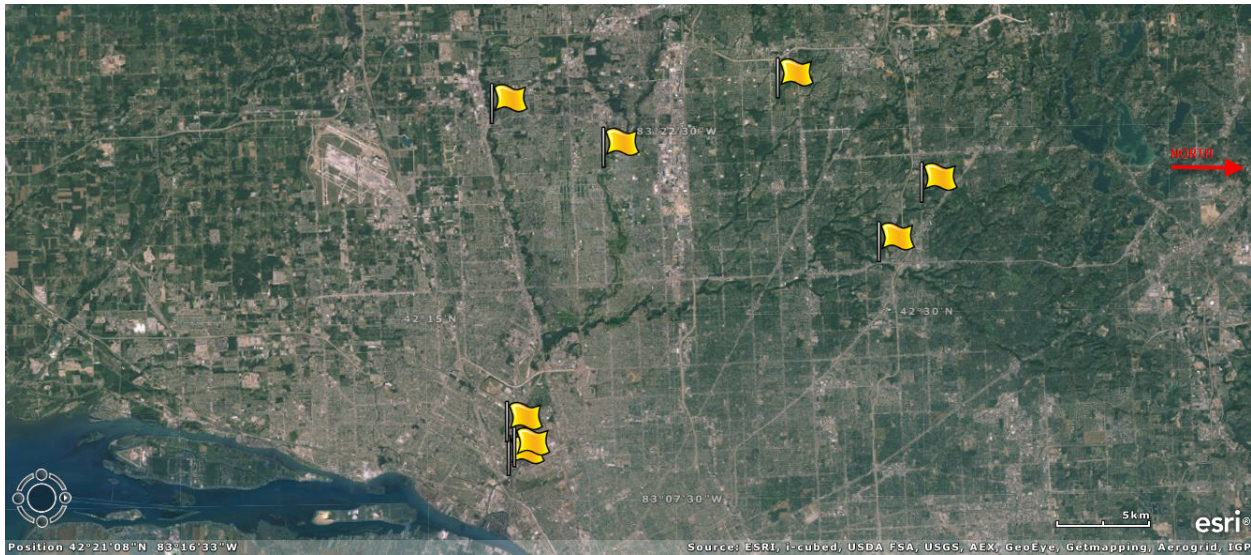
**Figure 5. Rouge River Aesthetics Monitoring Locations.**

The **Rouge River** was assessed from shoreline locations on July 28 and November 17, 2011. See Figure 5 for locations. Eight sites were assessed in the Rouge River AOC from shore. The mouth of the river was observed from the water on August 9, 2011, as an excursion from the Detroit River assessment, from the river mouth up to Jefferson Avenue. Significant rain fell overnight prior to the July and August dates. A number of aesthetic issues were identified, including frequent oil sheens, chemical odors, debris resulting from apparent Combined Sewer Overflow discharges (floating sanitary trash), and the appearance of the river in some areas was extremely turbid and almost opaque.

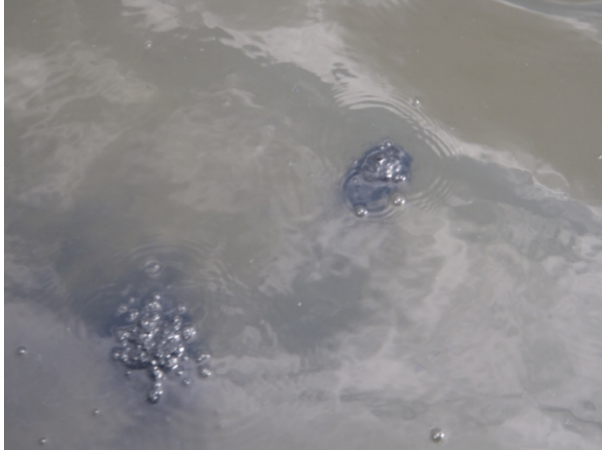
On August 9, for approximately a couple hundred yards downstream of the Detroit Water and Sewerage Department (DWSD) outfall #050, prolific gas bubbling was observed at the surface, which occasionally buoyed globs of fine, black sediment to the surface. At the outfall location, oil sheen was observed and the discharge was extremely dark, coloring the river from the outfall discharge point to the mouth where the Rouge River discharges into the Detroit River (see Figures 6 and 7). Additional photos and video of these phenomena were captured and are available. In July, at the Fordson Island site in Dearborn on the lower main stem of the river, staff disturbed the sediment to observe the release of oily black sediment from the river bottom.

Figure 6. Rouge River Sediment Globs, 8-9-11.

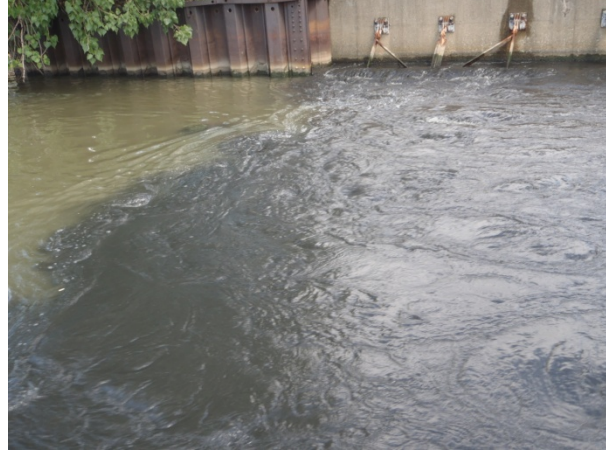
Figure 7. Rouge River DWSD Outfall #050, 8-9-11.

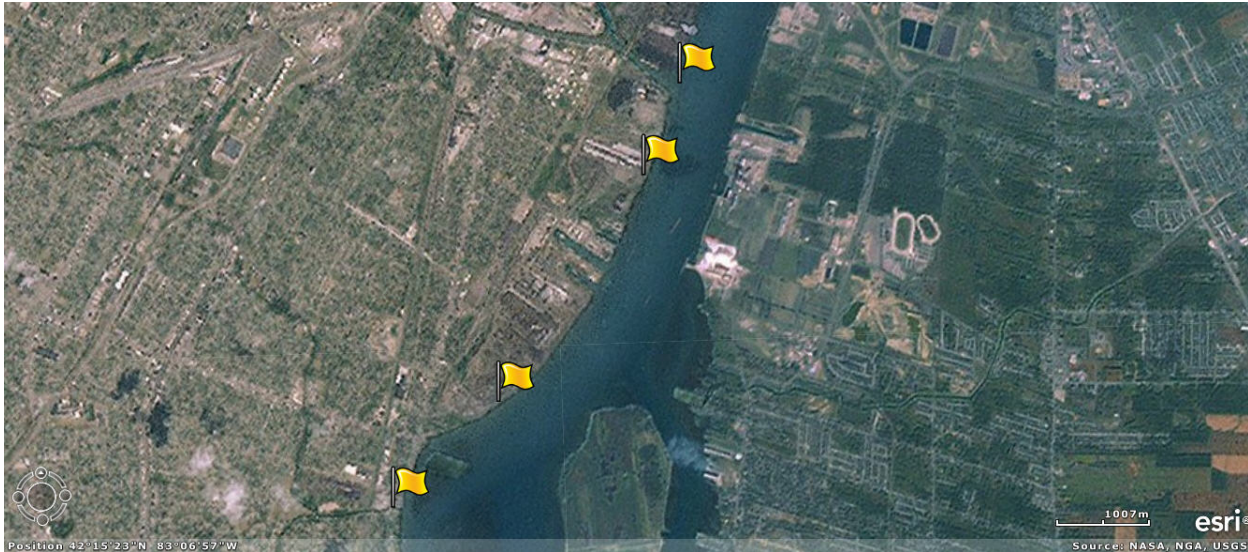
Figure 8. Detroit River Aesthetics Monitoring Locations.

The **Detroit River** was assessed on August 9 and October 31, 2011. See Figure 8 for locations. Four sites were assessed from the water, courtesy of Detroit Riverkeeper, Robert Burns. The DEQ would like to acknowledge and thank Mr. Burns and the Friends of the Detroit River for providing DEQ staff with the opportunity to observe the Detroit River system on board their vessel, and for sharing his personal knowledge of the history and conditions of the Detroit River.

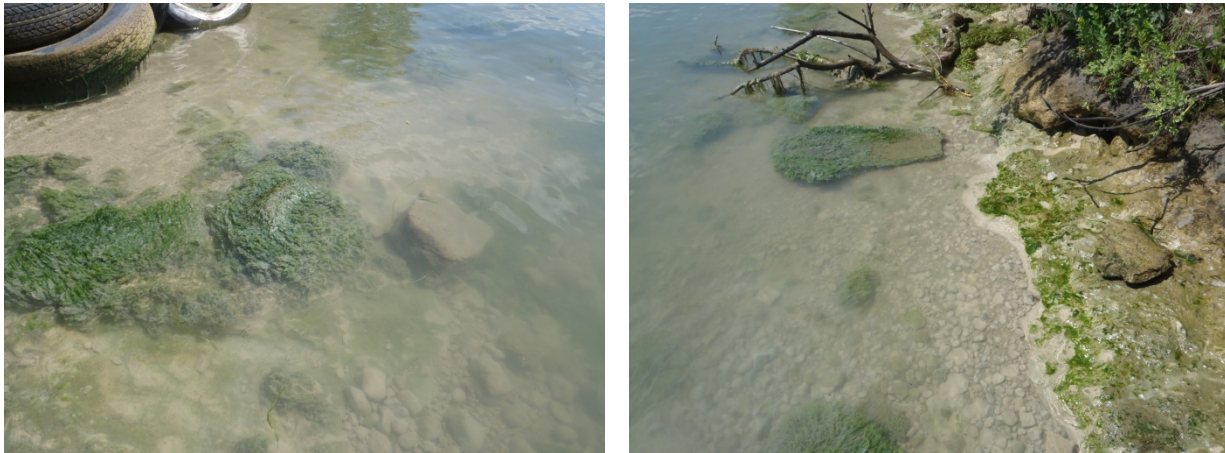
The shoreline adjacent to the US Steel Slag operation, identified by SEMI staff as being operated by Edward C Levy (industrial stormwater general permit holder), appeared to be bleached and has an unnatural grey/light brown color. Slag operation debris appears to have been dumped along the shoreline, perhaps for stabilization. Tires and other debris were noted as well. Closer inspection revealed calcified deposits and stains along the shore. Submerged aquatic vegetation was absent and no aquatic insects or other aquatic life was observed in the area, except discolored algae (see figures 7 and 8). Additional photos are available. During the initial assessment, DEQ staff conducting the aesthetics monitoring at this site did not evaluate any physical or chemical water quality parameters to assess any potential runoff that may be occurring. However, during the October 31 assessment, a pH meter was deployed in the river at this site, and several readings were taken, with the highest reading being 9.5. The pH level gradually fell as the readings were taken farther away from the shore.

Without performing a biosurvey, it is not clear whether the aquatic life designated use may be impaired at this location. However, based on the pH level and calcified deposits observed during the aesthetics assessment, DEQ staff conclude that the aesthetics beneficial use in the Detroit River remains impaired.

**Figures 7 & 8. Detroit River Shoreline Adjacent to US Steel Slag Operation.**
