# 2017 Rouge River Ecosystem Monitoring and Assessment Report

**ECT** Environmental  
Consulting &  
Technology, Inc.

**November 2018**  
ECT No. 150440-0500

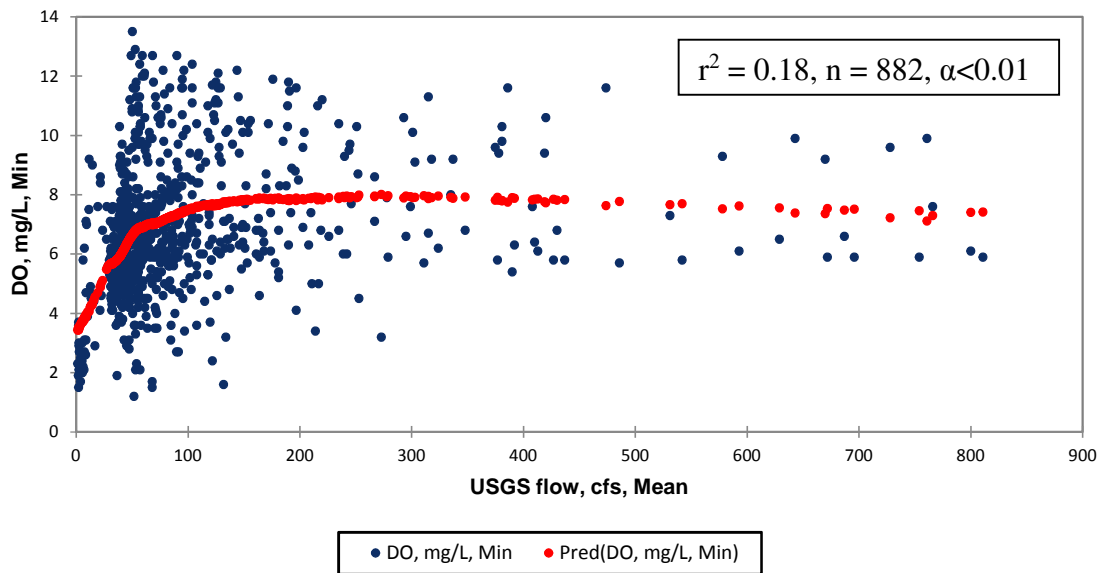
**Figure 20. Lower Branch (L05D/04168400): Relationship between DO and Flow**

exhibit a statistically significant relationship between TSS and flow during all weather conditions. In addition, the lack of a significant relationship between TSS and DO indicates that TSS does not drive DO. It is possible that BOD and organic matter content of the waters in the Lower Branch subwatershed control DO concentrations, but that these parameters are not related to or captured in TSS concentrations.

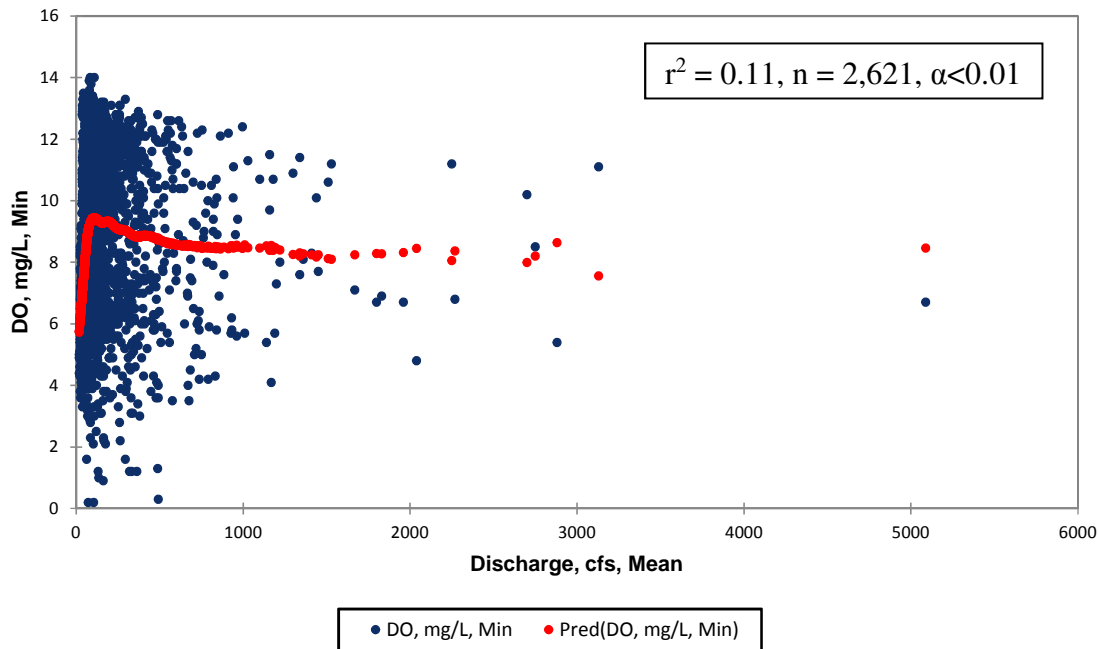
**Figure 21. Main Branch (US7/04166500): Relationship between DO and Flow**
