Rouge River Streamwood Stream Bank Erosion Mitigation Project (RVII-08) Final Report

Project Purpose and Objectives

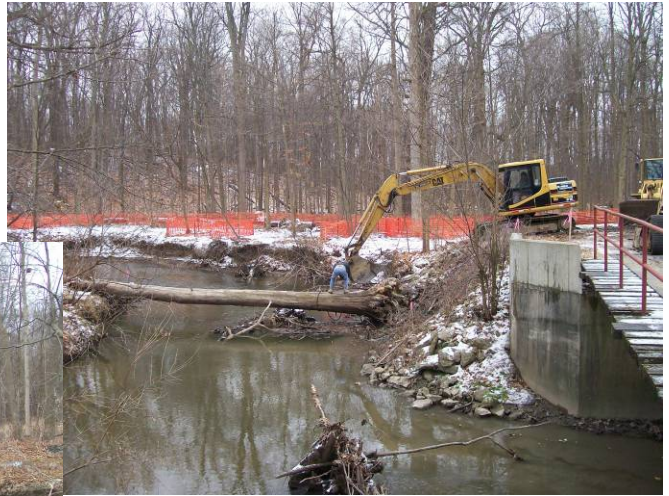
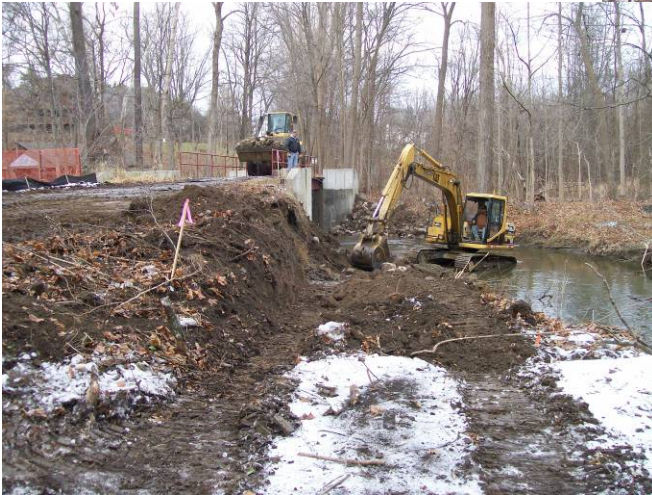
The main construction activities took place from December 14-December 21, 2007. On December 14, rock was placed along the north streambank and two debris jams were removed as well as concrete rubble from the slope near the southeast bridge abutment.

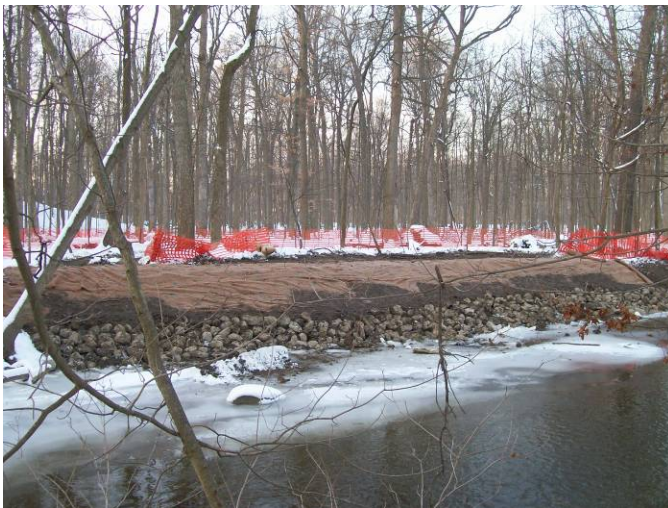
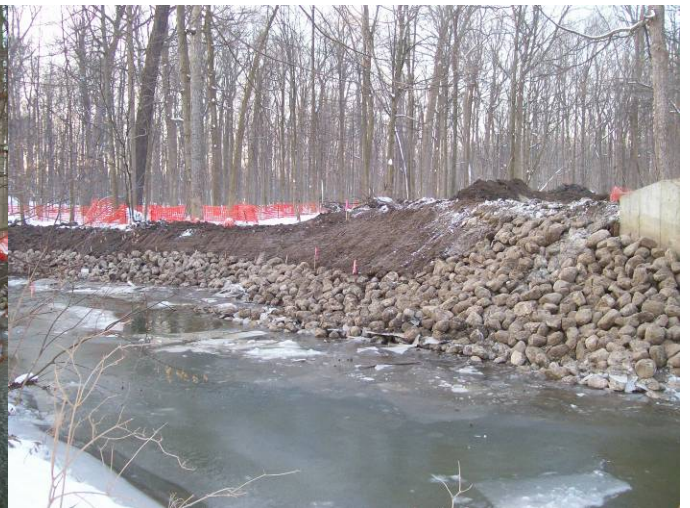
On December 20, all of the bank grading had been completed, all of the riprap had been installed including the installation of the rock vein within the river, and the equipment access route and pad had been restored. In addition, De Angelis had graded the eastern most portion of the woodland within the construction corridor and had spread some seed in that area.

The equipment access route to the river near the southeast bridge abutment was restored. The slope grade appeared to be consistent with the construction drawings and the toe alignment was consistent with pre-existing conditions. The bank was reconstructed using clay fill from the streambank excavation. Soil and debris was hauled from the site all day. A crew was on-site on December 21 to complete installation of the erosion control blanket, seeding, restoration within the woodlands, and tree planting.

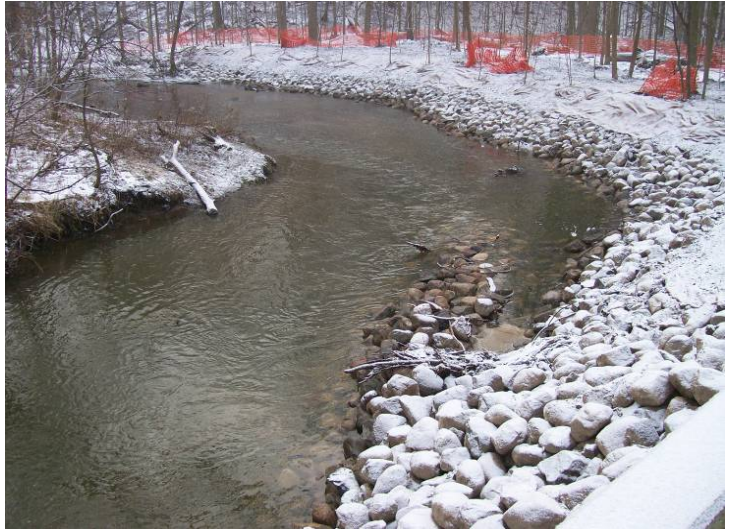
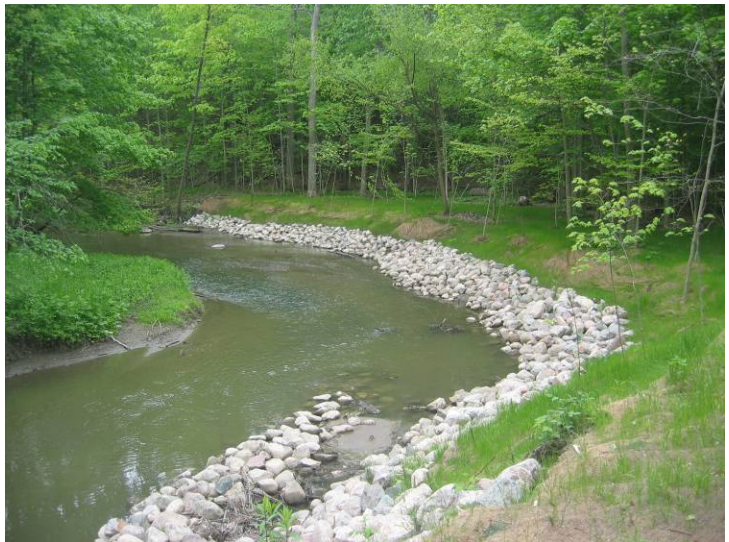
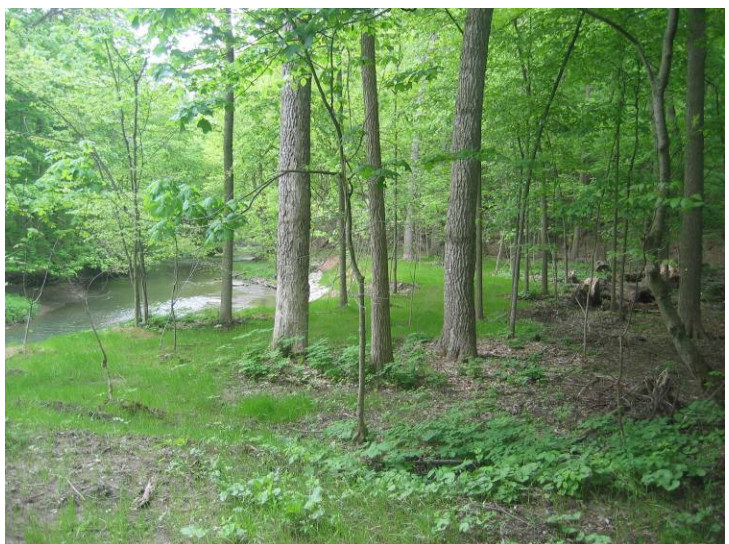
In March 2008, the contractor returned to install all the live staking material and re-transplant some vegetation ground cover that had been moved in the winter. In May 2008 the contractor completed final site restoration activities by grading and restoring areas that were disturbed during construction. Review of the site at this time indicated very good establishment of the vegetation, including the transplanted plants and trees. The live stakes had begun to establish and create the necessary cover. The rock vein installed has remained stable over the strong winter and was deflecting the main river flow as designed back to the center of the channel.
