**Wayne County ARC 2014 Illicit Discharge Elimination Plan (IDEP)
Activities
2014 Summary Report**

**Illicit Discharge Elimination
Investigation (IDEP)
Monitoring Report**

December 2014

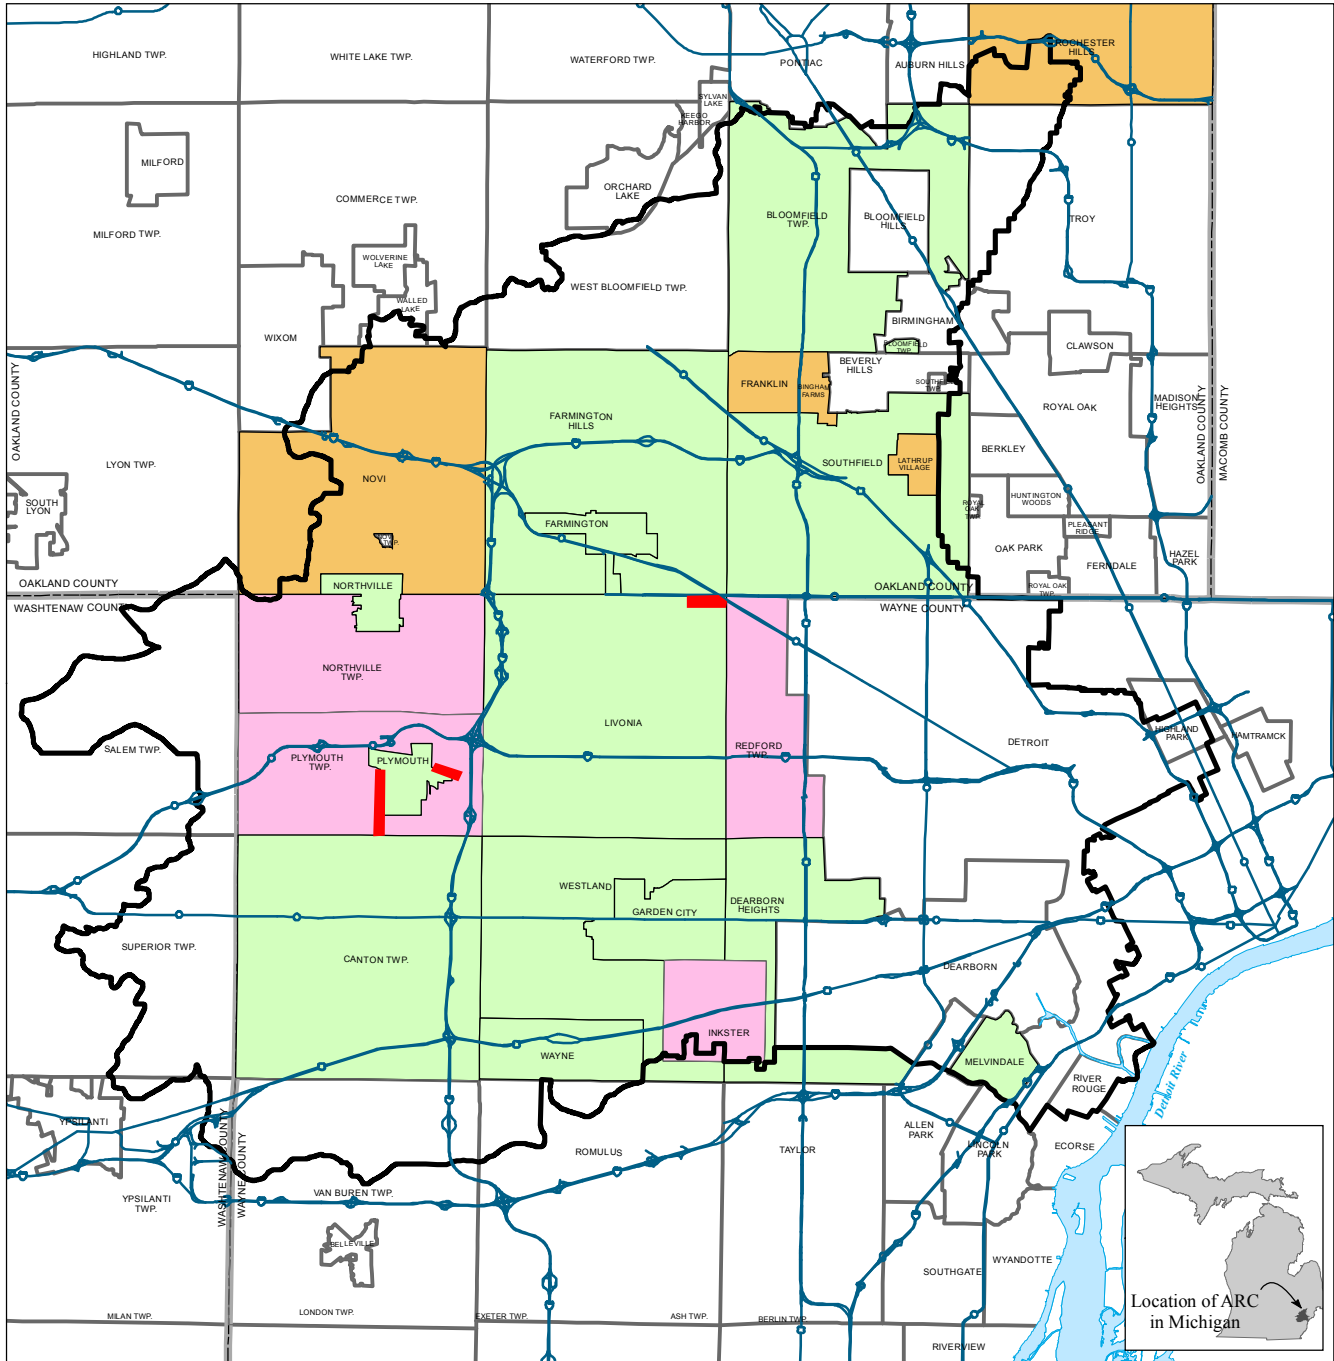
Figure 2

Municipal Facility Dye Testing 2011 through 2014

WQMD identified an additional priority area for commercial facility dye testing at Eight Mile Road and Grand River Ave in Upper Subwatershed. (See Figure 2: *Alliance of Rouge Communities Municipal Facility Dye Testing 2011-2014*). The business inventory for this area was developed, and 15 businesses were initially identified for facility dye test investigations.

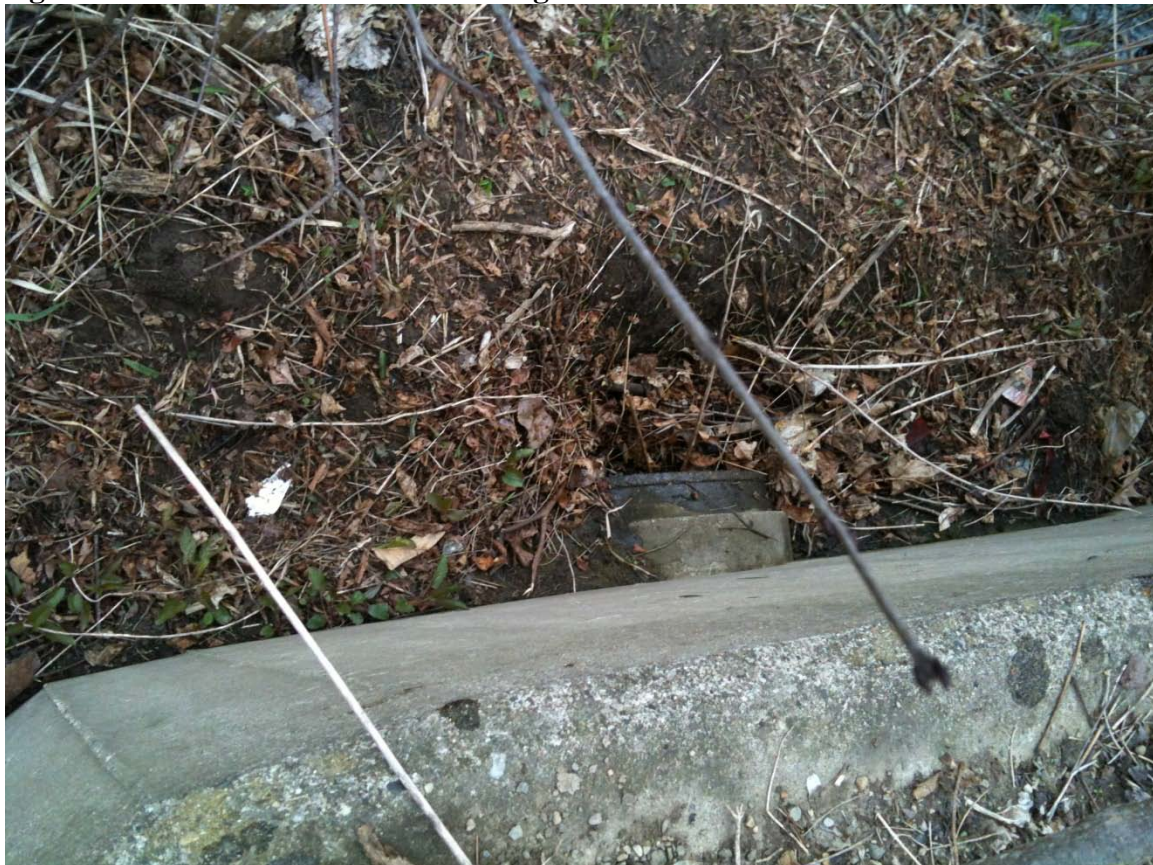
Figure 4: Private Storm Sewer Discharge to the Johnson Creek

Complaint/Spill Response: The WQMD staff collaborated with the City of Northville staff to investigate an oil spill to the Johnson Creek in the Middle Rouge. The source of the oil was identified as a hydraulic elevator with a broken seal in a nearby commercial facility. The hydraulic fluid reached the foundation sump and was discharged to a privately owned storm sewer system that drained to the Johnson Creek (See Figure 4: *Privates Storm Sewer Discharge to Johnson Creek*) The owner of the facility accepted responsibility and secured a cleanup contractor to clean up the spill to the satisfaction of the Michigan Department of Environmental Quality. The City of Northville Fire Department was planning to seek reimbursement for the Hazmat response involving the spill.

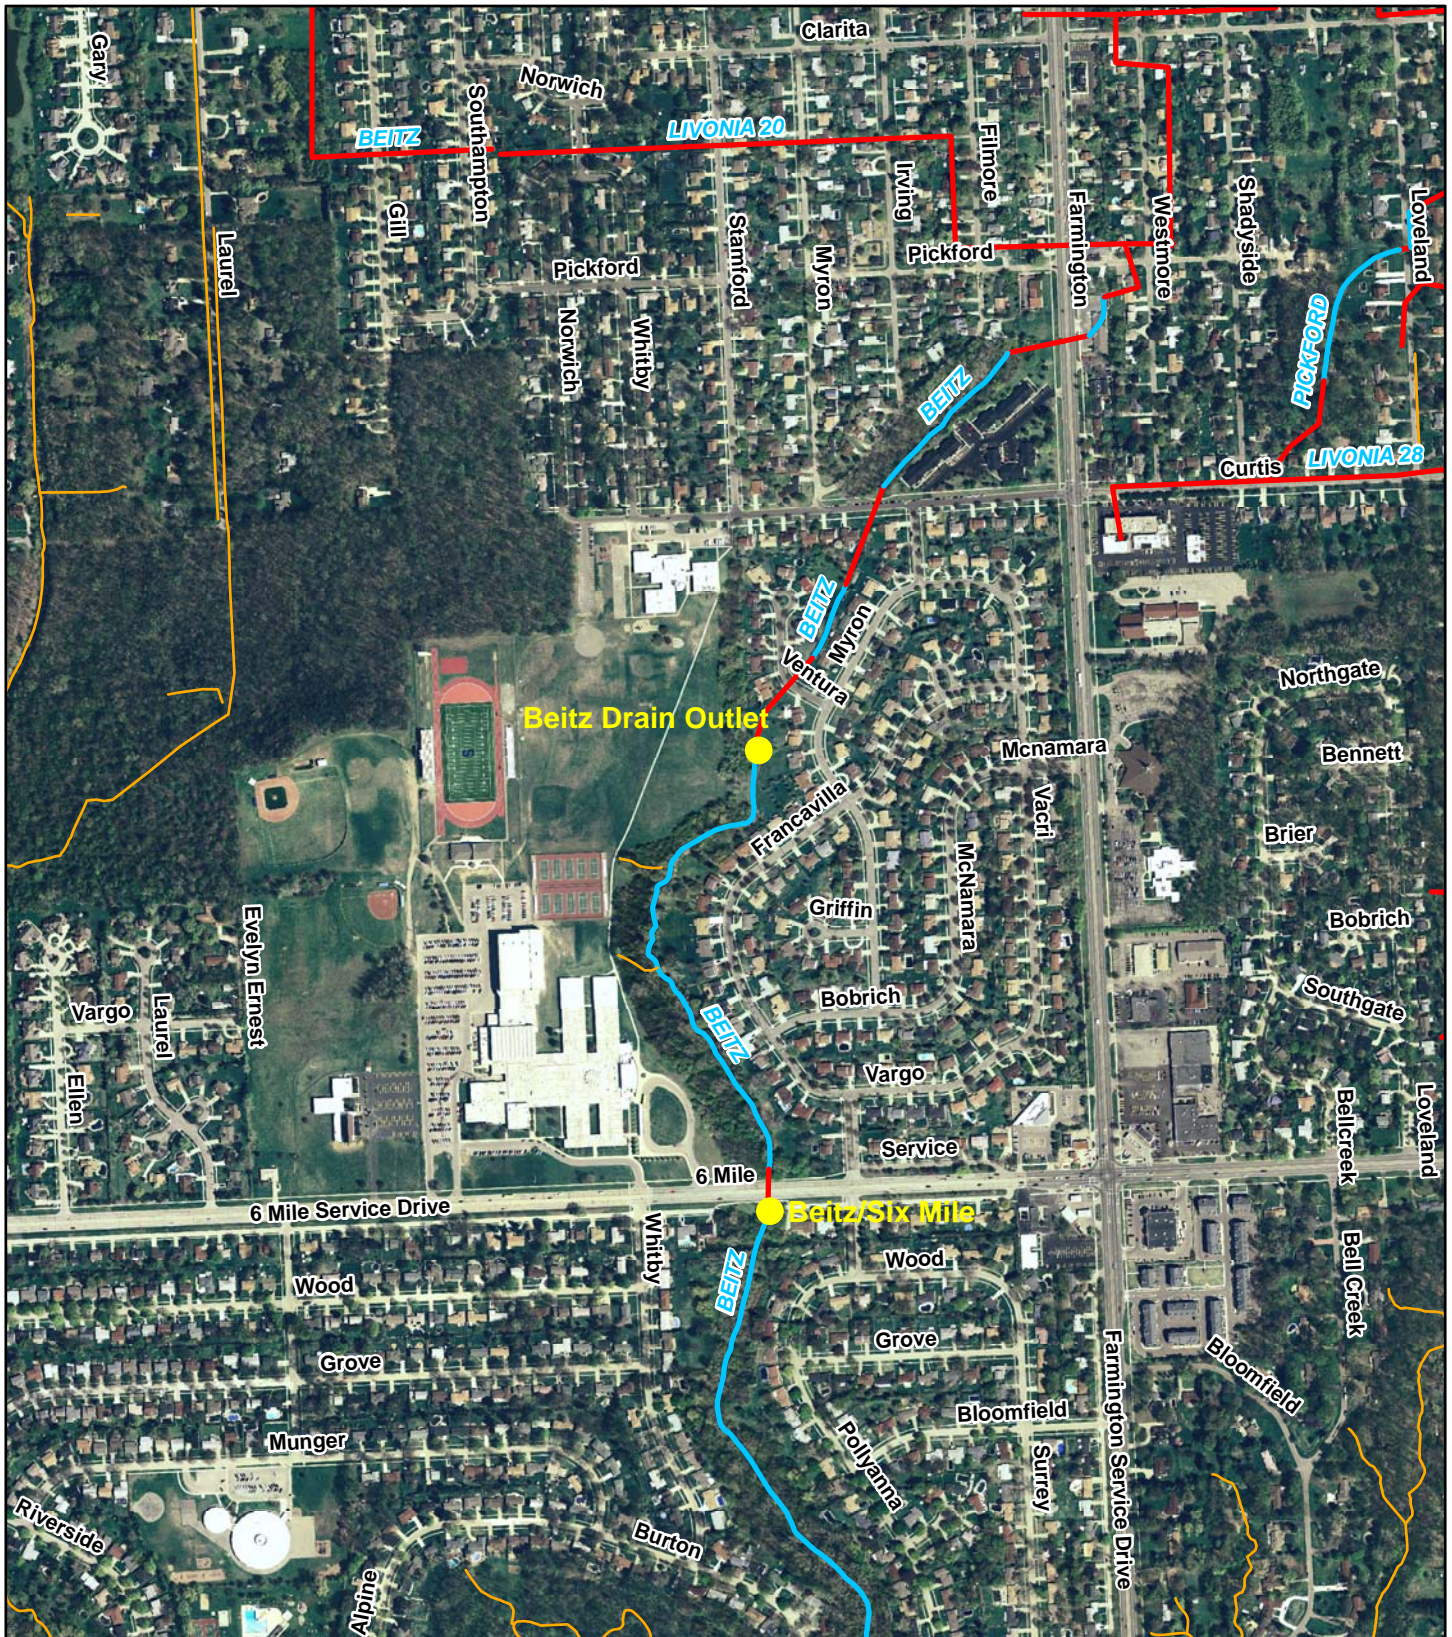
Beitz Drain Sampling Locations December 2014

The Beitz was sampled at two locations, three times with one replicate sample over a ten day period. The *E. coli* levels range from 20 to 460 cfu/100mLs with a median of 40 cfu/100mLs. These low levels do not demonstrate a significant source of sewage. The samples were collected at a time when ground water infiltration and other sources of potable water were minimized, therefore, dilution of bacteria sources would be also be minimized. These results allow us to conclude that further intense investigation of this area is not required and the area can be re designated from a high priority area to routine priority area for IDEP efforts.

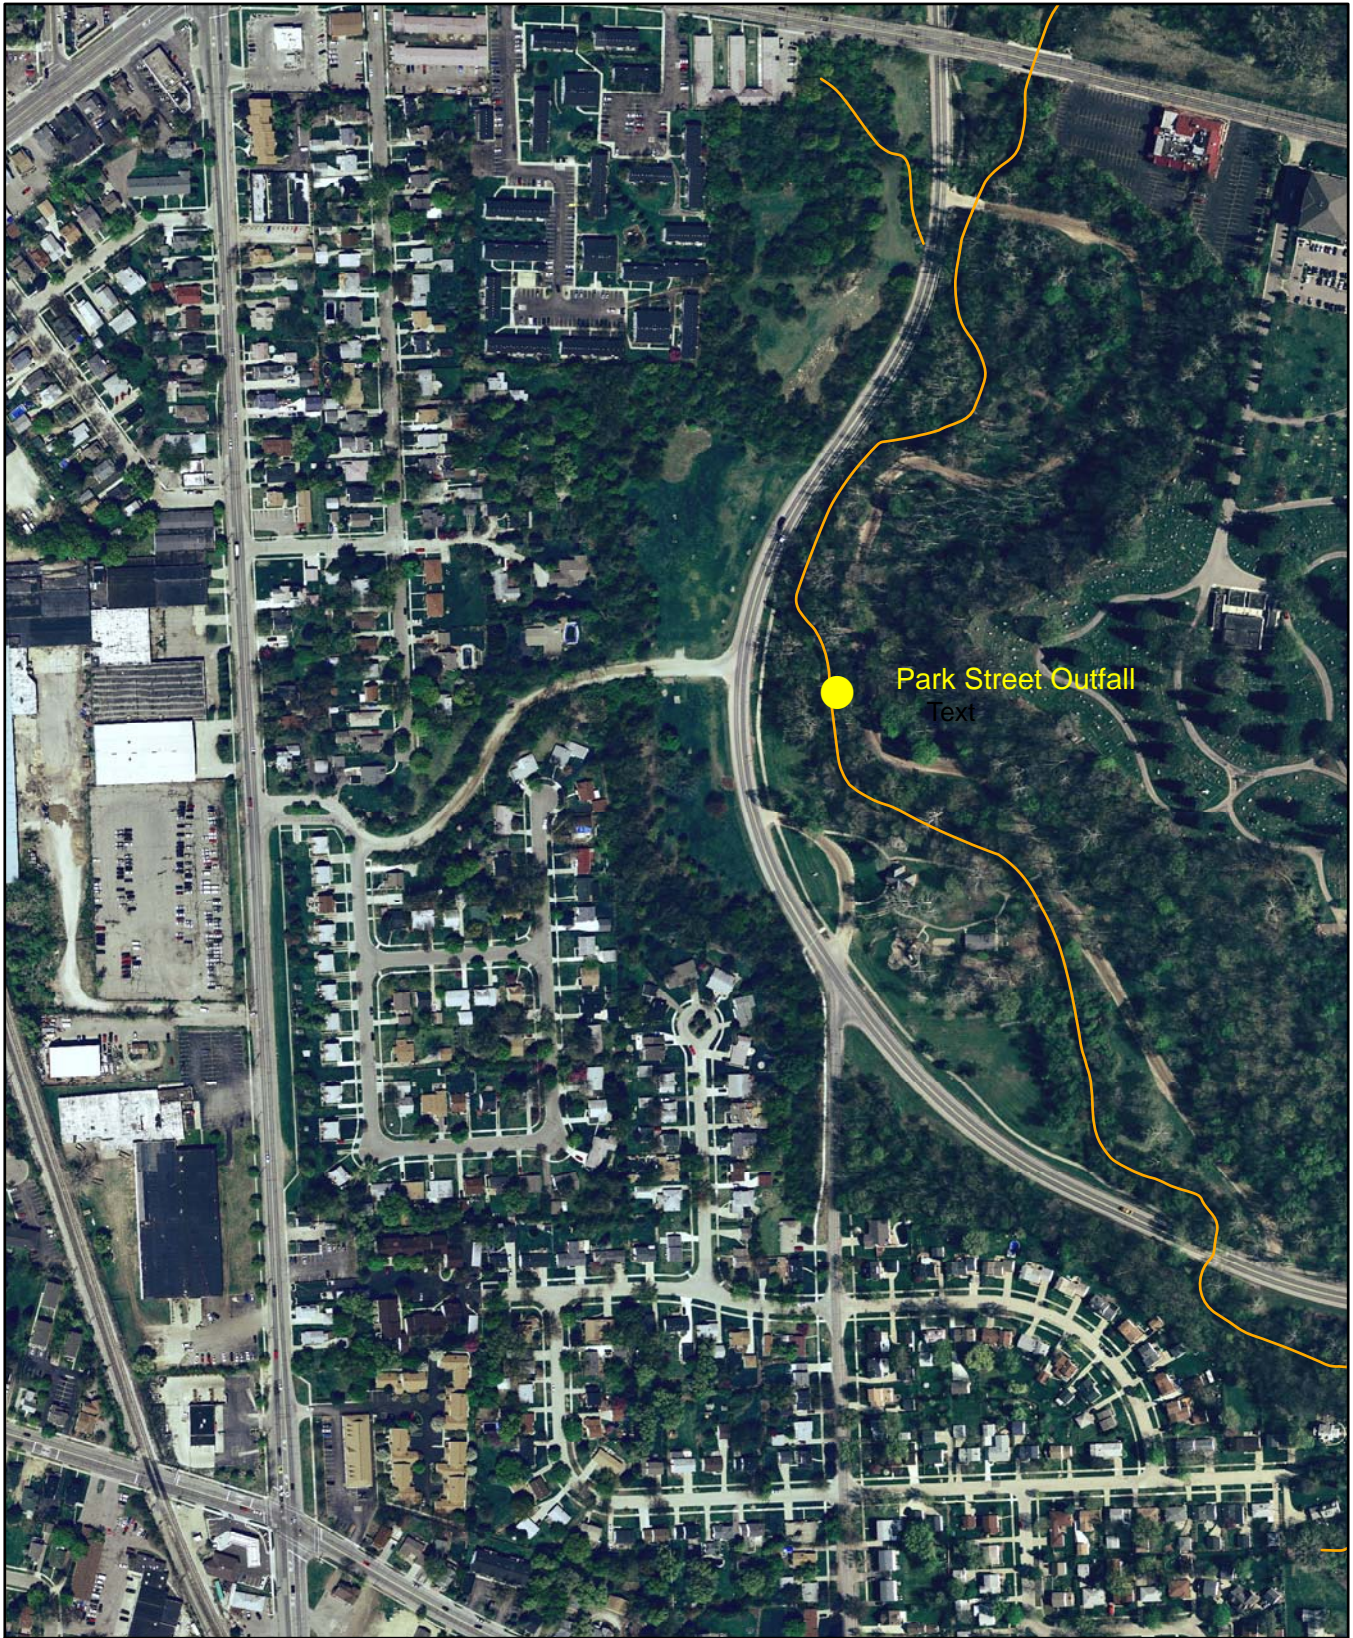
Park Street Outfall Sampling Locations December 2014

Based on the water quality data collected during the ARC IDEP monitoring project, there are areas in the Rouge River watershed where additional investigation is necessary to identify and eliminate illicit discharges. The sampling site 3, the Park Street Outfall, a storm sewer outfall that drains a portion of the City of Plymouth, is an area of concern based on multiple *E. coli* samples in excess of 1,000 CFU/100mL. Investigations are recommended to identify and eliminate the illicit discharge sources. WQMD will meet with the City of Plymouth to discuss this sampling project and its results. Follow up activities should include investigation of storm and sanitary sewer infrastructure for infiltration, leaking pipes, failing bulkheads in areas where there were combined sewers, sewers for infiltration and cross connections. Facility dye testing of commercial facilities in this area is also recommended. WQMD has performed facility dye test inspections in the City of Plymouth in the past as part of other illicit discharge elimination projects. Human Biomarker monitoring study may also be considered as an investigative technique that could assist with identifying the source of elevated *E. coli* in the Park Street storm sewer system.

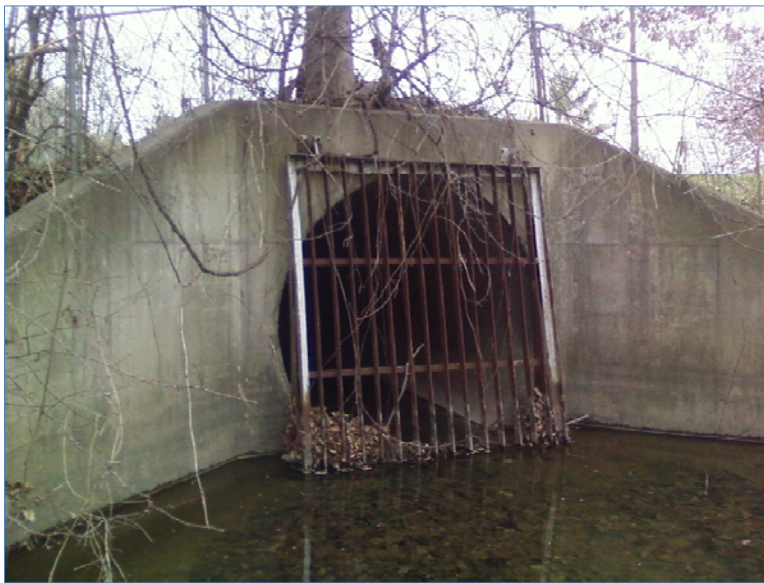
Site 1 Beitz Drain Outlet

SOME CLEAR FLOW FROM SMALL OUTFALL LEFT BANK SOME IRON BACTERIA GREEN PRESENT ON BANK
FLOW FROM LARGE DRAW OUTFALL

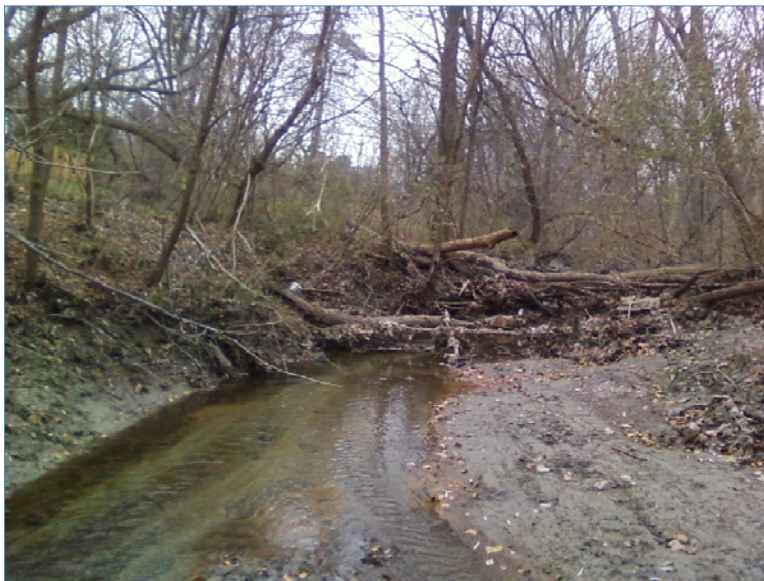
Site 2 Beitz Drain at Six Mile looking downstream

IRON BACTERIA ON BOTTOM, BANKS AT SITE
LARGE LOGJAM DOWNSTREAM OF BRIDGE

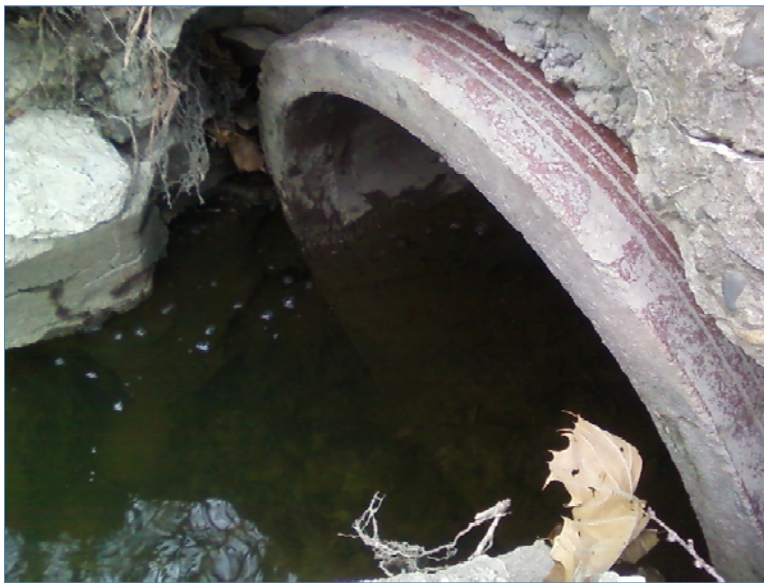
Site 3 Park Street Outfall

* RIVER IS LIGHT GREEN BY OUTFALL
OUTFALL IS DISCHARGING, SOME BUBBLES PRESENT
