Alliance
of Rouge
Communities

Executive Director 2010 Annual Report

ECT
Environmental Consulting & Technology, Inc.

March 2011

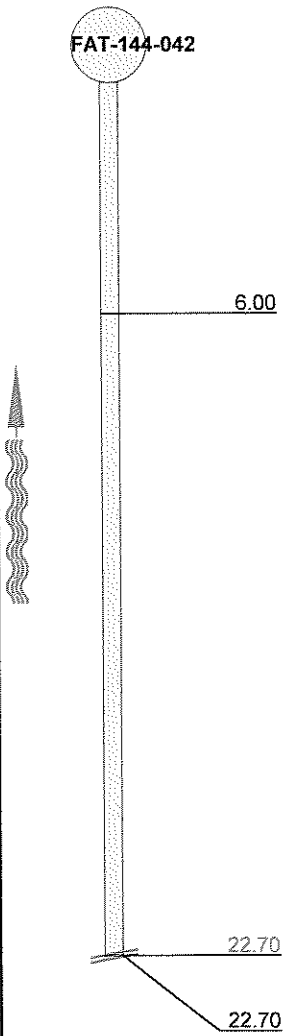
1:60	Position	Code	Observation	Photo

6.00	AMH	Downstream Manhole, Survey Begins, REMARK: 144-042	
	22.70	RMJ	Roots Medium Joint, from 01 to 11 o'clock, 35 %, within 8 inches of joint: YES, REMARK: w/ heavy debris	
	22.70	MSA	Survey Abandoned, REMARK: camera cannot pass roots and debris

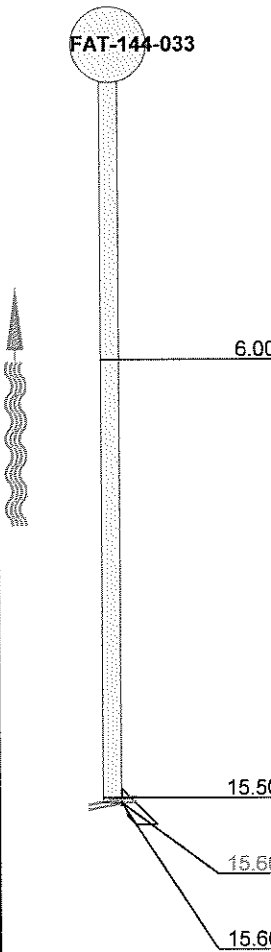
1:50	Position	Code	Observation	Photo

6.00	AMH	Downstream Manhole, Survey Begins, REMARK: 144-033	
	15.50	TFC	Tap Factory Made Capped, at 09 o'clock, 6", within 8 inches of joint: YES	
	15.60	DSC	Deposits Settled Compacted, 30 %of cross sectional area, from 04 to 07 o'clock, , within 8 inches of joint: YES	
	15.60	MSA	Survey Abandoned, REMARK: camera cannot pass debris

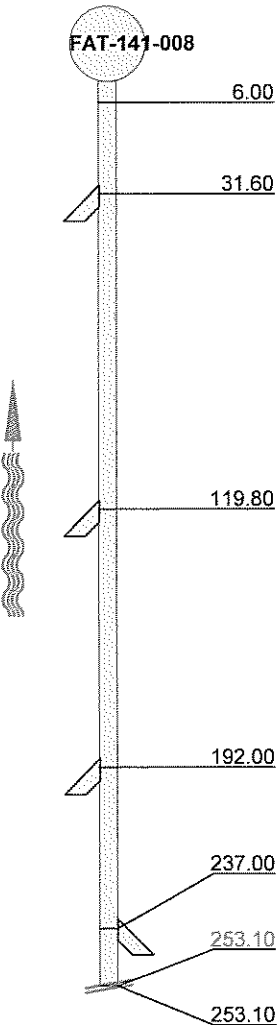
1:645	Position	Code	Observation	Photo

6.00	AMH	Downstream Manhole, Survey Begins, REMARK: 141-008	
	31.60	TB	Tap Break-In, at 01 o'clock, 6", within 8 inches of joint: YES, REMARK: Address 27780 Independence, no flow or evidence of past flow. Roots in lead	
	119.80	TF	Tap Factory Made, at 01 o'clock, 6", within 8 inches of joint: YES, REMARK: Address 21514 Colwell, no flow or evidence of past flow	
	192.00	TB	Tap Break-In, at 01 o'clock, 6", within 8 inches of joint: NO, REMARK: Address 21522 Colwell, no flow or past evidence of past flow	
	237.00	TB	Tap Break-In, at 10 o'clock, 6", within 8 inches of joint: YES, REMARK: 27835 Shiawassee Church looks like past flow	
	253.10	DSC	Deposits Settled Compacted, 25 % of cross sectional area, from 04 to 09 o'clock, , within 8 inches of joint: YES	
	253.10	MSA	Survey Abandoned, REMARK: camera cannot pass

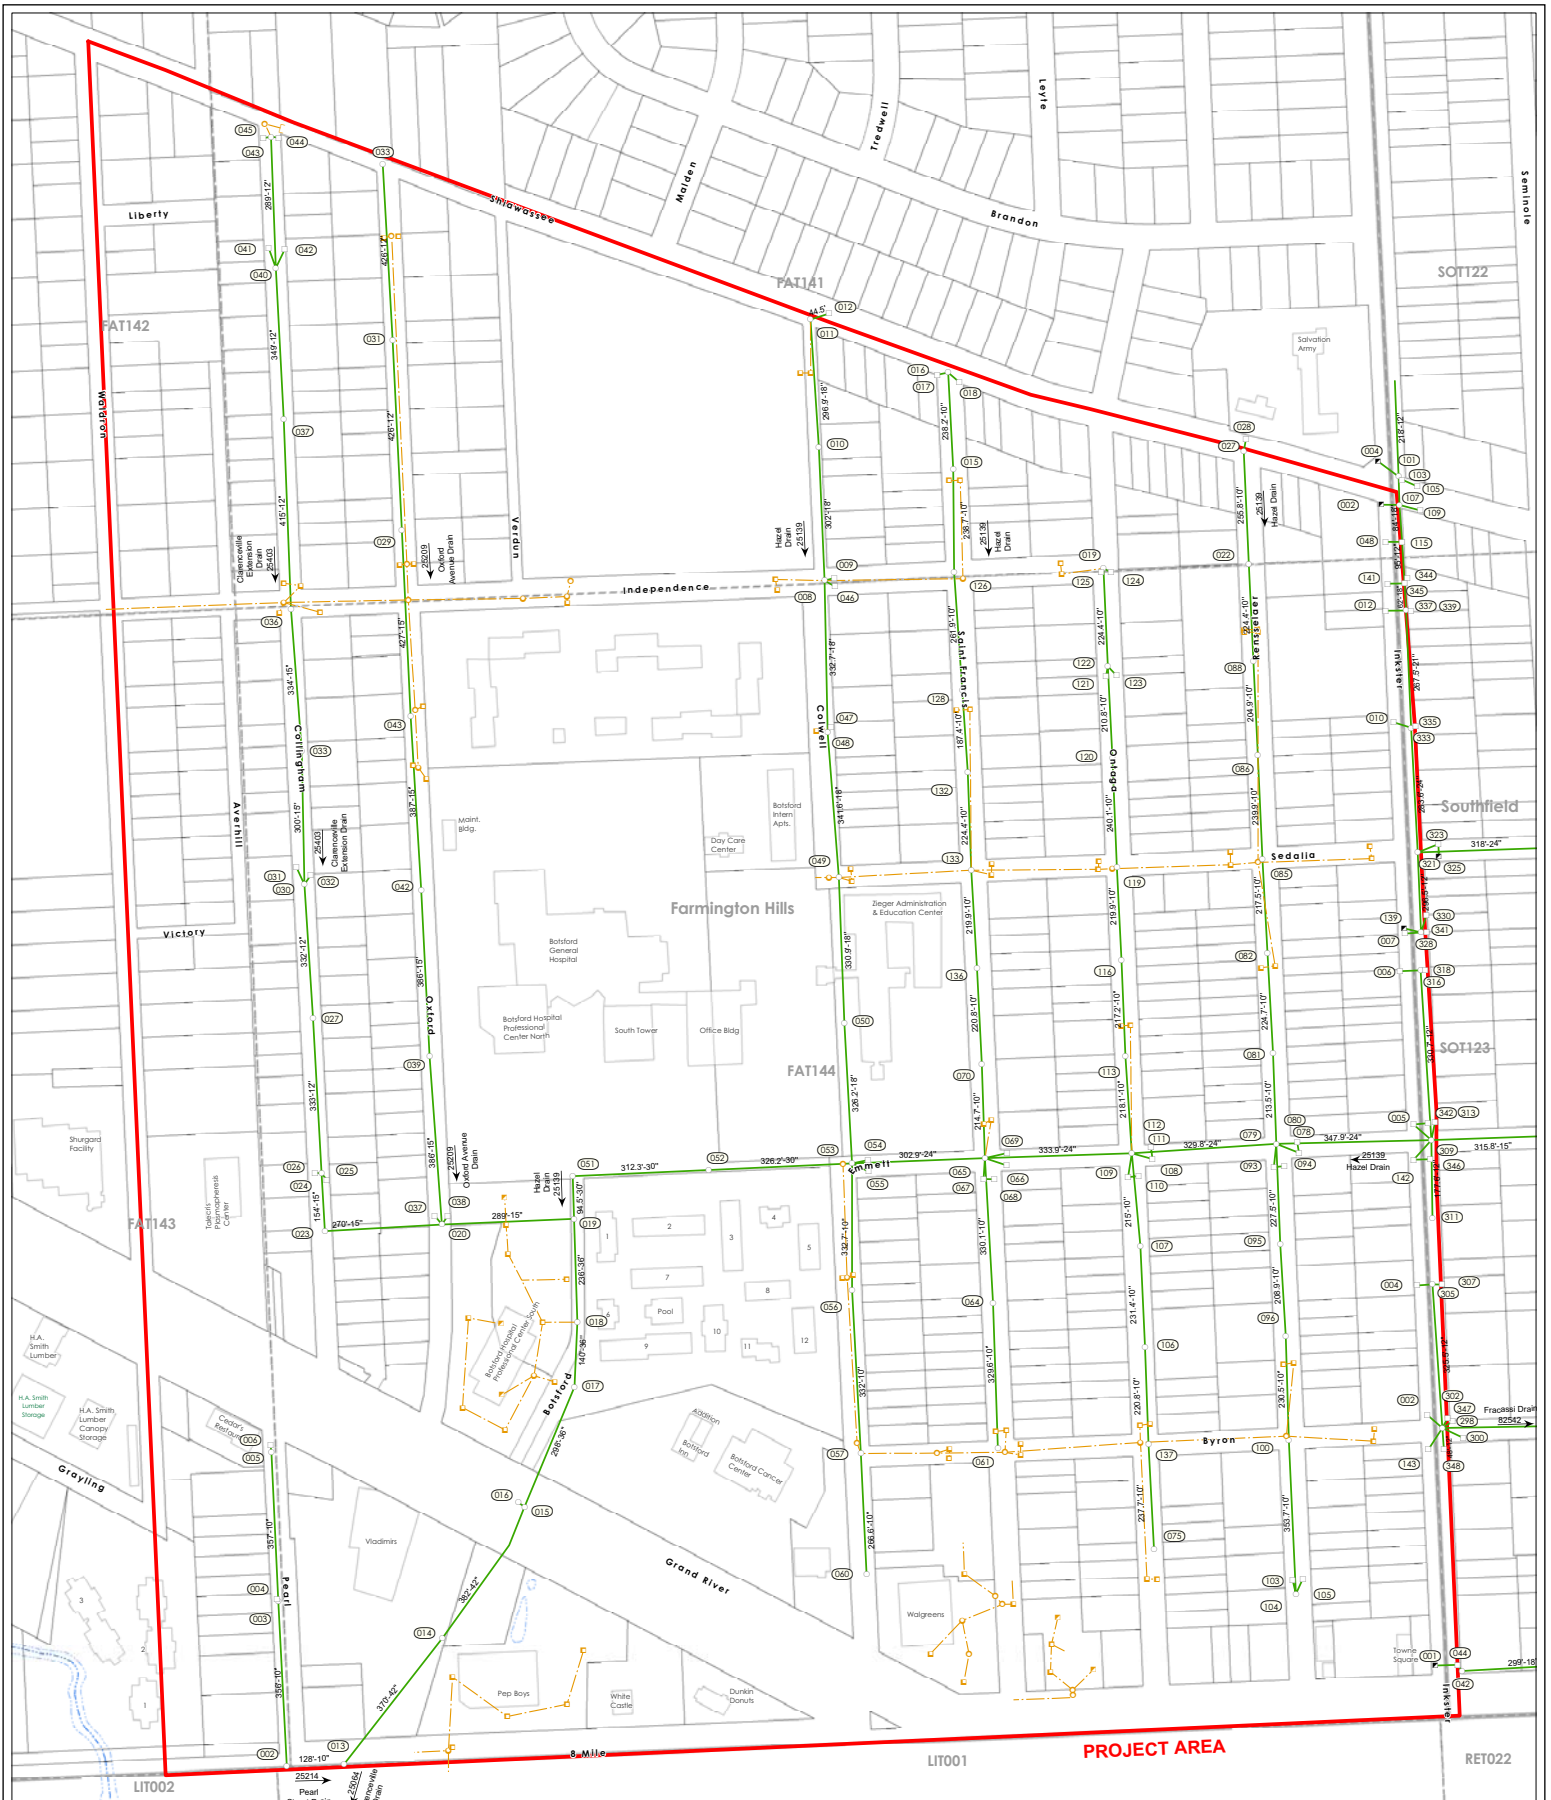
Map 3

- C.** The WRC completed a map (**Map 3**) of the storm drains in the project area including those owned and operated by the City of Farmington Hills. Pipe sizes for the Farmington Hills System could not be verified as well as ownership of some of the drainage structures due to a lack of funding. These items should be determined and added to the map with any other relevant information that might be found during subsequent work.

City of Farmington Hills Illicit Connection Source Identification Project Chapter 4 and FHC Storm Drain

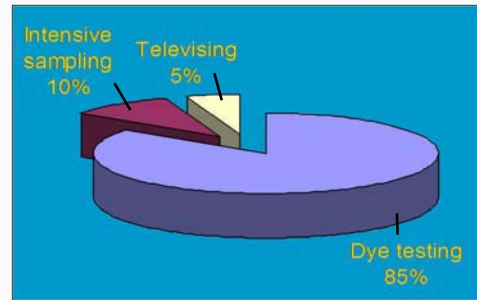
TELEVISING TECHNIQUE

- Televising (T.V.) the sewer
 - To see illicit taps
 - To see condition of the sewer line
 - To create permanent record
