ROUGE RIVER AOC HABITAT DESIGN PROJECTS

US EPA GRANT: GL-00E02344

FINAL DESIGN REPORT

Tamarack Creek and Johnson Creek-Fish Hatchery Park

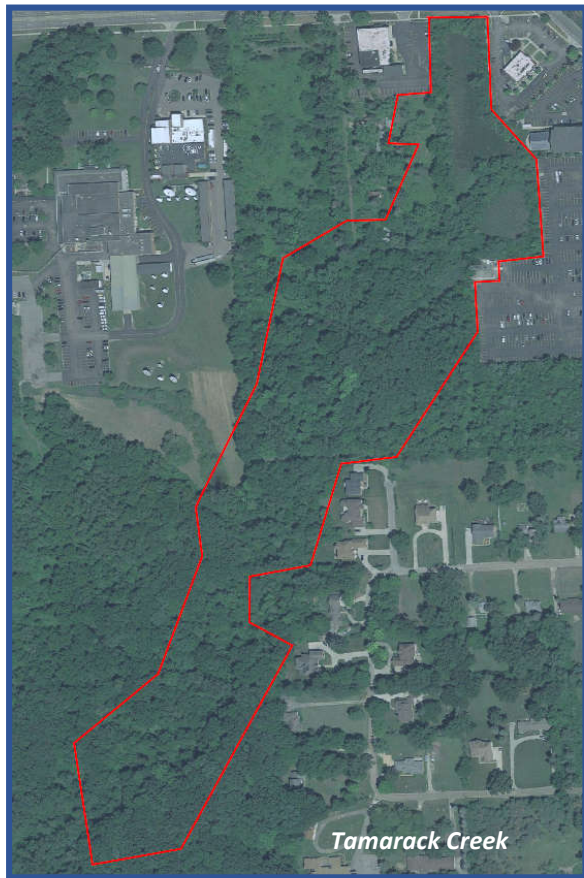
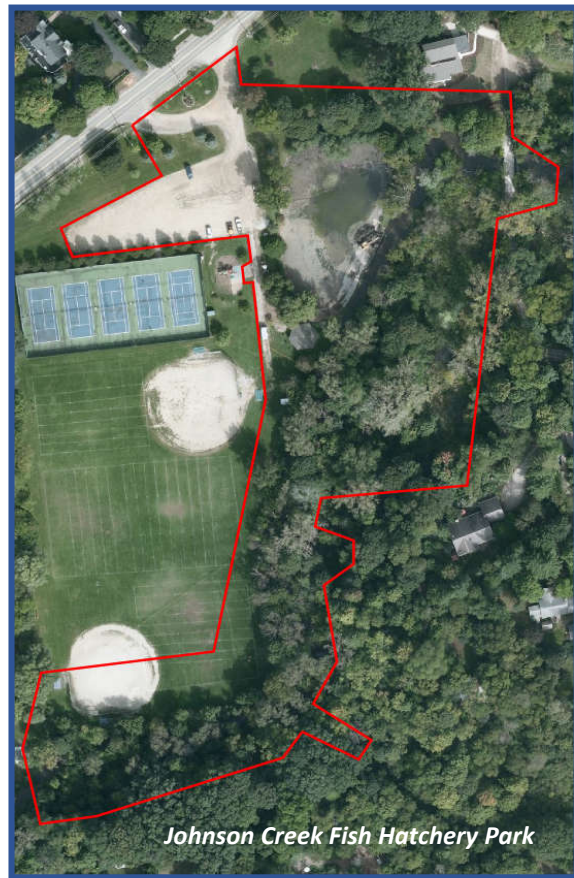
Figure 2. Extent of Topographical Surveys

A topographic survey of each property was conducted by a registered land surveyor. The spatial scope of the surveys is shown in Figure 4. The topographic survey played an essential role in the design of the project and the preparation of the permit application and contract documents. The Johnson Creek survey was completed in November 2018, and the Tamarack Creek survey was completed December 2018.

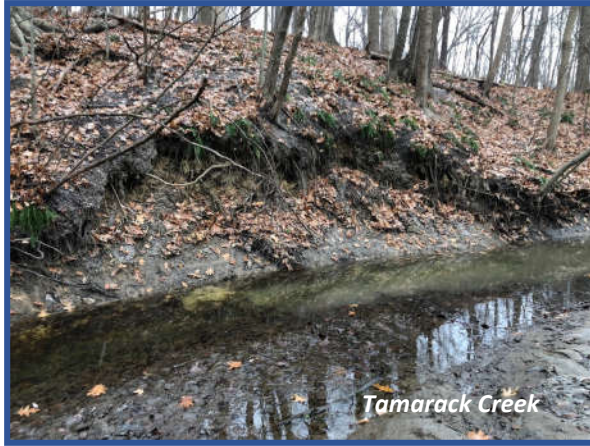
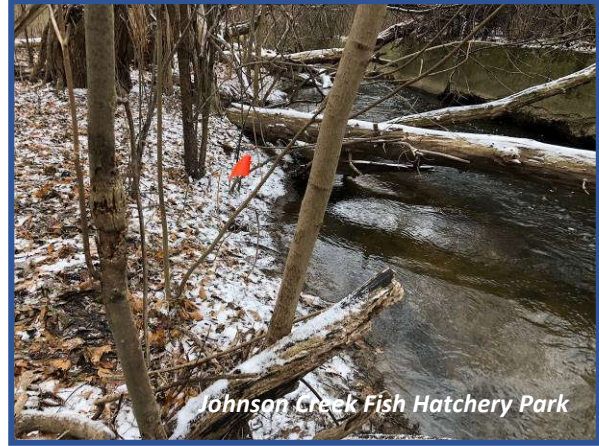
Figure 3. Sample observations from ECT's stream stability assessments.

(Left photo shows exposed tree roots and high slumping bank indicating erosion at toe. Right photo shows flagged bankfull elevation as well as large woody debris blocking channel flow)

ECT used qualitative and quantitative evaluations to assess the scope of stream stability problems at Tamarack and Johnson Creek Fish Hatchery Park. These evaluations included taking pebble counts, performing the Ribbon Test, and taking measurements to find the Bank Erosion Hazard Index (BEHI) on representative banks. Results from the stream stability assessment were used to target problem areas in habitat restoration design. Using the Rosgen morphological classification system, it was determined that the stream types for all reaches of Tamarack Creek are E-5 streams and Johnson Creek is an E6 stream. Assessment was completed in November 2018 for Tamarack Creek and in December 2018 for Johnson Creek. A memo detailing results of the stream stability assessment for both sites is included in Appendix C.

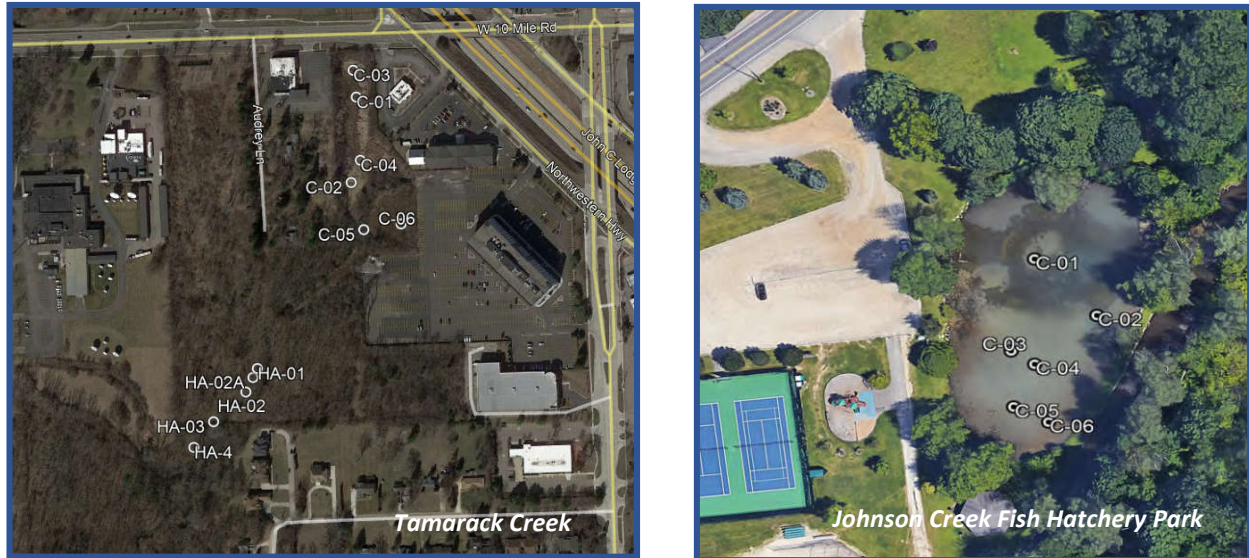
Figure 5. Sediment Core Locations

In November 2018, sediment cores were collected from six locations on each site: within the pond at the Johnson Creek Fish Hatchery Park site and focused in Basin Wetlands at the Tamarack Creek site. Two samples were composited from each core and were subjected to laboratory tests for determine physical and chemical properties of the existing substrate. In July 2020, four additional soil borings were taken from the Tamarack site to understand the physical characteristics of the soil found along the existing stream.

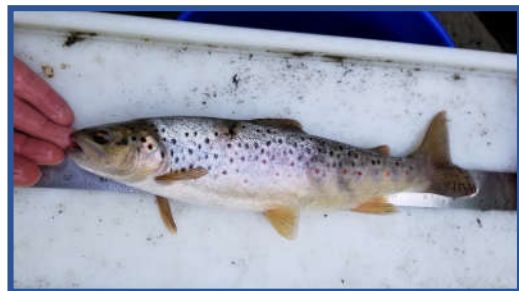
Figure 6. Brown trout sampled during electrofishing conducted in Johnson Creek in June 2019

To accurately characterize the fish community to inform project design and establish baseline conditions, sampling of the fish community was conducted at Tamarack Creek and Johnson Creek by Fish Hatchery Park using electrofishing equipment. Commonly reported metrics were used to describe the baseline fish assemblages in the vicinity of the project site. Species richness and abundance, catch per unit effort, and size-frequency distributions were calculated. Ultimately, Tamarack Creek contained very few species and did not have a diverse assemblage, while Johnson Creek contained species typical of cold-water streams and had a moderately diverse assemblage, though overall fish abundance was low. ECT conducted fish analysis field work in June 2019 at Tamarack Creek and Johnson Creek. Summaries of fish sampling efforts at both sites is available in Appendix H.
