# Wayne Road Dam Removal and Habitat Restoration Project

## Lower Rouge River, Michigan

### NOAA/GLRI Final Report

NOAA Grant Number: NA11NMF4630146

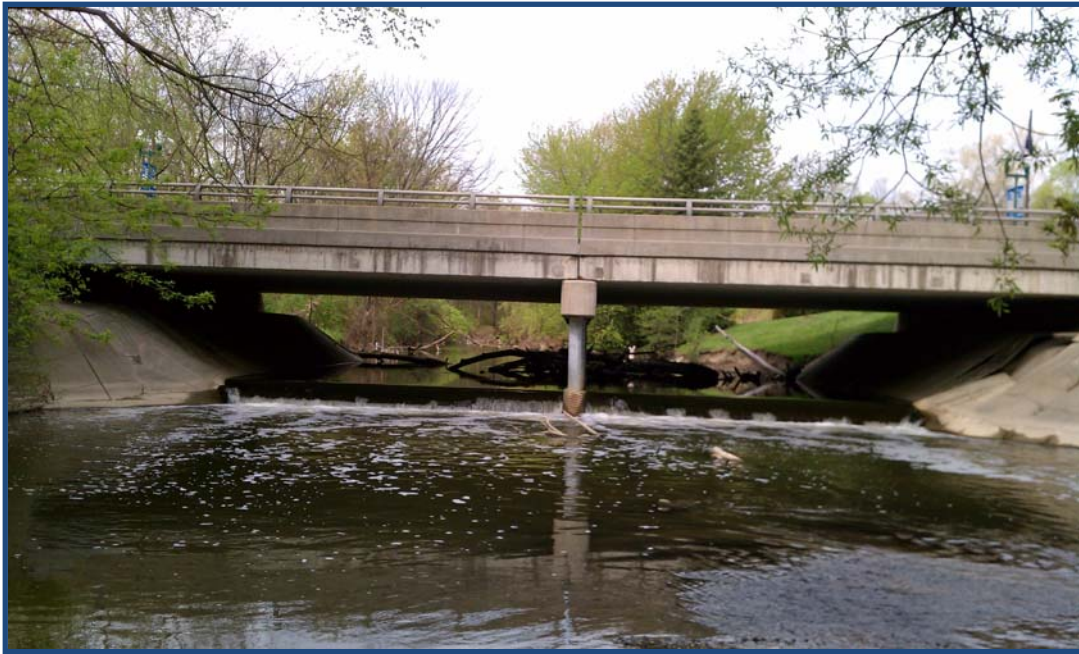
**Wayne Road Dam prior to project implementation**

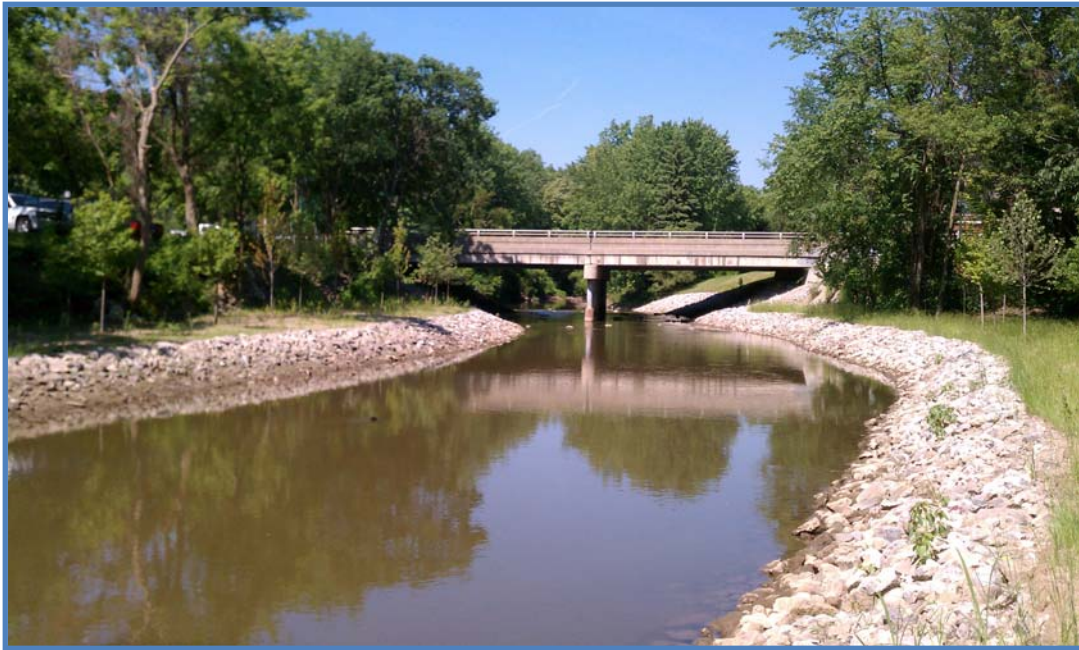
**Restored reach**

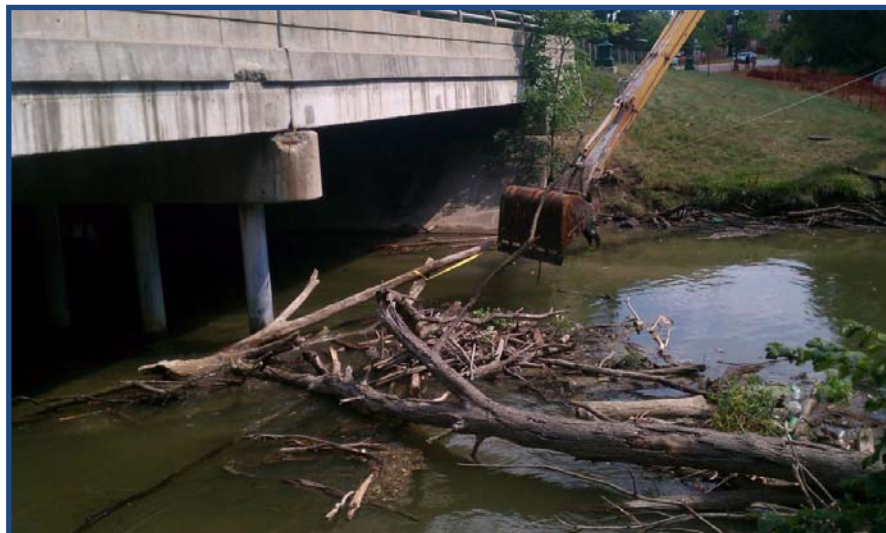
**Log Jam Removal (Upstream Side of Wayne Road Bridge, view looking south)**

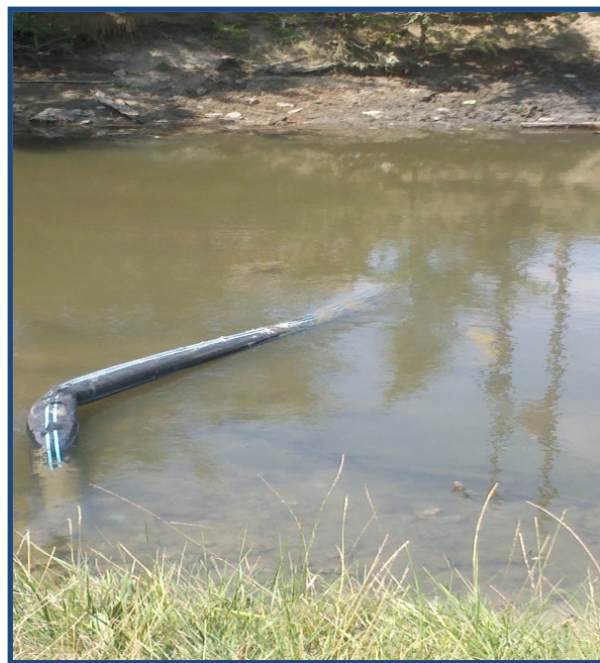
On August 8, 2012, A 6-inch sanitary siphon was found at or just below the bed of the river. It was determined that this siphon and another 6-inch sanitary relief siphon would need to be lowered in order to accomdate the removal of the dam, installation of the riffle and provide adequate cover to protect the utilities.

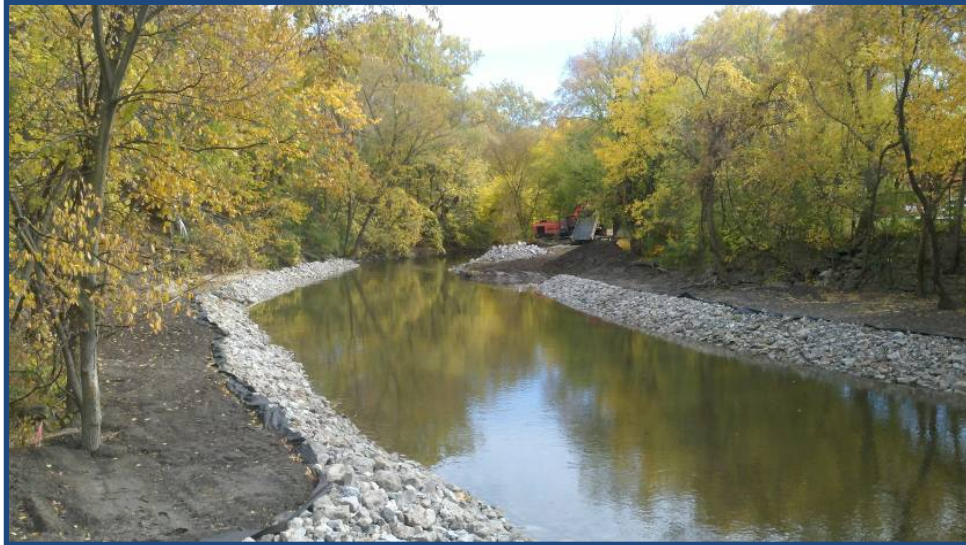
**October 24, 2012: View from bridge looking downstream (east). Note: rock at north bench complete**

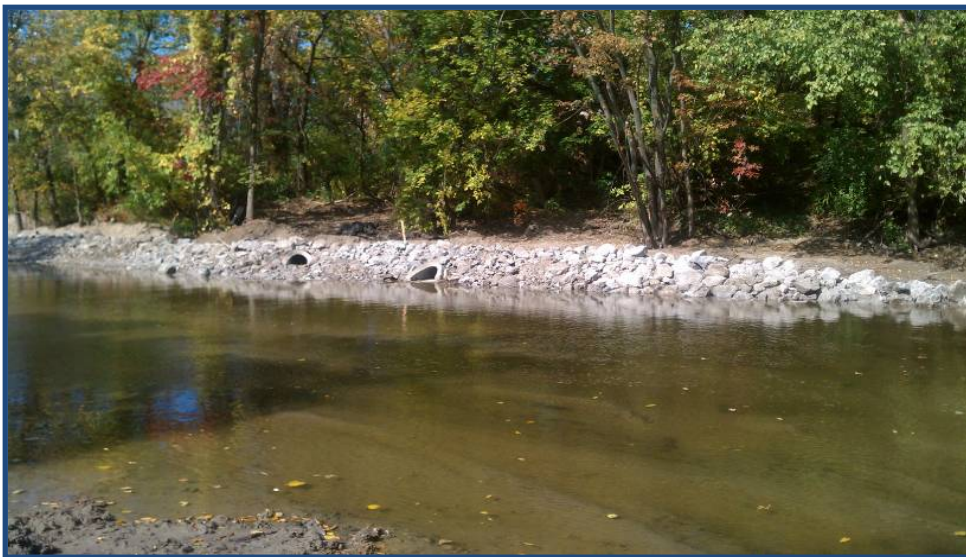
With the construction of the north bankfull bench, two storm sewer extensions and outlets were installed.

**North bankfull bench, downstream of bridge, view looking northwest. Note: two newly installed stormwater outfalls**

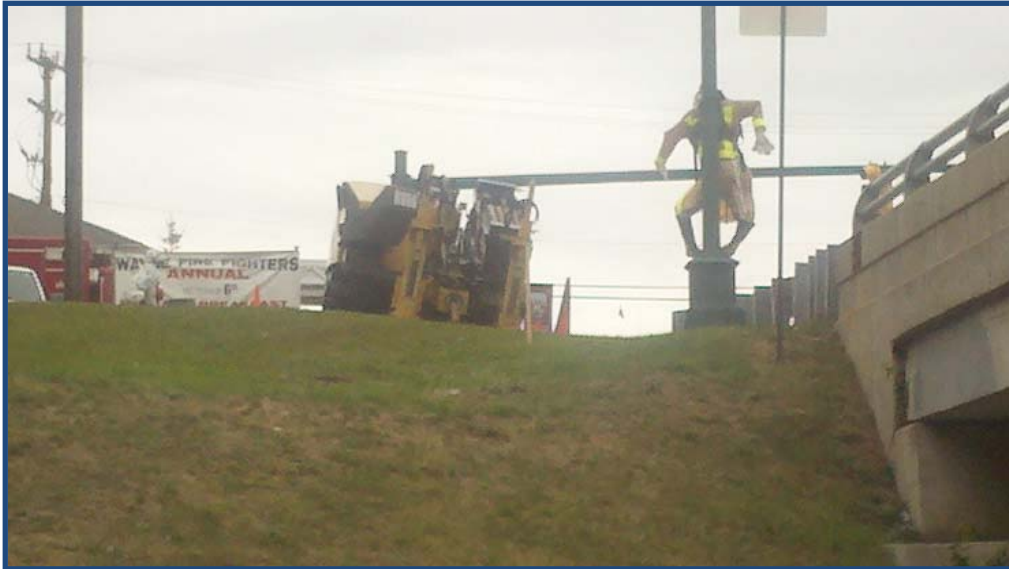
On October 5, 2012 the directional driller mobilized to conduct the replacement of the sanitary sewer siphon.

**Directional drill equipment mobilized on the north bank, upstream of the bridge**

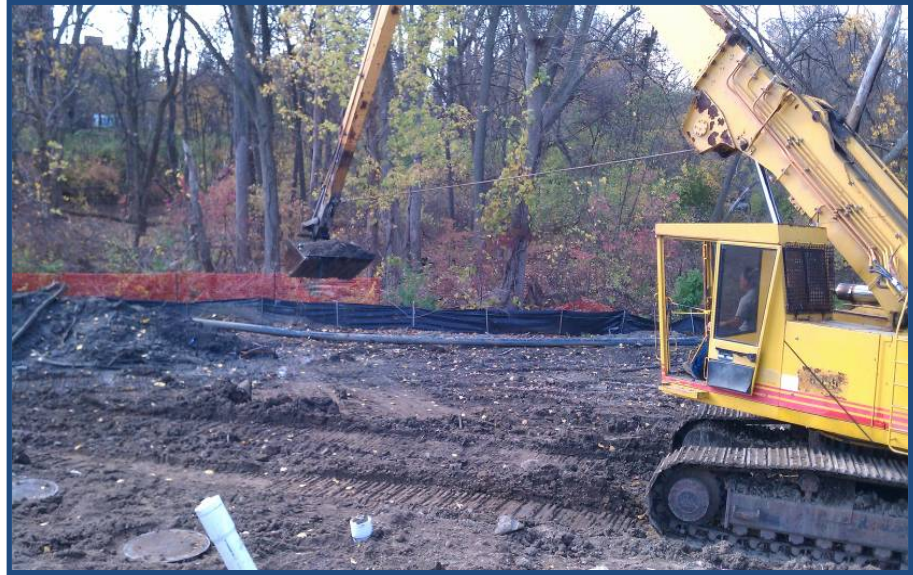
**Excavating upstream of the bridge. Note old sanitary sewer pipe in staging area**

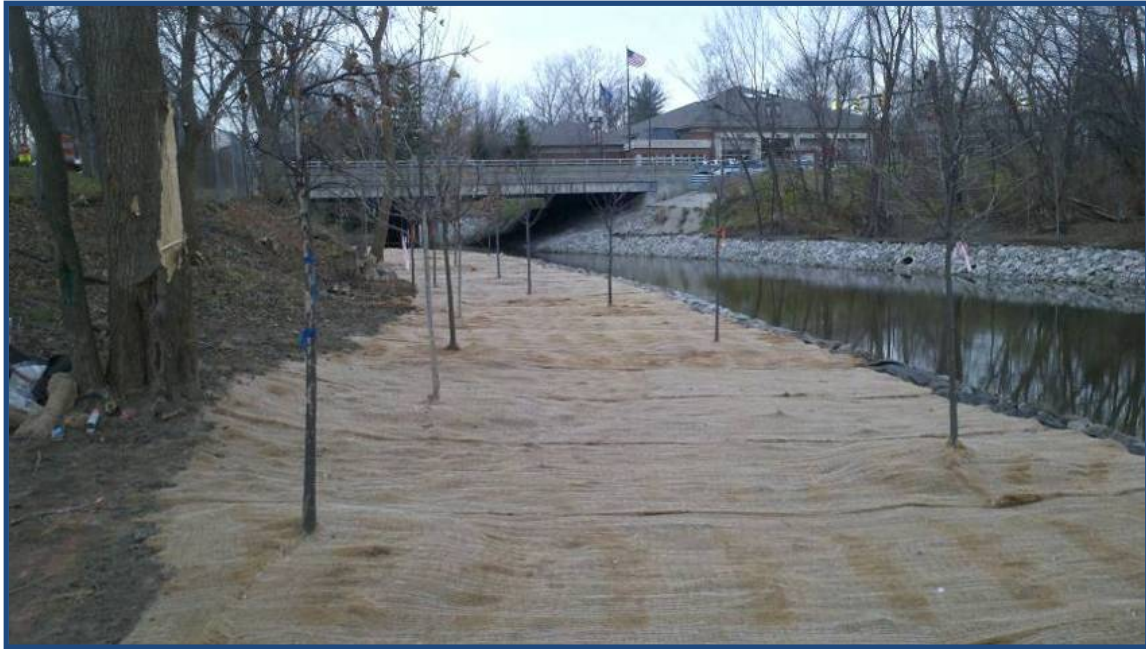
**November 19, 2012: View from downstream end of constructed south bench looking upstream (west) and erosion control blanket installation**

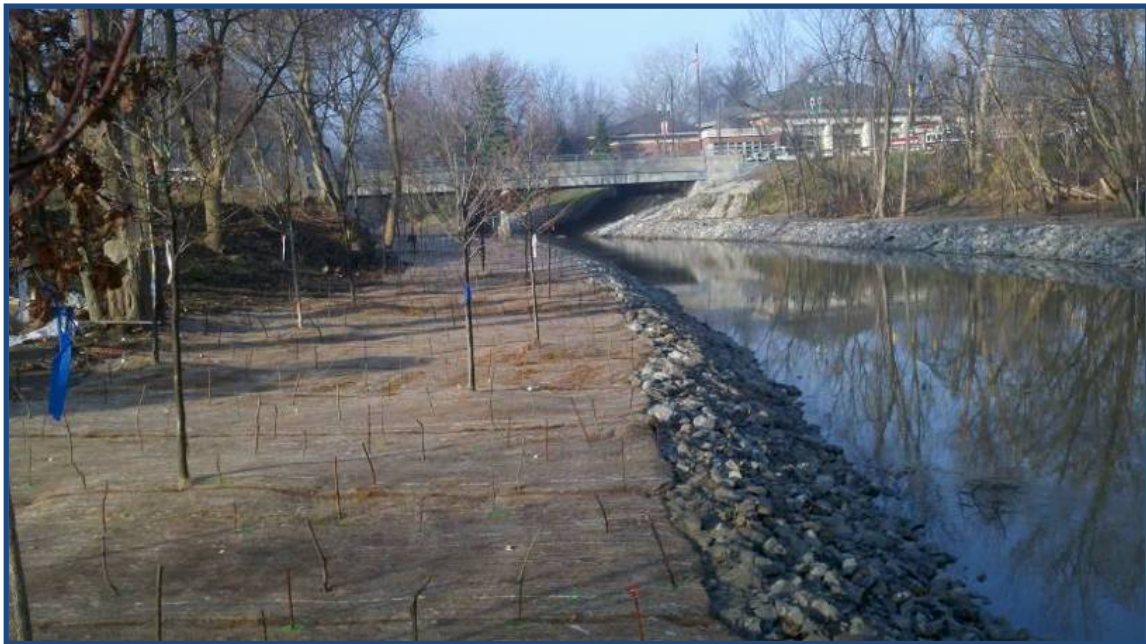
**November 21, 2012: View from downstream end of constructed south bench looking upstream (west) and live stakes installation**

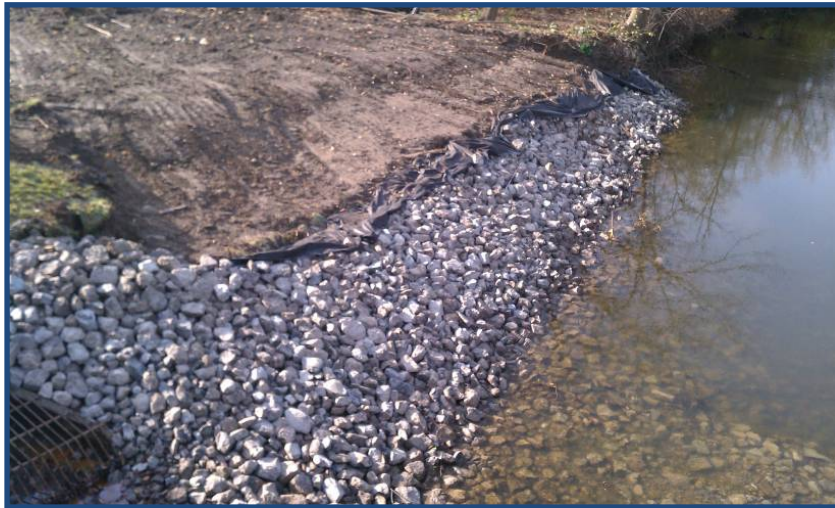
**November 14, 2012: View from bridge looking upstream at south bank. (southwest). Rock toe and shaping of top of bank**

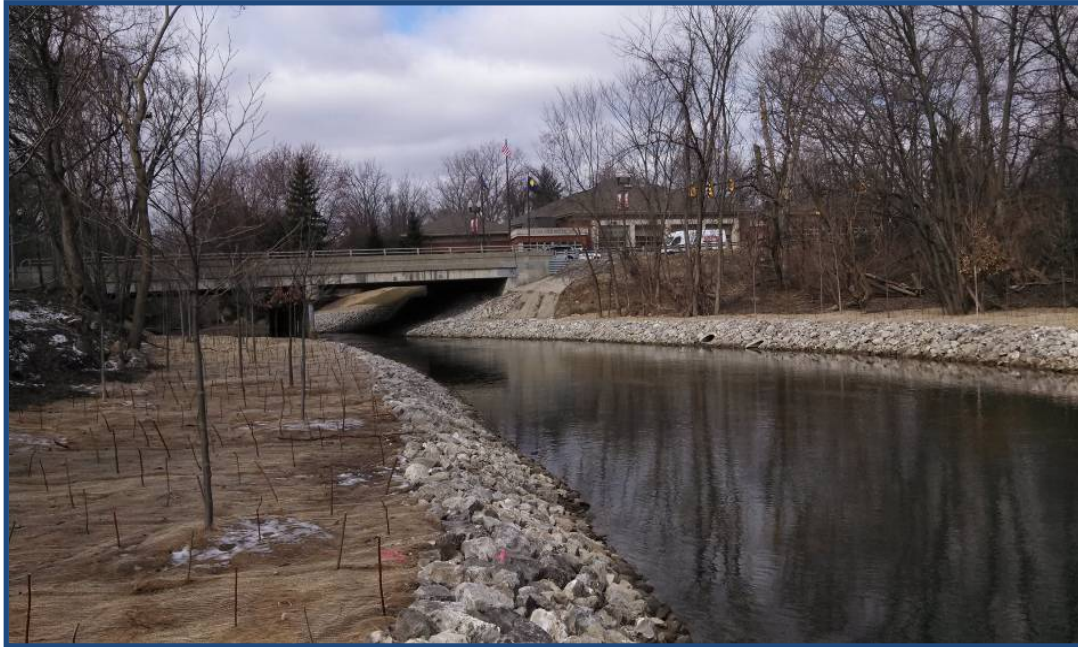
**March 22, 2013: View from downstream end of constructed south bench looking northwest**

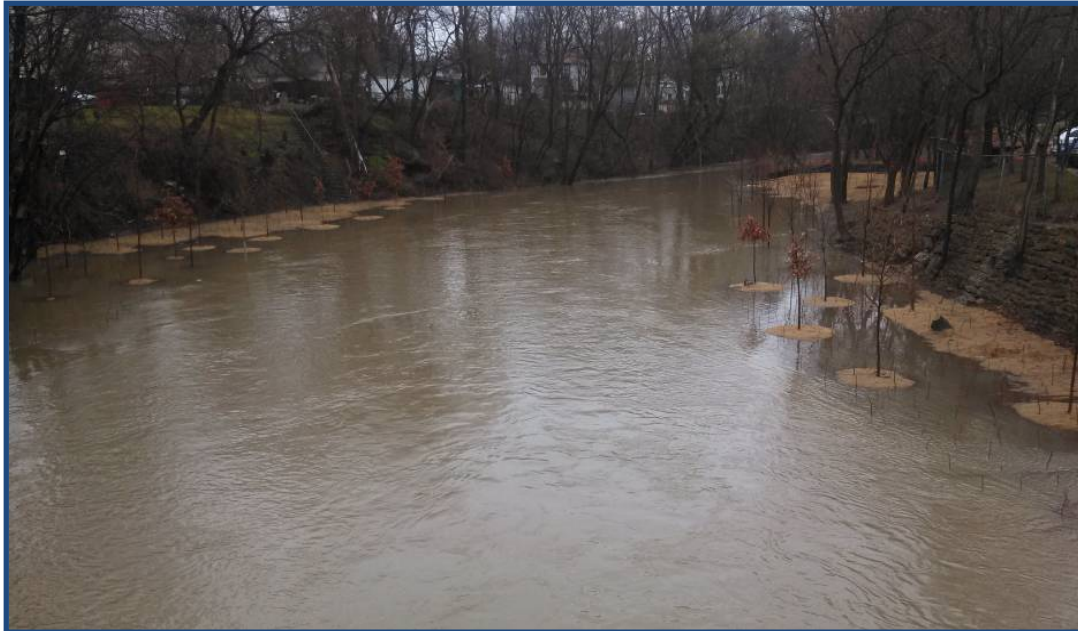
**April 11, 2013: View from bridge looking downstream (east) after sequence of rain events, note, bankfull benches overtopped**

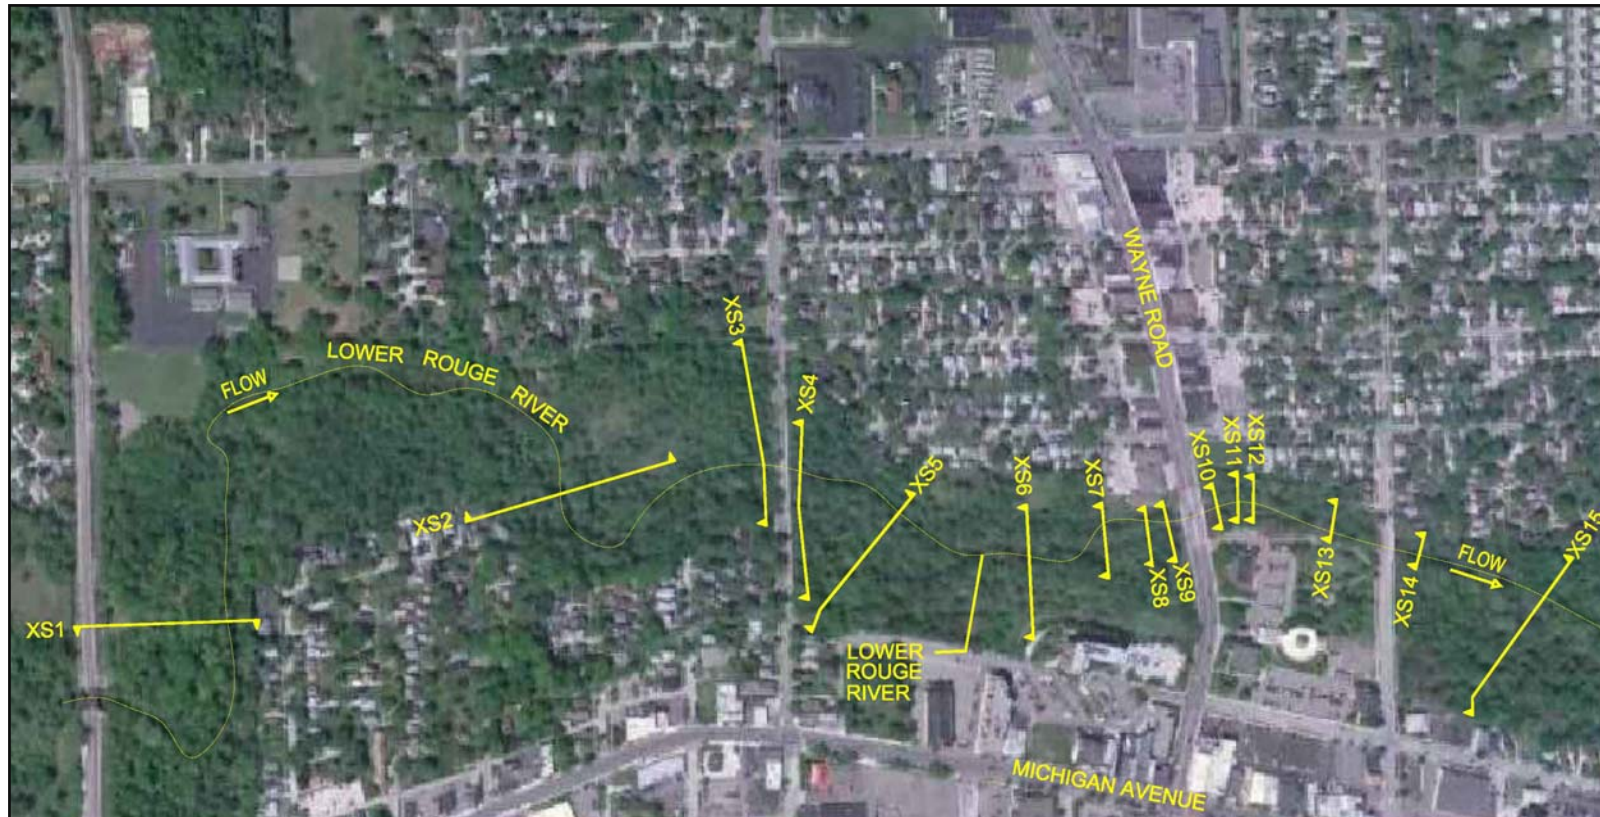
Figure 2. Location of channel cross-sections used to monitor morphological changes in the Lower Rouge River in response to removal of the Wayne Road Dam, Wayne, Michigan.

Thirty cross-sections were surveyed by a Registered Land Surveyor prior to removal of the dam. The pre-removal cross-section data were used to develop a hydraulic model using HEC-RAS, to determine morphological dimensions of the channel, determining the bed slope, and for developing construction drawings. Fifteen of those cross-sections were resurveyed following dam removal. Figure 2 shows the location of the cross-sections that were chosen for post-removal surveying and monitoring. Cross-sections were chosen to represent boundary conditions upstream and downstream of the project

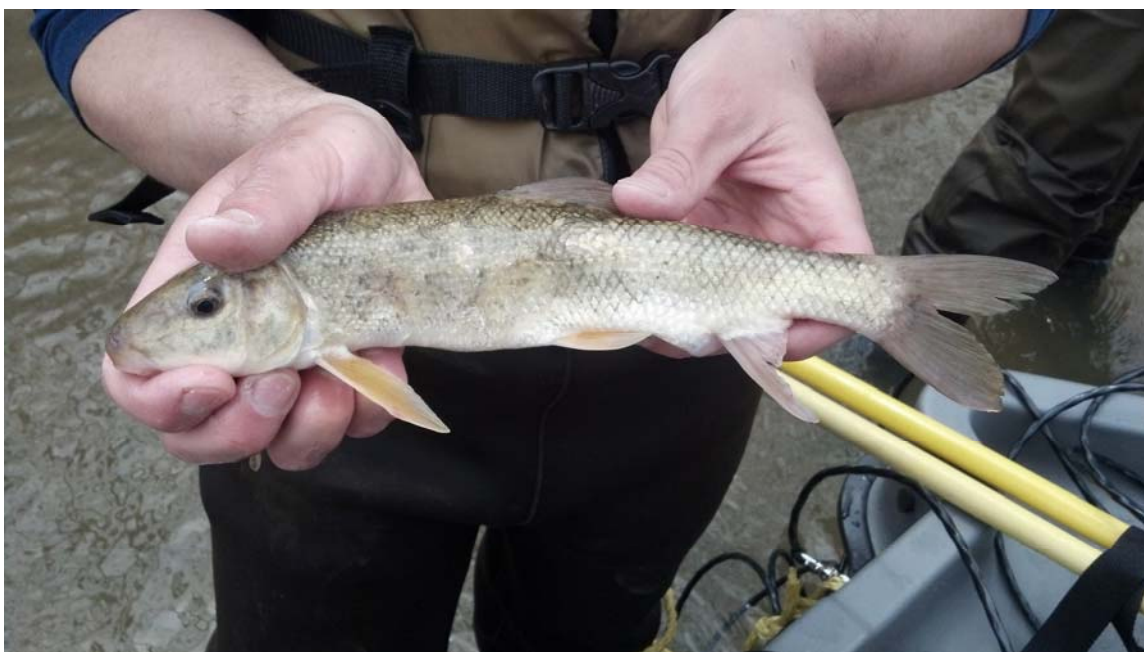
Figure 3. Fin-clipped white sucker (*Catostomus commersoni*) marked in Reach 6 downstream of the Wayne Road Dam on April 4, 2012 and recaptured in Reach 2 upstream of the Wayne Road Dam on April 23, 2013.
