2021 Habitat Sites Report

Blue Water River Walk and Wetlands County Park

Report prepared for: Community Foundation of St. Clair County and St. Clair County Parks and Recreation Commission

Report date: March 28, 2022

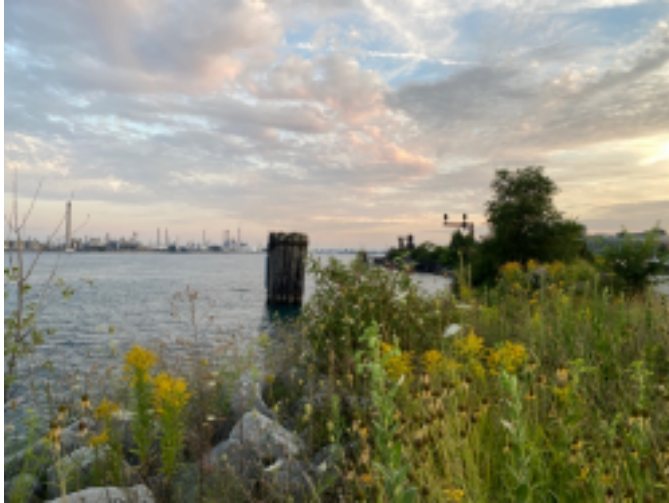
At the north end native vegetation is dominant and varied. Canada Thistle (*Cirsium arvense*) is present in disturbed areas. Invasive Tree of Heaven (*Ailanthus altissima*) is present at the ferry dock area. Some areas have standing dead invasive *Phragmites* left after treatment. An approximately one foot-wide section of plants bordering the paved walkway is being mowed short. Native plants are dominant and thriving along the walkway beyond this closely mowed strip.

Native vegetation thrives along much of the

Recommendations: A low-growing native ground cover is needed along the border of the pavement and around structures so these areas would not need to be mowed. Invasive Tree of Heaven (*Ailanthus altissima*) needs to be removed. Native plants around the Native American sculptures would be a good addition and a public education opportunity. Several Tree Swallow nest boxes need to be repaired or replaced.

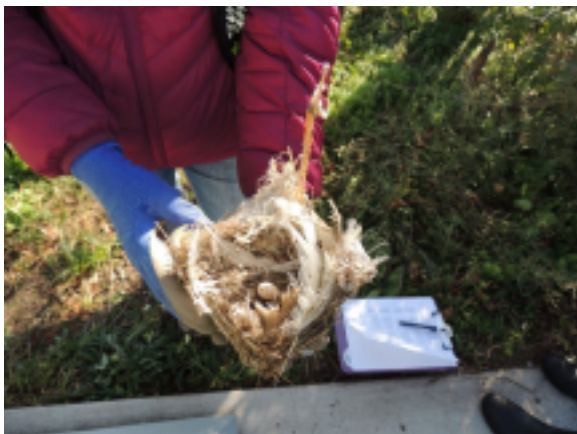
The Tree Swallow nest boxes appear to be used by the target species but some are in poor condition. Some butterfly and moth activity were observed. Friends volunteers have seen fox, muskrat and various waterfowl including blue heron in the shallows. The outer reef, which helps to reduce wave action against the shore, is visible due to lower water levels. There is ample exposed rock nearshore to provide habitat for amphibians and reptiles, however, the hibernacula originally installed are no longer functional. Beach areas are intact and the

Evidence of spring Tree Swallow nesting from fall clean out of nest box

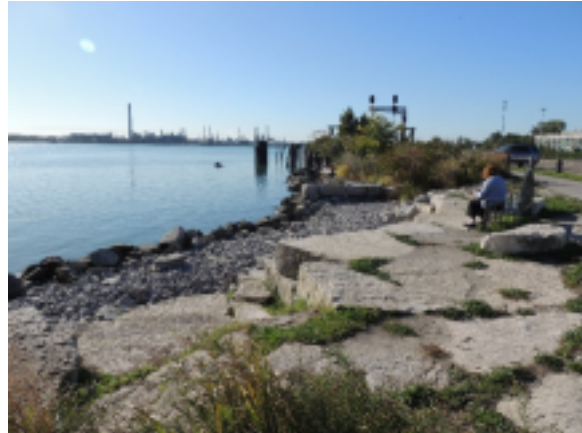
Outdoor classroom area

The River Walk is well used by the public for recreation, wildlife viewing, fishing and general viewing of the river landscape. A Friends volunteer noted that kids have been climbing on the sculptures trampling the surrounding plants. There is some evidence of camping on the site. Native American wooden sculptures, a patio and a pergola have been added to the area that was occupied by the River Rat building. Efforts are underway to install native plants that are traditionally used by native peoples.

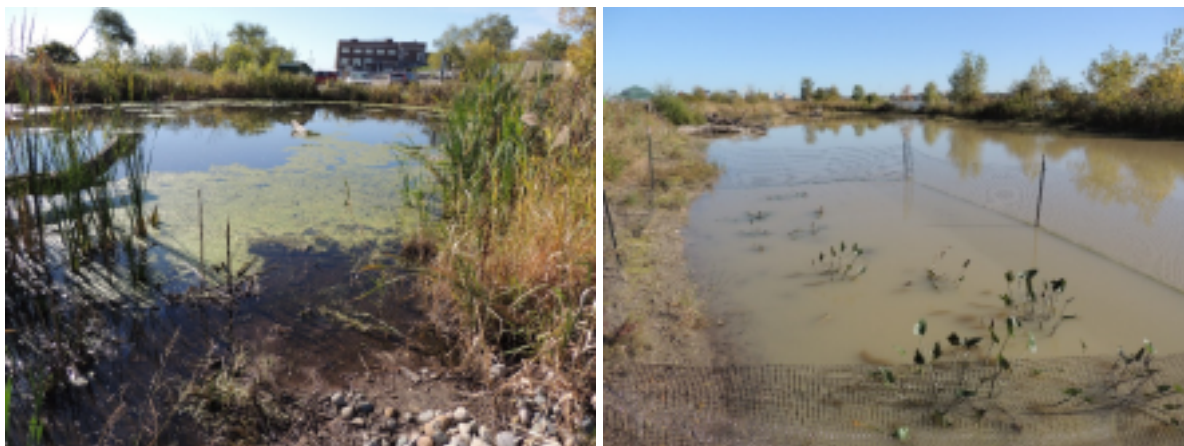
Middle pond (left photo) and South pond (right photo)

Native aquatic vegetation is dominant in the north pond. *Phragmites* and other invasive species are controlled by Friends volunteers and by contractors. Volunteers have planted Ironweed (*Vernonia* sp.) and other native species in several areas of the park. The middle pond has native plants Arrowhead (*Sagittaria* sp.) and Waterlily (*Nymphaea odorata*) present. In the south pond, cattails (*Typha* sp.) dominate, and some Duckweed (*Lemna* sp.) was present. Invasive Japanese Knotweed (*Fallopia japonica*) on the hillside is being controlled by contractors. Invasive *Phragmites* are dominant around the elevated walkway and are also being controlled by contractors.

In the north and middle ponds, the water was very muddy. A muskrat lodge in the north pond that was present earlier in the year is now gone. There is ample basking habitat in the middle and south ponds. In the south pond the water was clear. Wetland Wanderings events held in the summer showed good diversity of macroinvertebrates indicating good water quality and habitat health.

Recommendations: Volunteer stewardship efforts and contracted spraying are keeping the invasive plant species controlled. Maintenance practices appear to be working well and should be maintained.
