2024 AOC Habitat Restoration Monitoring Site Report Wetlands County Park

Project: Wetlands County Park

Monitoring Date: August 19, 2024

Report Prepared by: Friends of the St. Clair River

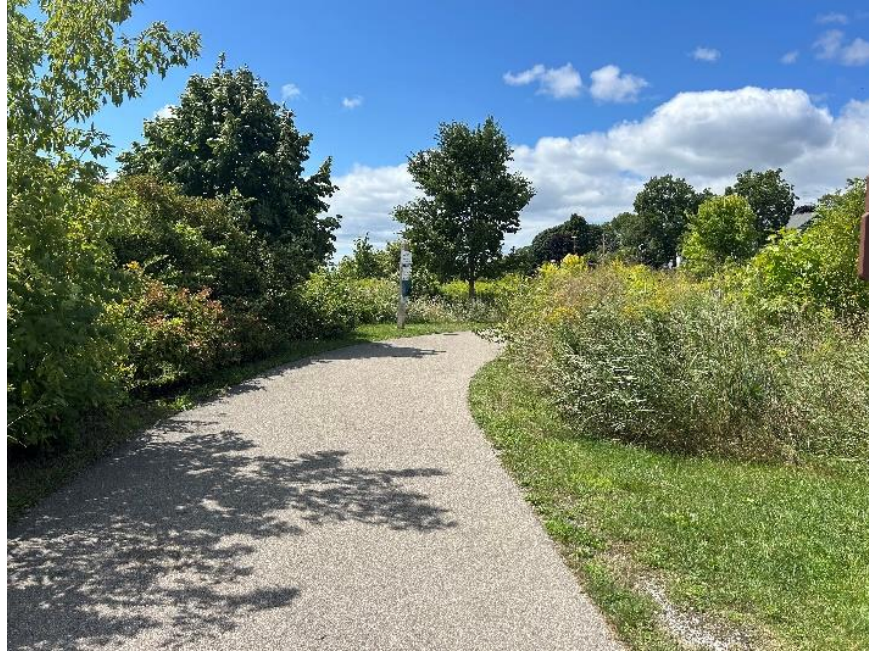
Figure 1. View from northern boundary shooting southward. Native trees, shrubs, and forbs are visible on both sides of the path. Mowing the path edges is maintained for pedestrian safety and to maintain the longevity of the cement pathway. L. McFadden.

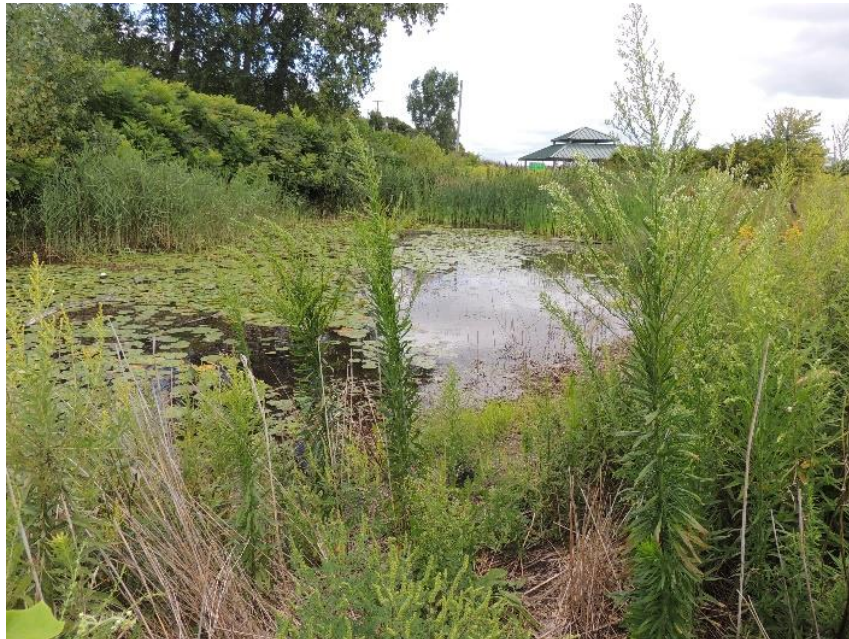
Figure 2. Southern boundary of northern pond, northward view. White water lilies are the predominant emergent aquatic vegetation. Staghorn sumac, phragmites, fleabane asters and goldenrod line the shoreline. P. Duhaime.

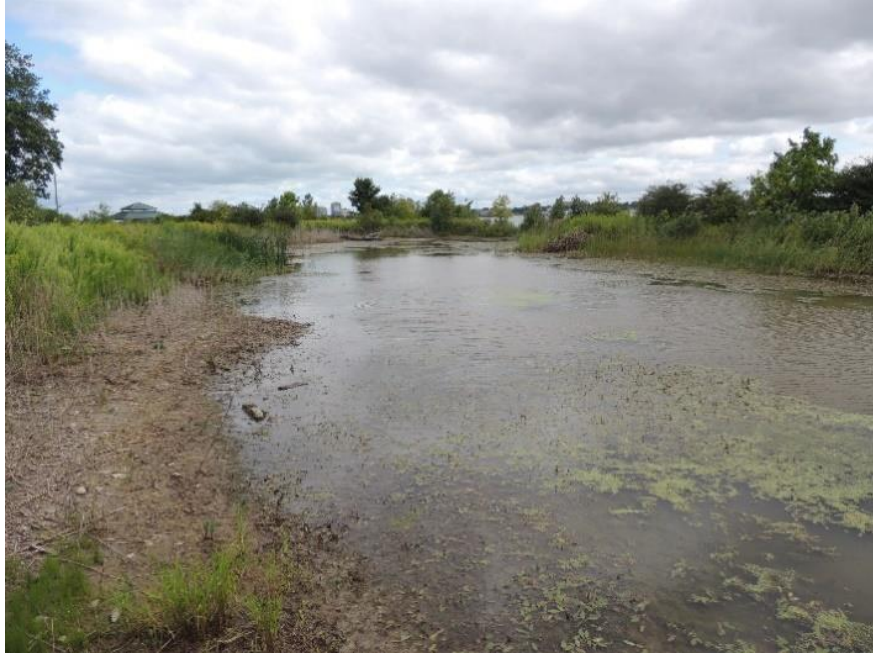
Figure 3. Mid-section of bridge over large middle pond; northward view. The water level was very low. P. Duhaime

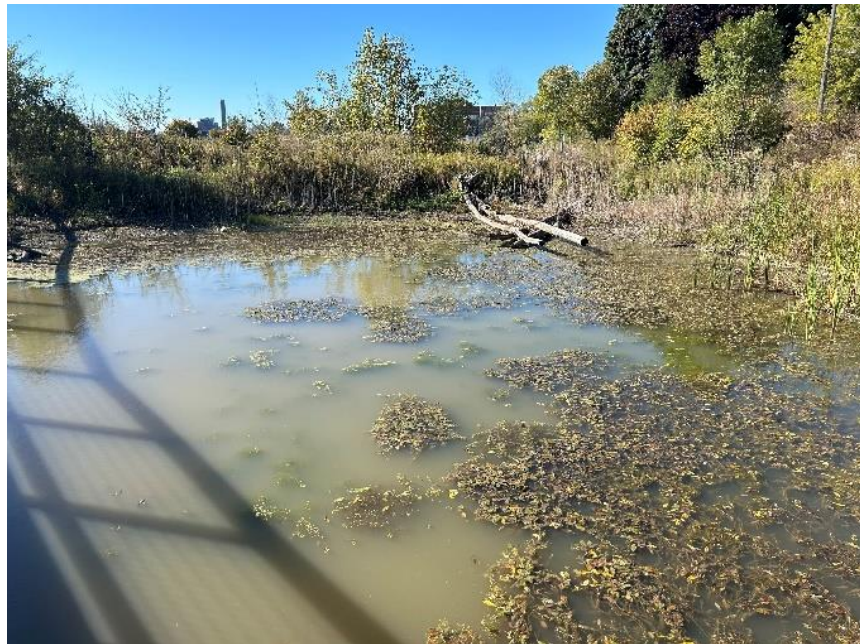
The water level was lower than in previous years in each of the wetlands. Several logs were exposed providing basking habitat. Visible aquatic vegetation consisted of white water lilies, flat leaf pondweed, duckweed, and algae. Each of the ponds were surrounded by a combination of staghorn sumac, phragmites and cattails.

Figure 4. Mid-section of bridge over large middle pond; southward view. The water level was very low, causing some basking logs to be out of the water. L. McFadden.

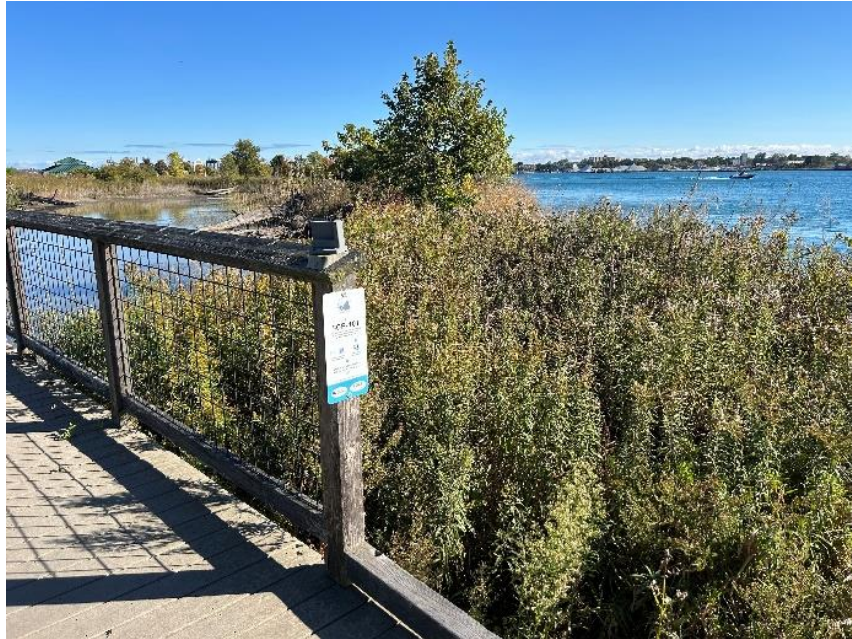
Figure 5. Chronolog Station on the bridge. This Chronolog station could use additional signage for enhanced visibility. L. McFadden.

- Tree of heaven should be removed. This exotic invasive species has the capacity to produce hundreds of seeds and seedlings annually. The allelopathic nature of the plant prevents other species from thriving when found growing in close proximity, giving this tree a competitive advantage against the native species in the restoration area. Tree of heaven is also a preferred host plant for the invasive spotted lanternfly, which threatens Michigan’s multibillion-dollar agricultural industry.
- The current Chronolog station blends in with its surroundings and is not very visible to the public as it blends into its surroundings, nor does it offer any identification or education to its purpose. Updating the Chronolog station with additional educational signage to draw attention to its presence and purpose would likely bring more use by pedestrians.

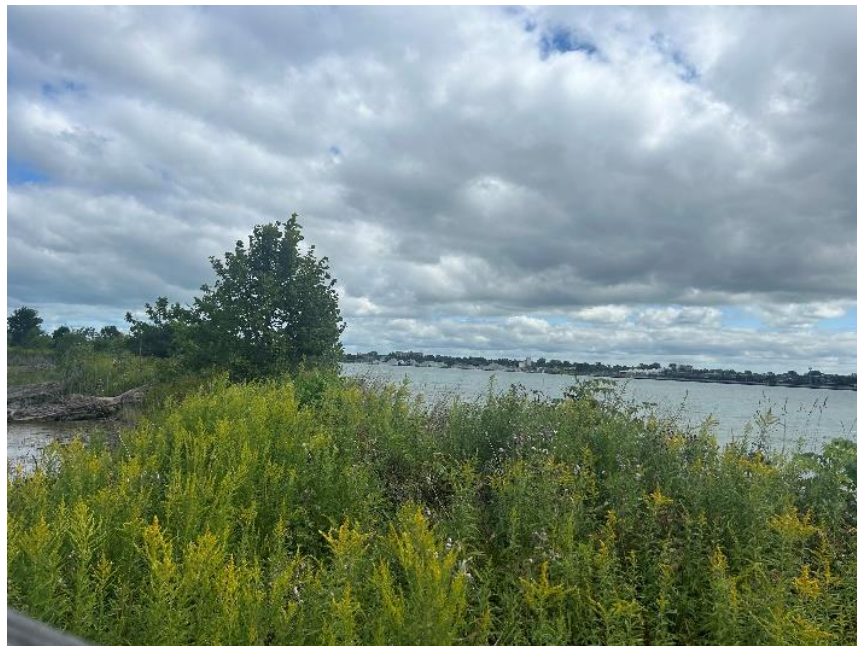
Figure 6. View from Chronolog station. Photos taken from this Chronolog station are submitted to Wetlands County Park Chronolog timeline to observe changes in the ecosystem over time. L. McFadden

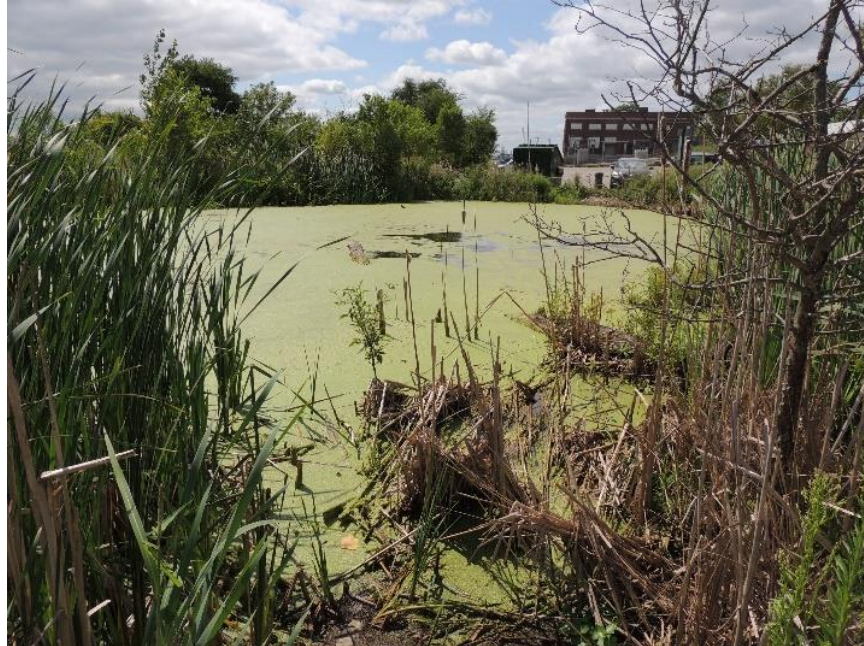
Figure 7. The surface of the southern pond is almost full of duckweed. Cattails, phragmites and staghorn sumac line the edges. L. McFadden.

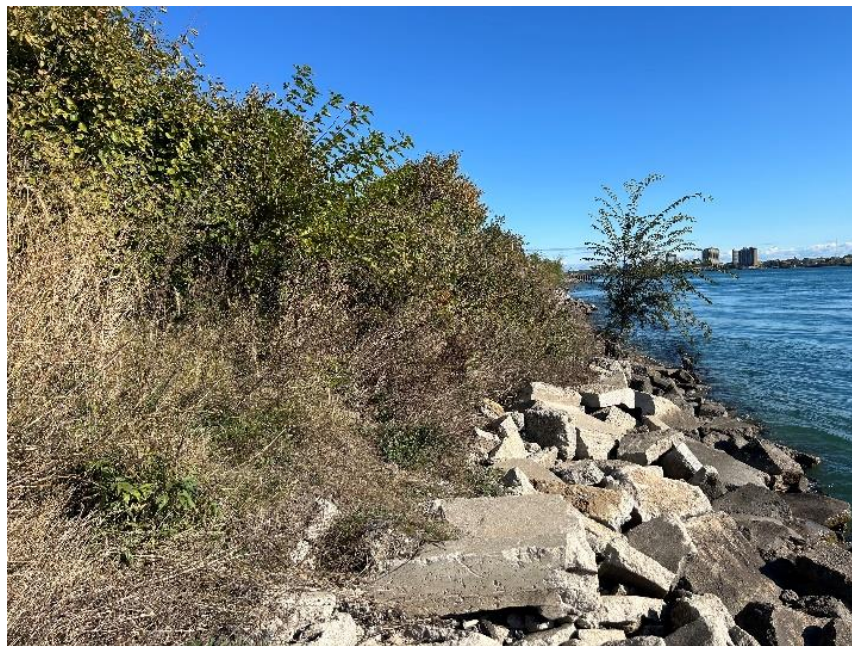
No shoreline erosion along the St. Clair River was evident at the site. The breakwater habitat structures and rock armored shoreline prevented such significant erosion impacts. The water level was low in each of the three ponds, which is unusual due to the recent heavy rains and wet season in general.

Figure 8. Cement riprap lines the shoreline edges helping to prevent erosion from large waves and fast river currents while also providing habitat for aquatic fish and macroinvertebrates. Native plants, as shown in this photo, have large root systems that hold soil in place and maintain the integrity of the shoreline. L. McFadden.
