Rouge River Watershed

Ingersol Creek Dissolved Oxygen Assessment

Final Report

DECEMBER 2017

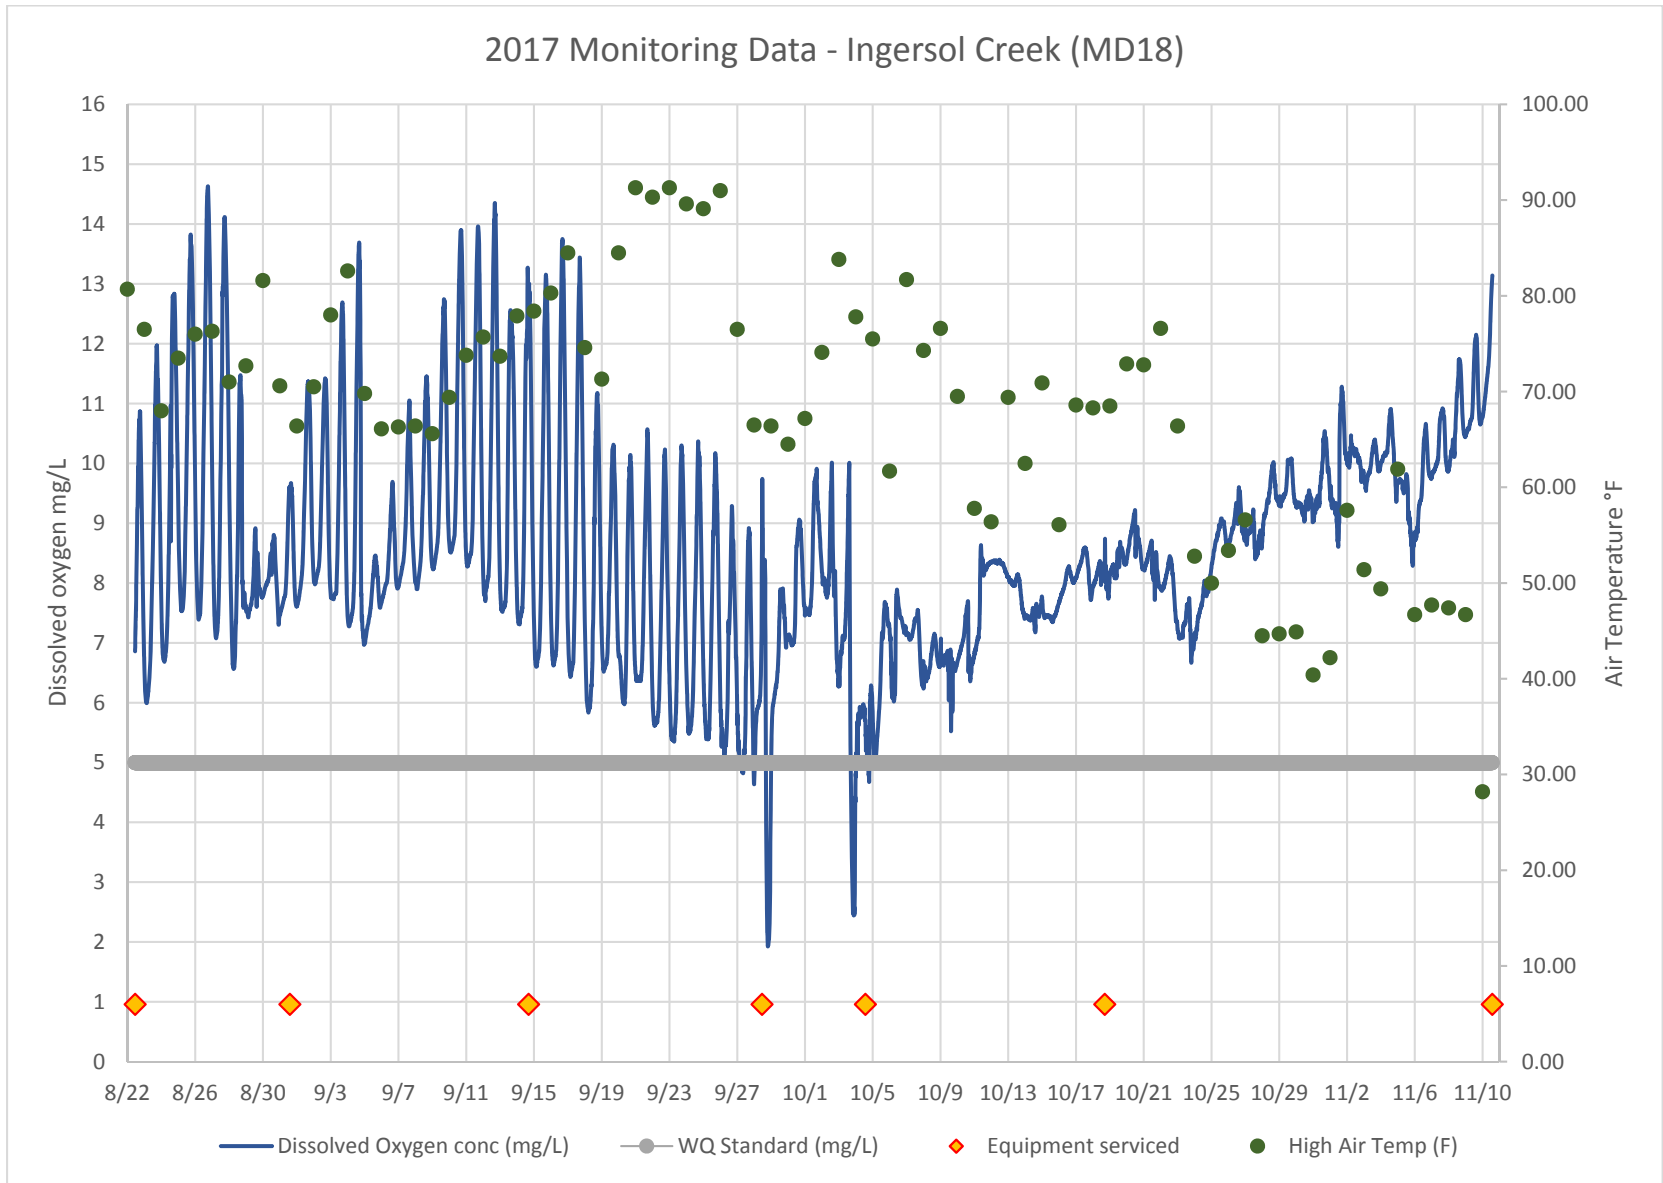
Figure 2: Dissolved Oxygen Levels and Daily Average Temperatures

More than 7,600 DO readings were collected over 81 days. The majority of these measurements (98.6%) were above the water quality standard of 5 mg/L (**Figure 2**). In addition, the following observations were made:

- The daily high air temperature was over 70°F 60% of the time, and over 80°F 27% of the time.
- Between September 27th and the early morning hours of the 29th. These low readings occurred during the early morning hours when water temperature was at its lowest.
- On Sept 28th DO readings fell below 2 mg/L for 1.5 hours.
- Between October 3rd and 5th there were brief periods of time when the DO dropped below 5 mg/L. These values did not correlate with water temperature or normal diurnal fluctuations.

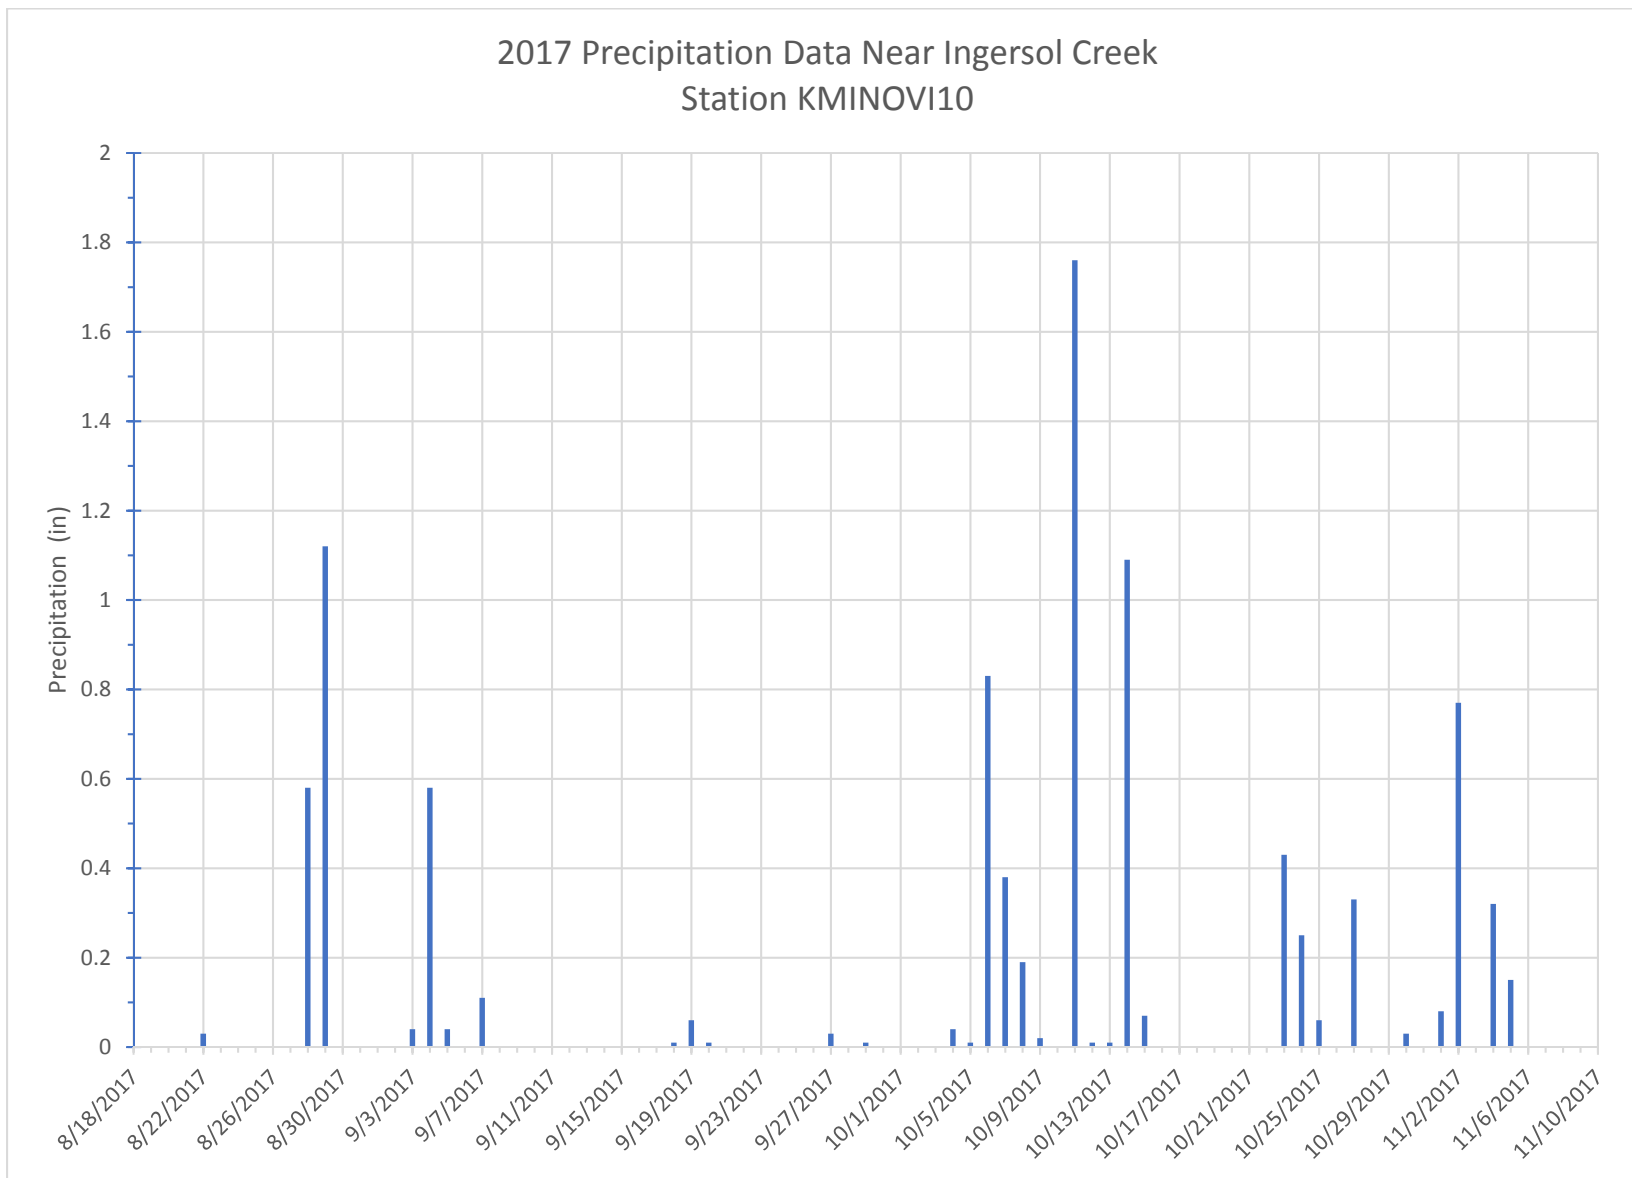
Figure 3: Precipitation Data, Novi, MI

There were several significant rainfall events (> 0.5 inches) that occurred during the monitoring period as shown in **Table 1 and Figure 3**. These events caused the daily peak DO concentrations to decrease by 0.2 to 0.4 mg/L; however, DO levels remained above the water quality standard. The rain events also dampened the diurnal fluctuations normal seen at the site. This can be seen after the August and October rain events.

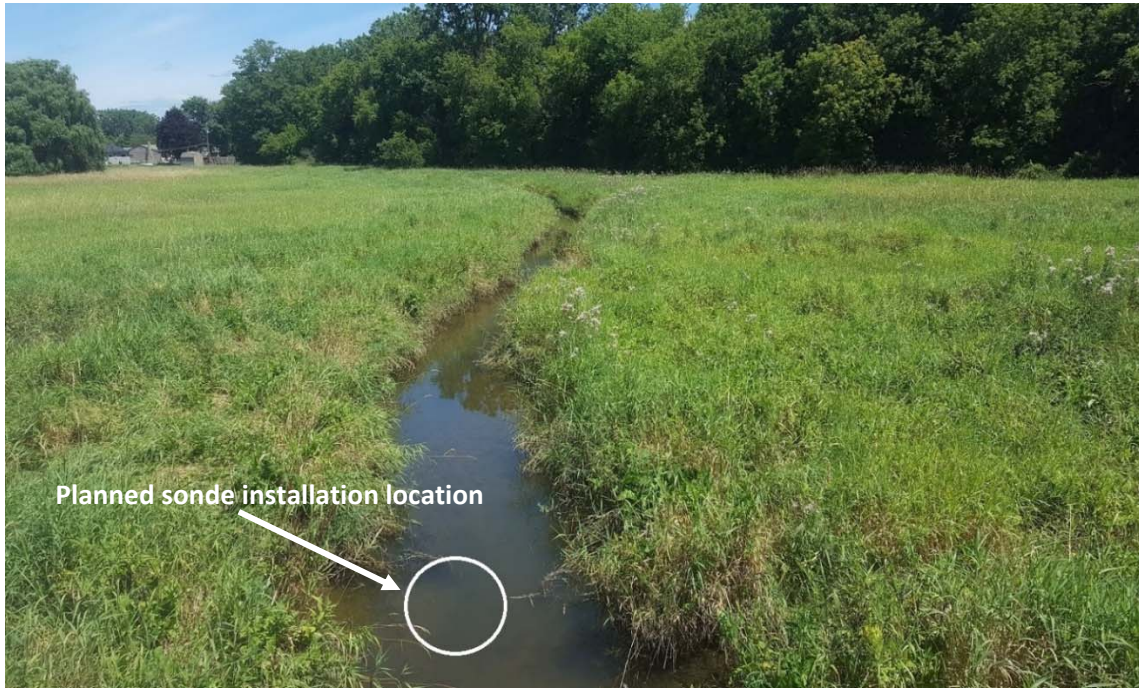
Monitoring Site (MD18) looking Upstream from Meadowbrook Road

Continuous DO monitoring was performed between August 22, 2017 and November 10, 2017 on Ingersol Creek as shown in **Figure 1**). A sonde with an optical DO probe (YSI 6920) was used to collect the data in 15-minute intervals. The sonde was located on the east side of Meadowbrook Road (coordinates: 42.458975, -83.454819). Photographs of the site can be found in Appendix A.

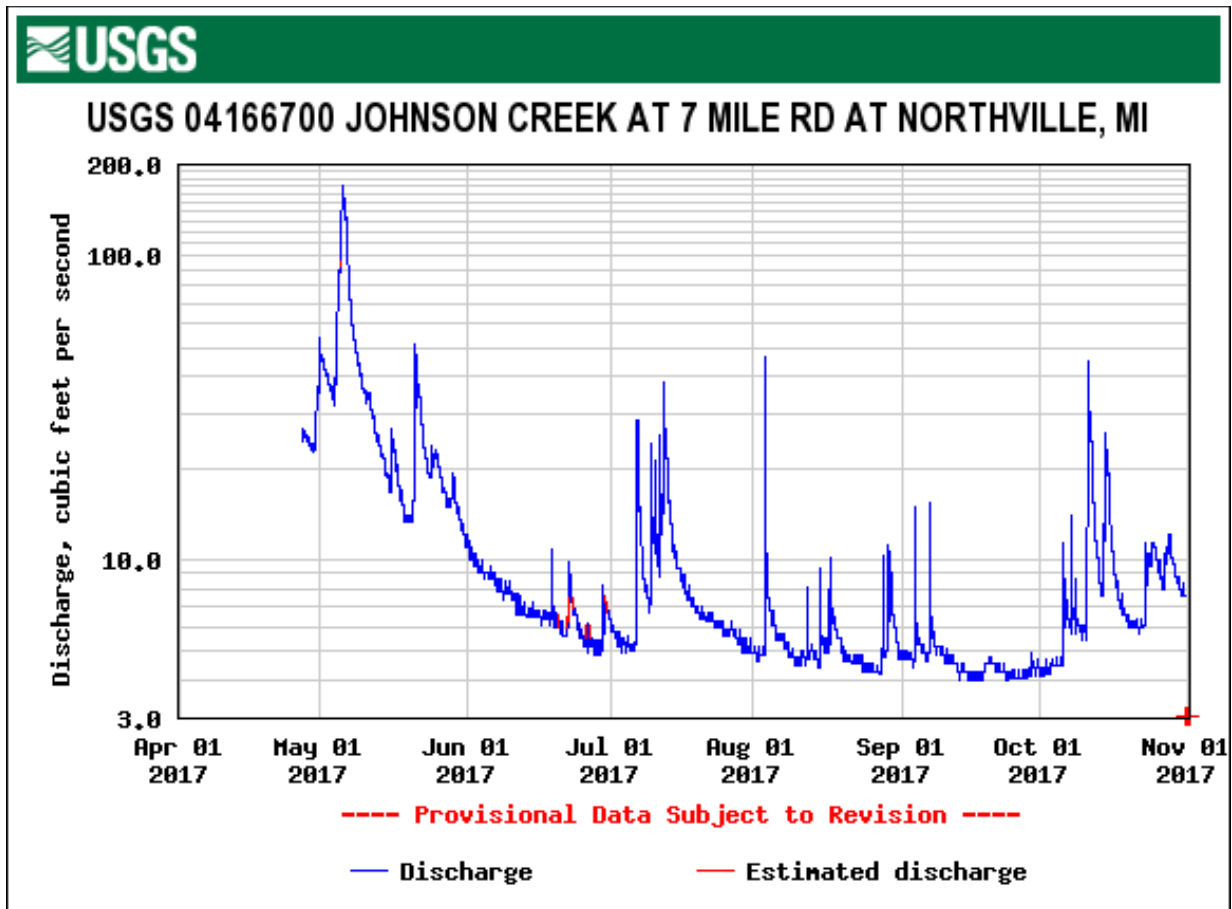
Appendix B. Johnson Creek discharge data as a relative indication of stream flows on Ingersol Creek

- Between September 16th and October 4th, stream flows on Johnson Creek were at their lowest of the summer as shown in Appendix B. This indicates that stream discharge was likely at its lowest on Ingersol Creek during the same time period.
- During the maintenance visits on 9/28, 10/4, and 10/18/17 the field crew noted mud buildup on the sonde. During the maintenance visit on 10/4/17, the field crew noted a streambank stabilization project occurring upstream of the monitoring location which was causing a higher sediment load to the creek. This stabilization project had been going on since 10/2/17.

During the monitoring period, stream discharge was measured at the outlet of Johnson Creek which is within 3 miles of Ingersol Creek. This data provided a relative sense of discharge conditions of Ingersol Creek during the time of the study.
