2018 ILLICIT DISCHARGE INVESTIGATIONS IN OAKLAND COUNTY'S PORTION OF THE ROUGE RIVER WATERSHED

FINAL REPORT

PREPARED BY:
OAKLAND COUNTY WATER RESOURCES COMMISSIONER

JANUARY 31, 2019

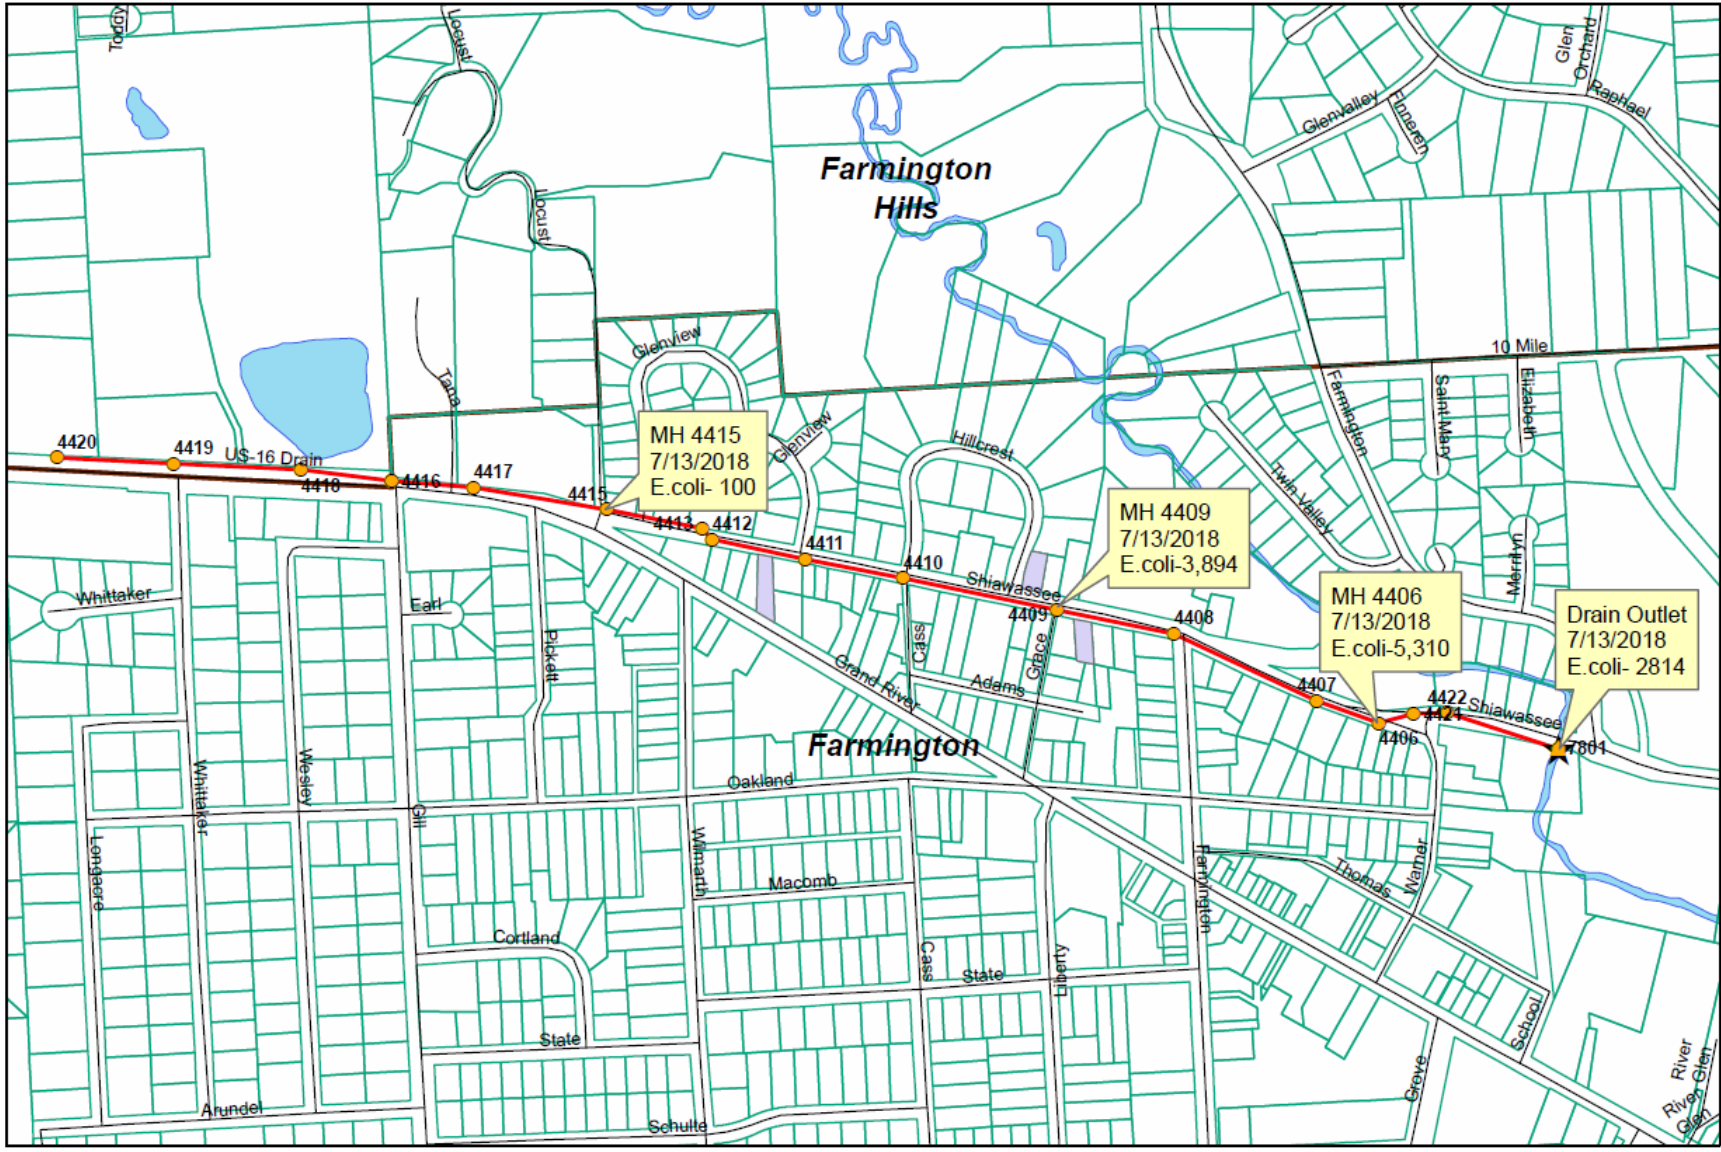
Figure 2: US 16 Drain, 2018 E. coli Sampling Results

Sampling results for *E. coli* indicates elevated counts above 1,000 CFU / 100 ML at the outlet and at manhole locations downstream of the eliminated sanitary connections. Counts ranged from 2,814 CFU / 100 ML at the outlet to 5,310 CFU / 100 ML at manhole 4406 at Shiawassee and Varner St (Figure 2). The upstream manhole location at Grand River and Shiawassee, manhole 4415, was 100 CFU / 100 ML, which is below the State Water Quality Standard of 300 CFU /100 ML. This indicates that the portion of the enclosed drain west of Shiawassee Road on Grand River Avenue is no longer a concern. Although counts along Shiawassee Road are above the State Water Quality Standard, the highest being manhole 4406 at 5,310 CFU / 100 ML, they are not high enough to be considered indicative a sanitary sewage source which is typically greater than 10,000 CFU / 100 ML. Considering no physical sign of sanitary sewage was evident in the drain it is not believed that these conditions are related to a continual sanitary sewage source and no additional IDEP investigations are planned. It should also be noted that the drain experiences continual dry weather flow from upstream connected drainage ponds and the outlet of the drain is at river level at its confluence under the bridge on Shiawassee. This provides direct access to the drain system for animals to migrate along and or live in the drain system between the River and upstream ponds. Muskrats and animal fecal matter have been seen in the drain system during past inspections and drain cleanings which could contribute to the elevated *E. coli* counts in the drain.

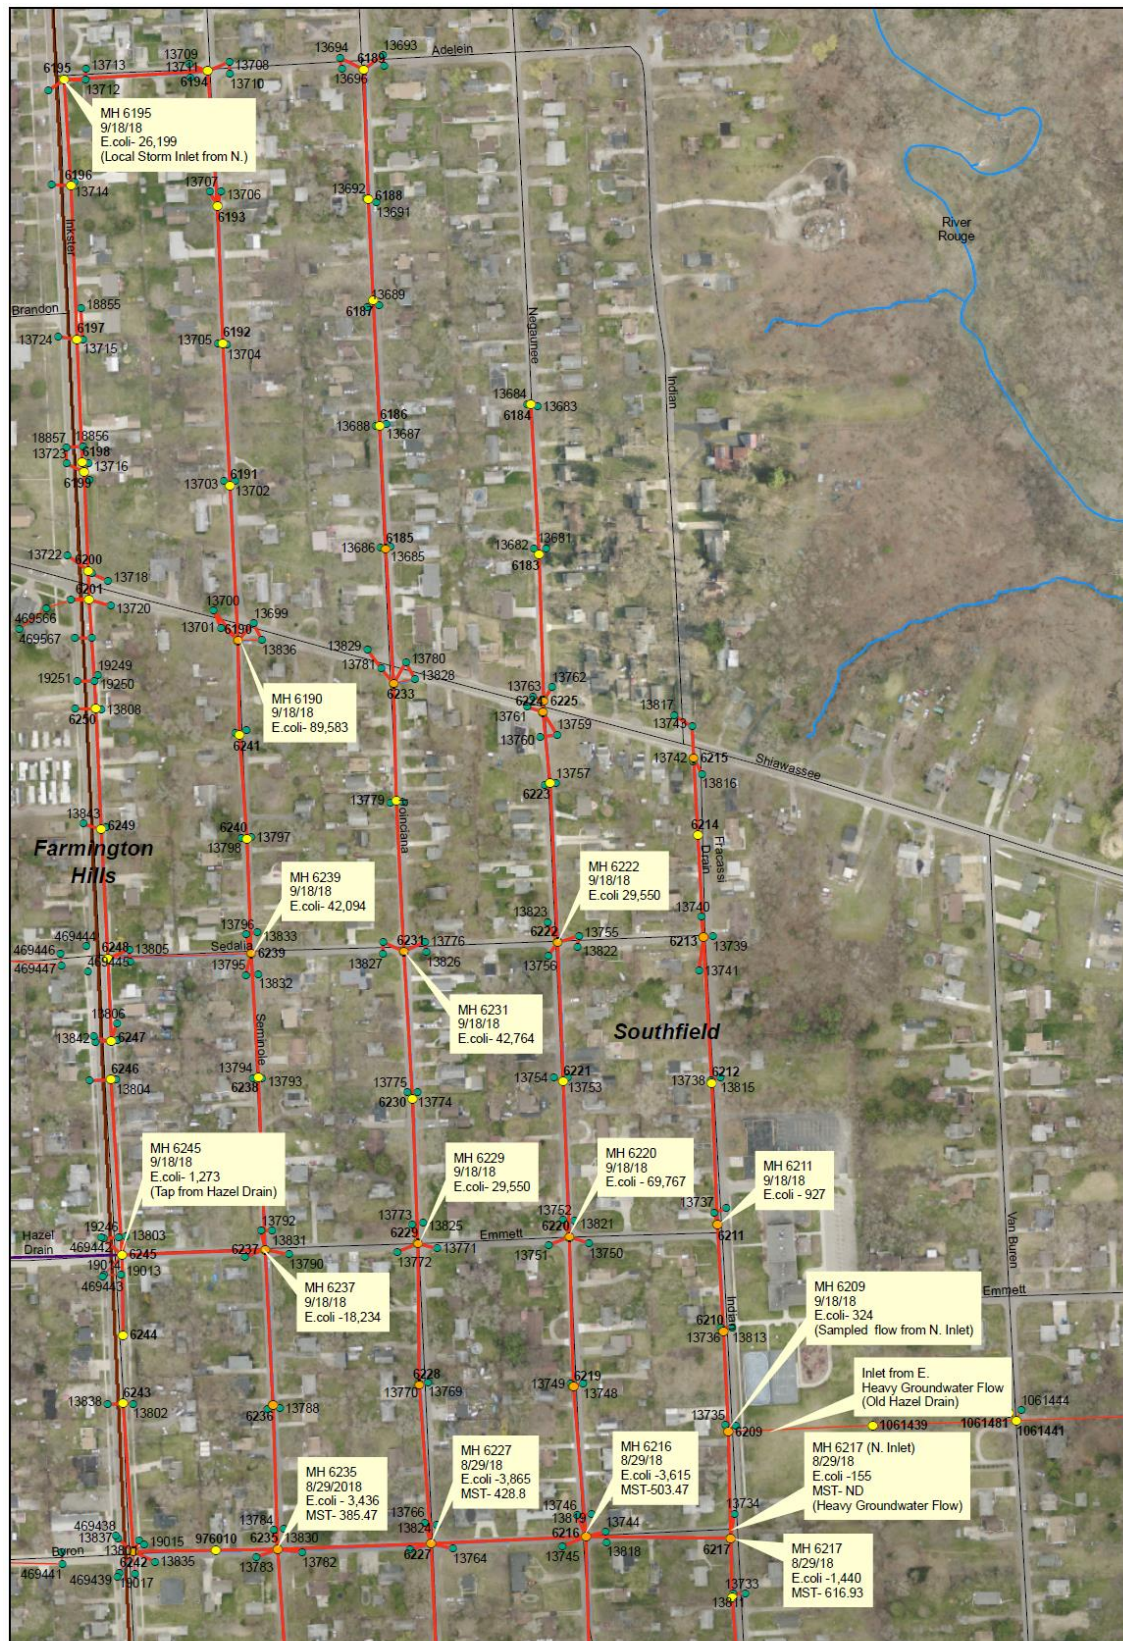
Figure 3: Fracassi Drain, 2018 Sampling Results.

Additional samples for *E. coli* were collected on the Indian Street drain lateral from Byron Street to Emmett Street. All counts were below 1,000 CFU/100 ML (Figure 3). These concentrations do not indicate that a continued source of sanitary sewage is present. Additionally, results of an MST sample taken at the outlet at manhole 6217 was non-detectable (ND) for human DNA markers. However, in 2017 manhole 6210 (located directly across from the John Grace Community Center and just downstream of the unknown six-inch clay tile inlet) showed *E. coli* concentrations greater than 1,002,500

Additional samples were collected on the Negaunee Street storm drain lateral in 2018 (Figure 3). Elevated *E. coli* concentrations in the drain, the highest being manhole 6220 at 69,767 CFU / 100 ML, continue to indicate the likelihood of an illicit discharge of sanitary sewage upstream of Emmett Street. *E. coli* concentrations from previous samplings have been as high as 649,000 CFU / 100 ML in 2017 at MH 6219. A CCTV inspection of the drain was completed in 2017 and 2018. The inspection did not locate any unidentified connections to the drain. Inspections of upstream drainage manholes and connected drainage ditch inlets have not identified any directly connected sources of contamination to the drain. MST sampling at manhole 6216 indicated a low human Bacteroides concentration (503.47 gene pairs / 100 ML). The corresponding *E. coli* concentration was relatively low (3,615 CFU/100 ML) as well. These concentrations are less than what would be expected from a direct discharge of sanitary sewage.

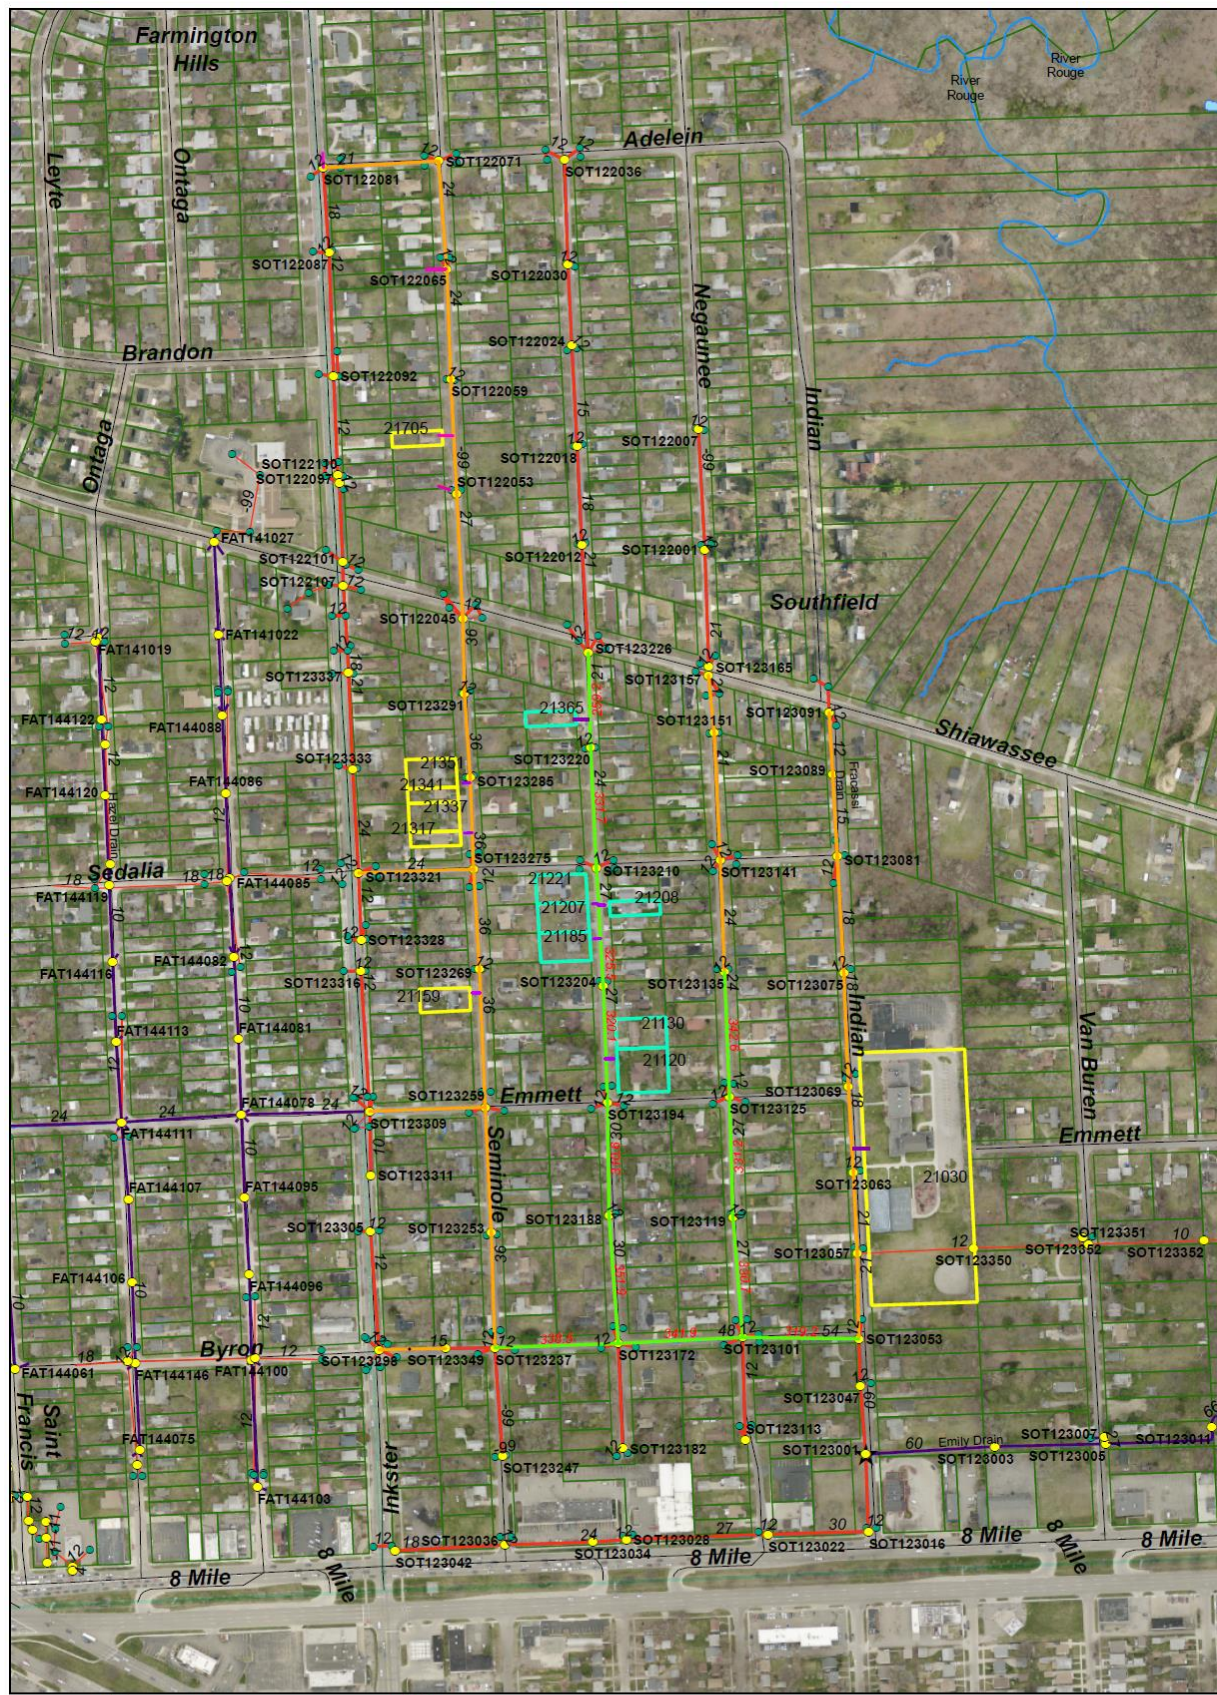
Figure 4: Fracassi Drain CCTV & Suspect Property Locations

No illicit discharges have been confirmed. A map of CCTV inspection locations and along with results and locations of suspect properties are included as Figure 4. A summary table of suspect properties

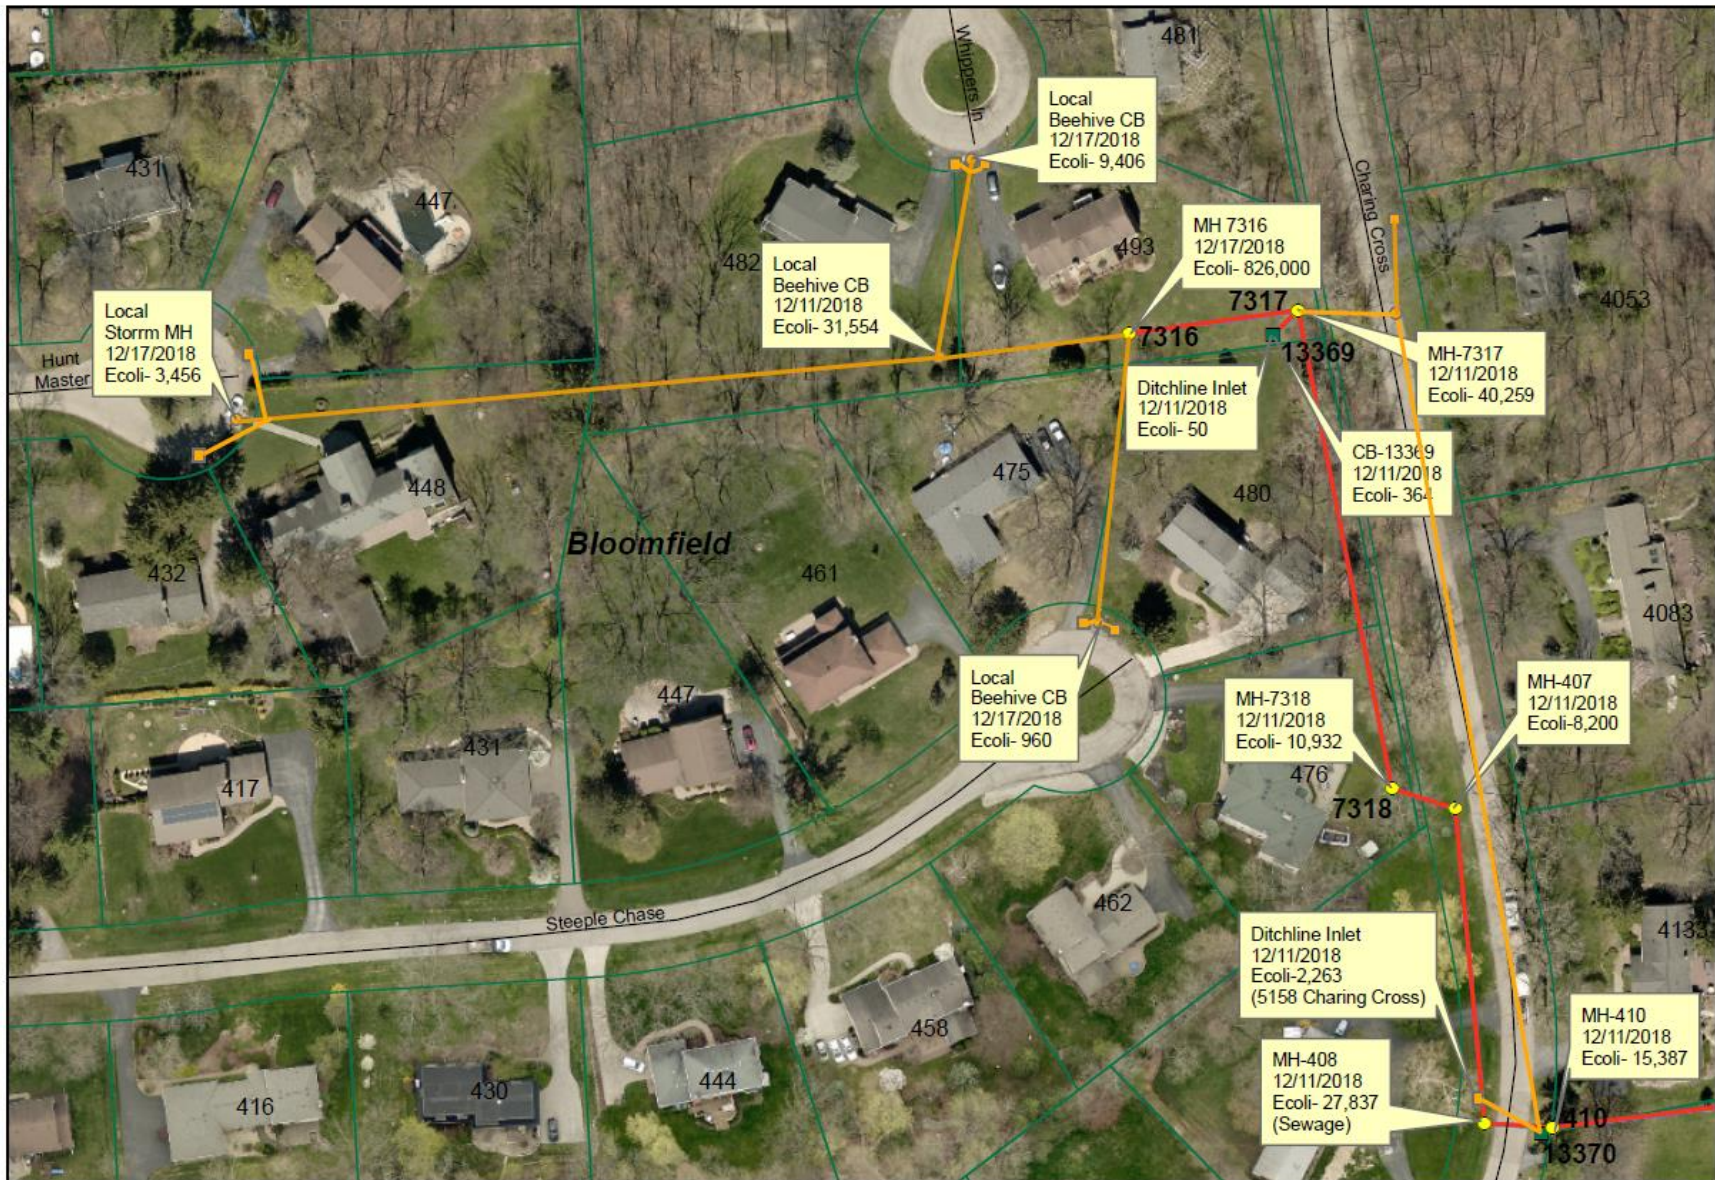
Figure 7: Claude H. Stevens No. 3 Drain, 2018 Sampling and Investigation Map

In 2018 additional sampling and investigations were conducted on the CH Stevens No. 3 Drain at manhole 408 and upstream manhole locations and on the local drain systems for subdivisions on Whipple Lane, Steeple Chase and Hunt Master. A map of sampling locations and results are included as Figure 6. Upstream inspections were conducted at seven (7) manhole and catch basin structures on the CH Stevens No. 3 drain and (5) manhole and catch basin structures from the local connected drain systems. During the survey, manhole, catch basin and inlets structures were located, photographed and examined for dry weather flow and any evidence of pollutants associated with illicit discharges. Samples were collected at thirteen (13) locations and taken to the Walled Lake / Novi Waste Water Treatment Facility (WWTF) for *E. coli* analysis. A map of locations with results of *E. coli* sampling is included as Figure 7. Copies of manhole, catch basin, and inlet inspections, notes and photographs are included in

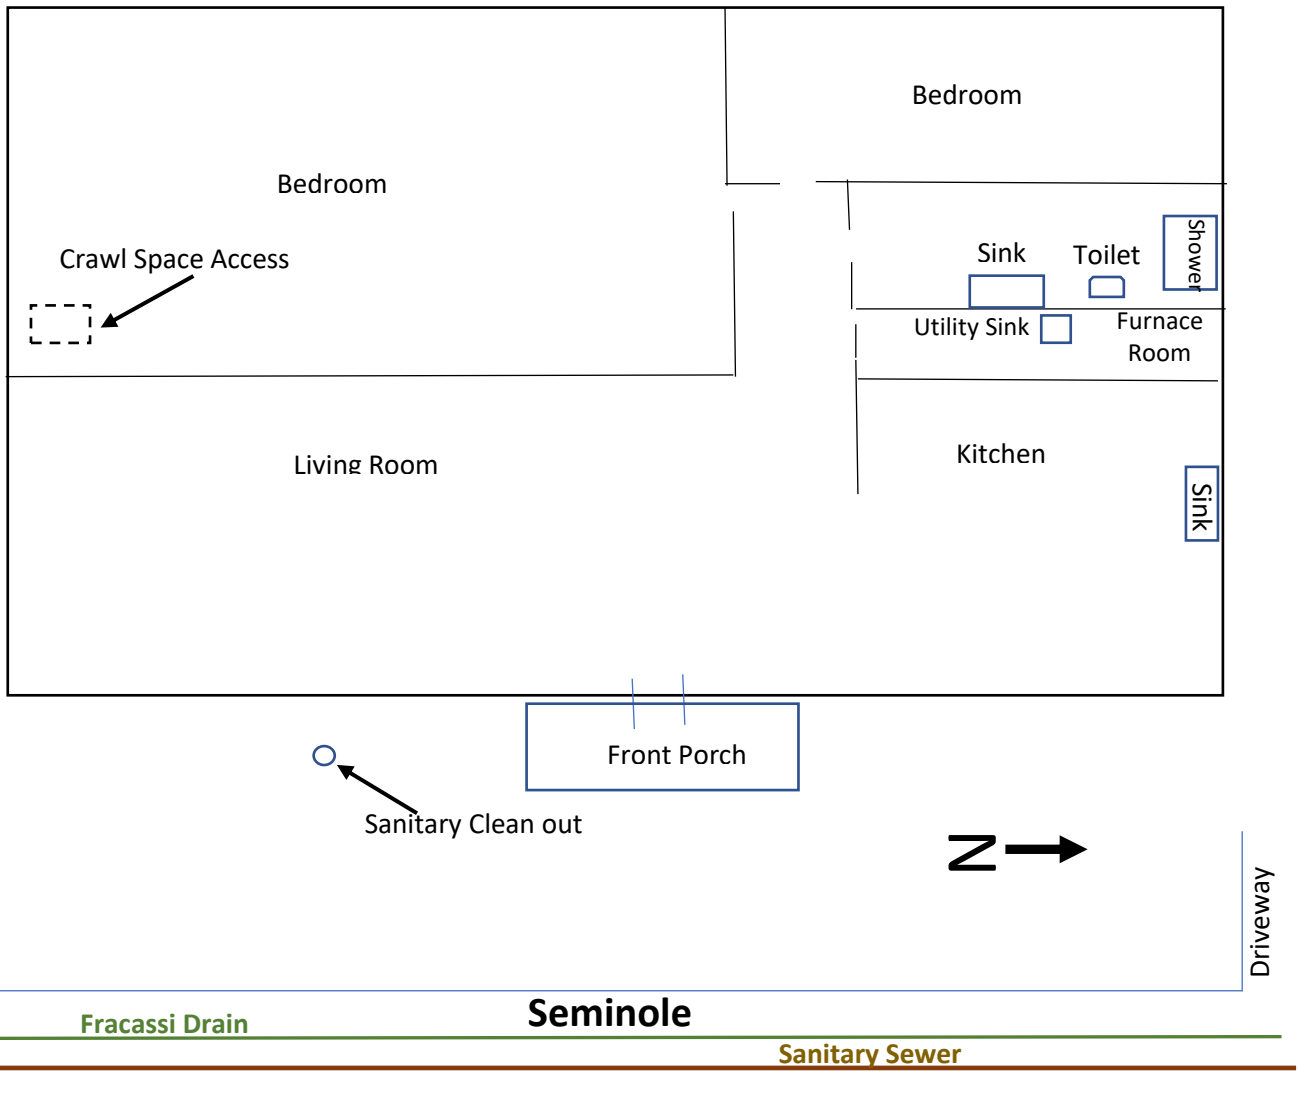
Address: 21317 Seminole Contact: Dan Borovoy Number: (248) 210-4999

Result: House is 1 level with crawl space. Bathroom and utility room fixtures are connected through cleanout to the sanitary sewer. Kitchen sink is not tied in through the cleanout connection. Flow from kitchen sink did not show up in storm or sanitary sewer

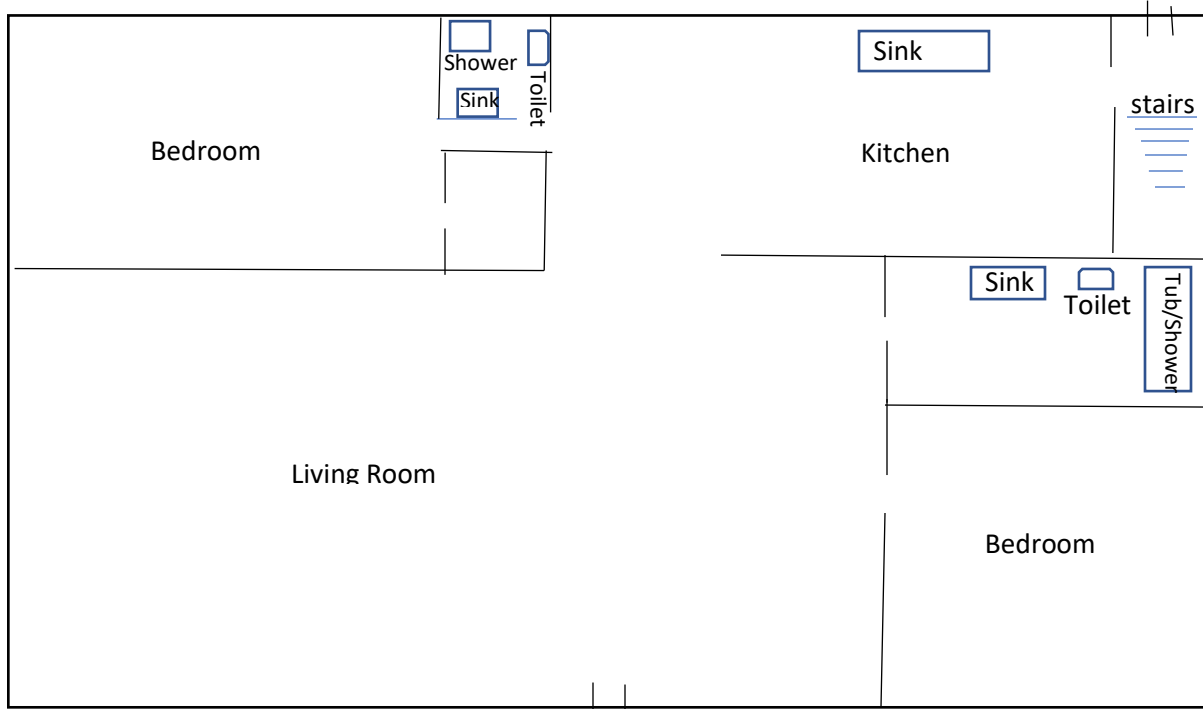
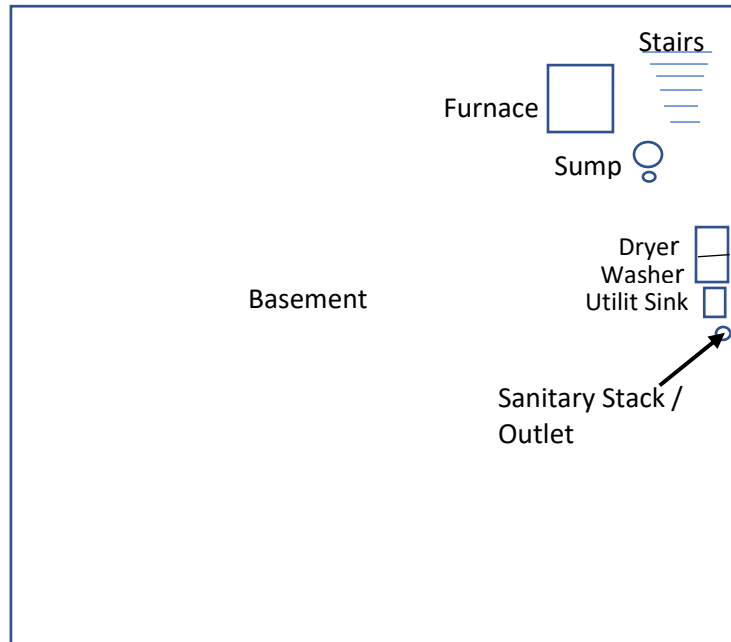
Address: 21341 Seminole Contact: Ray Oliver Number: 248) 352- 4386

All sanitary fixtures are properly connected to the Sanitary Sewer
