# Danvers Pond Dam Removal and Stream Restoration Project

## Great Lakes Restoration Initiative Grant Final Report

US EPA Contract Number E-00639

December, 2012

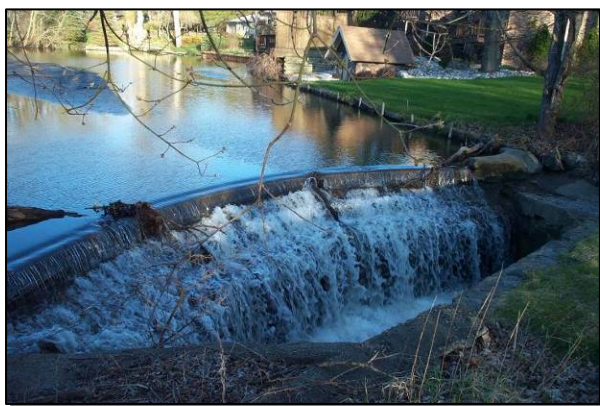
**Danvers Pond Dam prior to project implementation**

*Dam Removal-* During the site investigation the existing concrete and masonry structure was observed to be in disrepair and seepage and flow was observed at the dam, indicating deterioration and possible impending structural failure. The extent of dam removal was investigated and the initial concept alternative that was developed included the removal of the arch dam structure, wing walls and entire box culvert to the existing 84" x 120" corrugated metal pipe (CMP) culvert. In this concept, the earth fill outside the box culvert would be re-graded to a 1:3 (v:h) slope and stabilized with rip rap. The existing CMP culvert would be extended to a minimum of 12 feet in order to maintain the proposed 1:3 (v:h) slope from Danvers Road. The flow of Pebble Creek would then be restored through the existing CMP culvert. The existing culvert under Danvers Road would serve as downstream grade control for the restored stream channel.

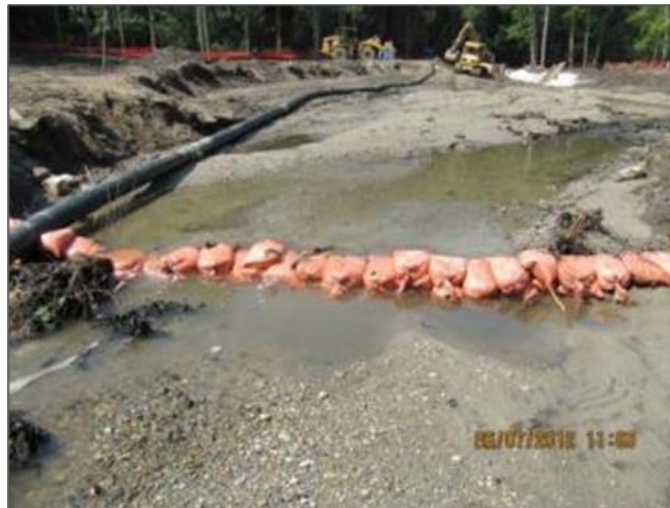
**Sand bags at the downstream end of the site, just upstream from the culvert**

Once onsite, the contractor isolated the flow using sandbags and started pumping from upstream of the cofferdam across the site and into the culvert at Danvers Drive. Additional sheet piling was installed at both ends of the cofferdam and the banks were restored.

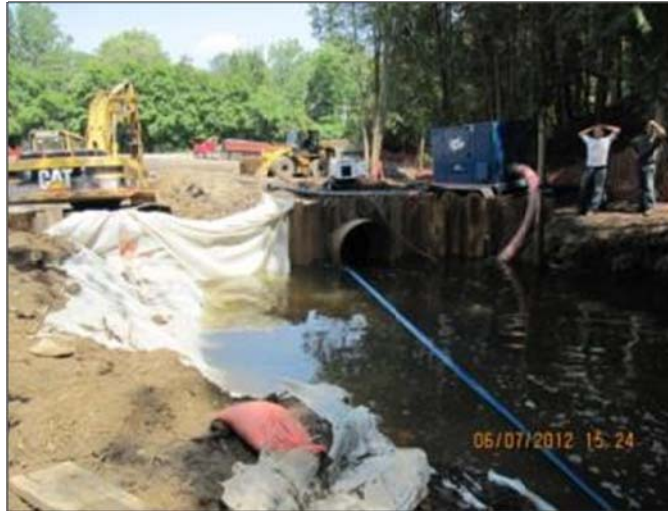
**Upstream side of cofferdam, note pumping**

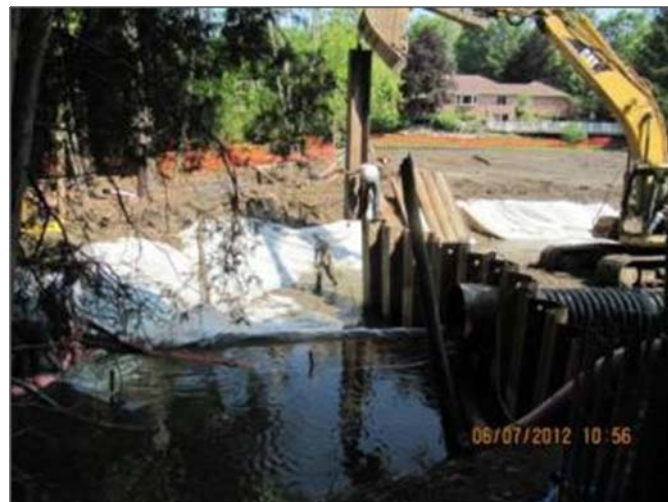
**Installation of additional sheet piles at north end of cofferdam**

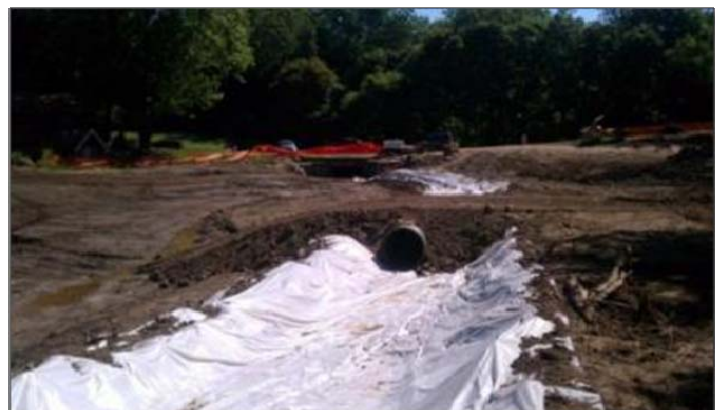
**Temporary overflow channel**

Due to this short duration, high intensity storm event, the contractor installed a temporary emergency overflow plastic lined channel and notched the top of the sheet pile cofferdam. The purpose of this channel was to receive any flow that overtops the cofferdam after the bypass flume is at capacity and/or plugged. Once the site was cleaned up, site grading resumed.

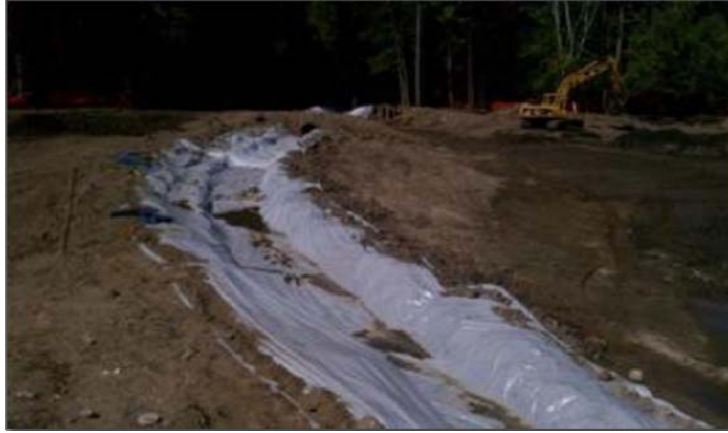
**Temporary overflow channel**

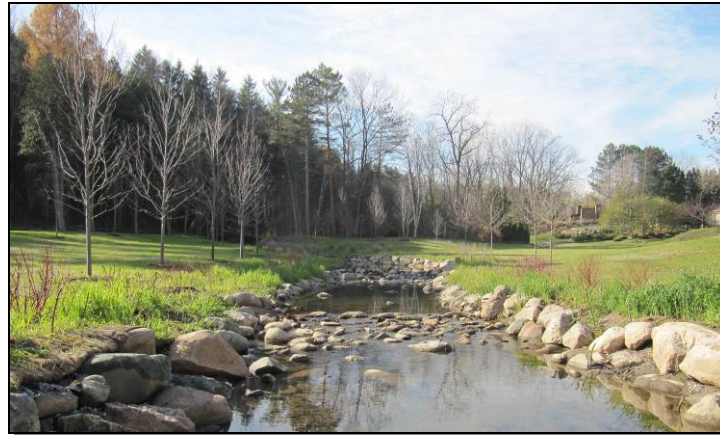
**Completed Stream Channel**

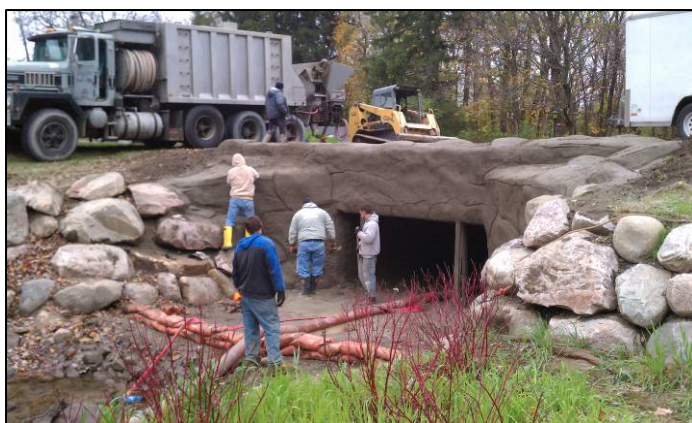
As indicated above, the initial design included the removal of the existing concrete box culvert at Danvers Drive just downstream of the spillway. Due to cost concerns (available grant funding), this was not included in the construction cost. Therefore, the arch spillway portion of the dam was the only part of the dam that was removed and the wing walls remained. During construction and the changes that were made to the grading plan, the need for additional rock or boulders was evident near the existing wing walls at the culvert near Danvers Drive.

**Shotcrete (Gunite) work**

Therefore, additional boulders were placed to stabilize the slopes and the wing walls near the culvert. Additionally, due to changes in resident participation, as well as the contractor's efficiency, there was some budget remaining toward the end of the project and available for some treatment at the wing walls. Removal of the box culvert was not feasible at that point as the stream channel was already in place. So it was decided to face the wing walls with shotcrete (Gunite) to provide some

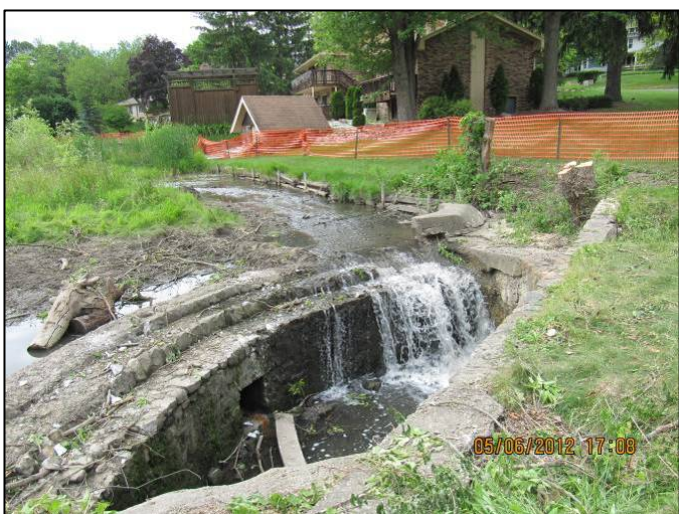
**June 5, 2012:**  
Looking southwest over dam

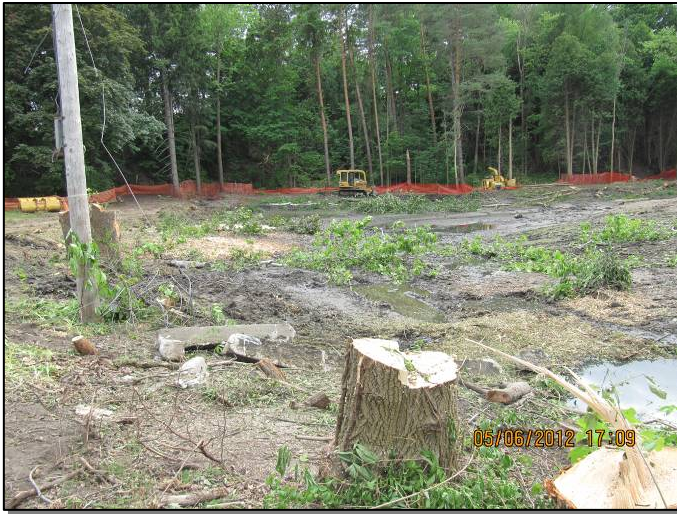
**June 5, 2012:**  
Looking south across pond; cleared and dredged area

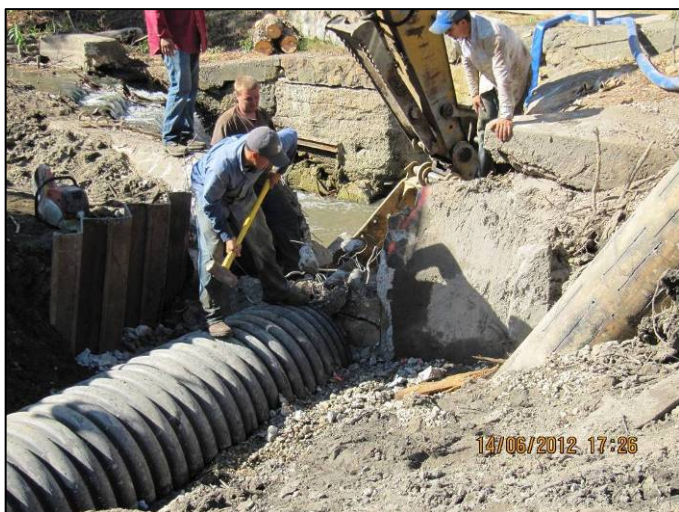
**June 14, 2012:**  
Demolishing dam to make room for bypass pipe

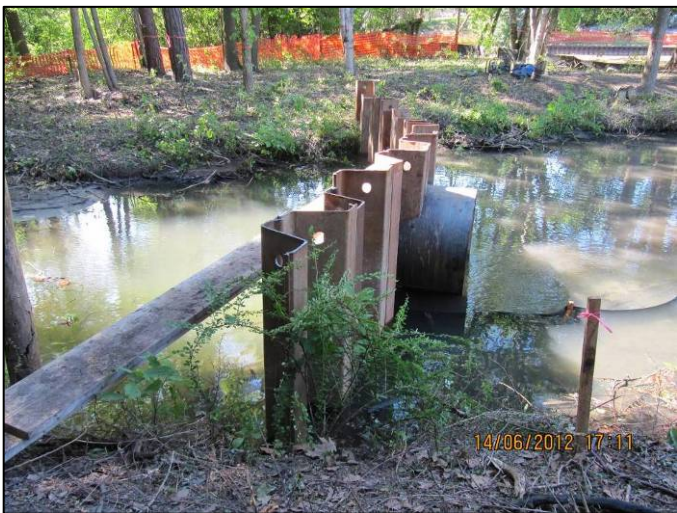
**June 14, 2012:**

The pond bottom is extremely soft

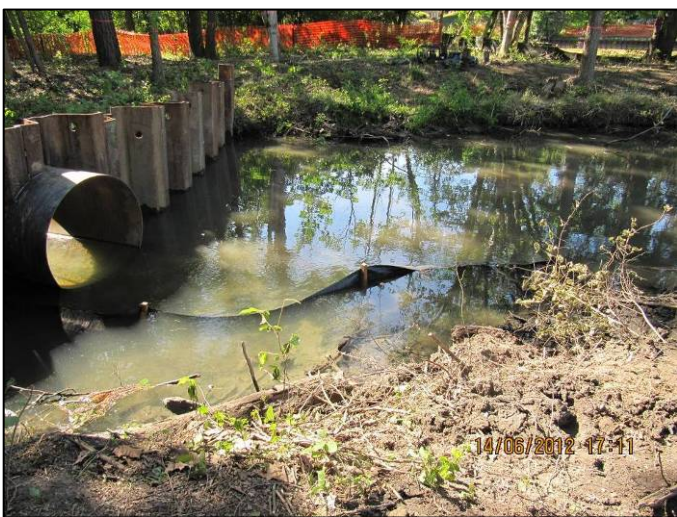
**June 14, 2012:**  
Temporary dam with tap for bypass pipe

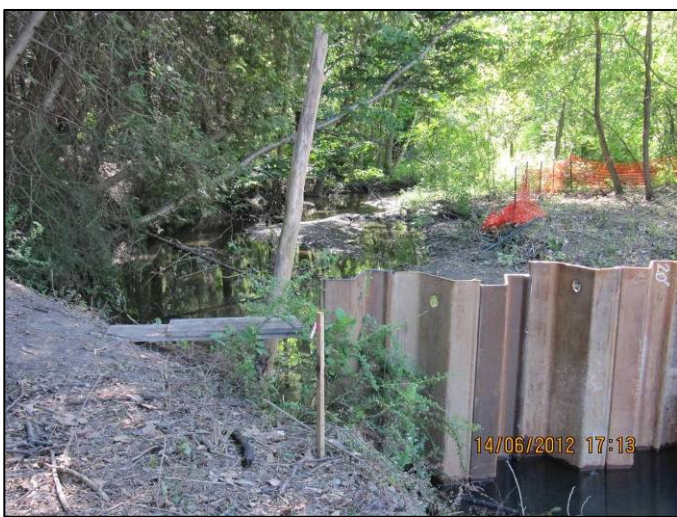
**June 14, 2012:**  
Temporary dam with erosion fence

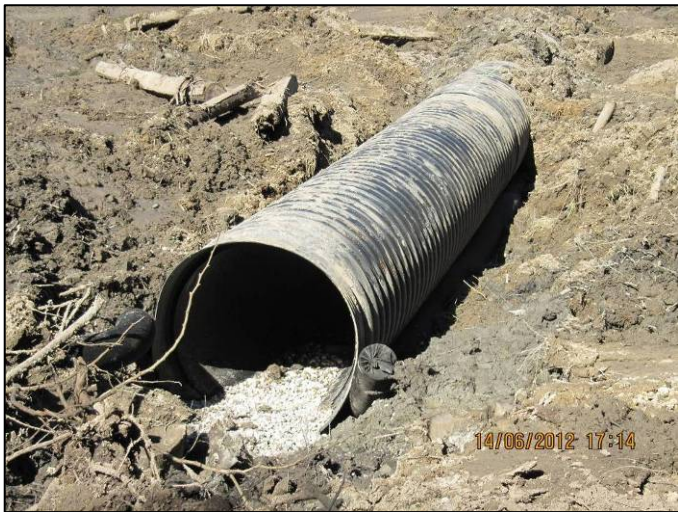
**June 14, 2012:**  
Groundwater surfacing

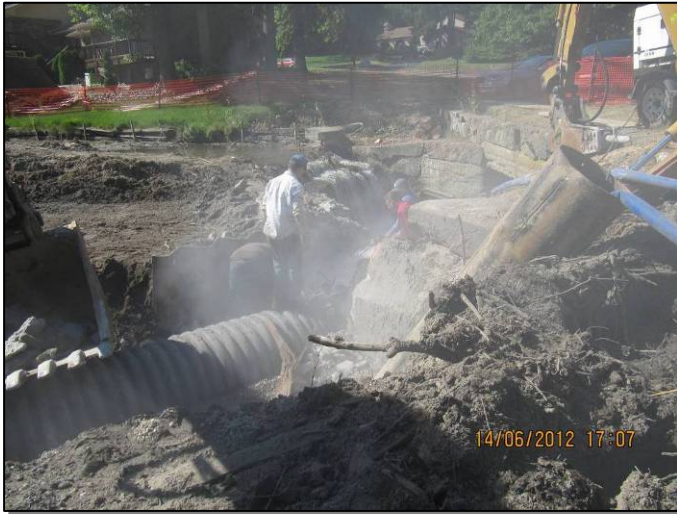
**June 14, 2012:**  
Bypass pipe with drainage along either side

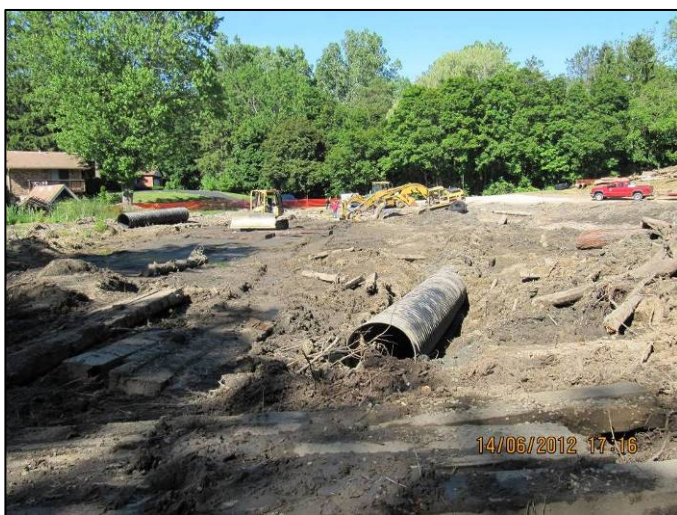
**June 14, 2012:**  
Sheet pile cofferdam with pipe stub.

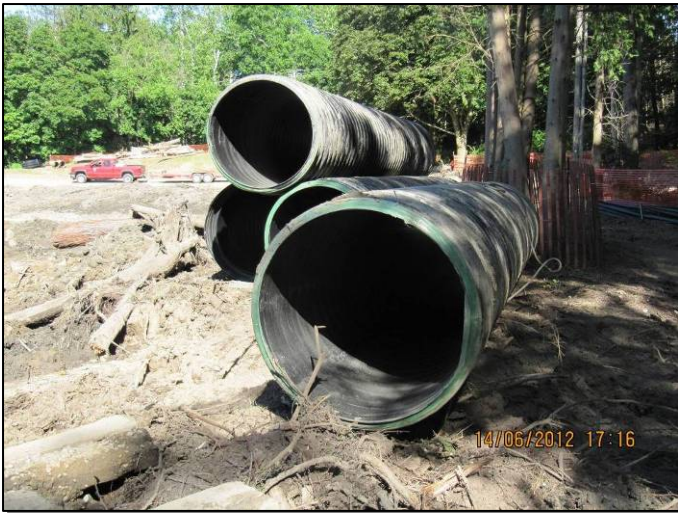
**June 14, 2012:**  
Installation of bypass flume

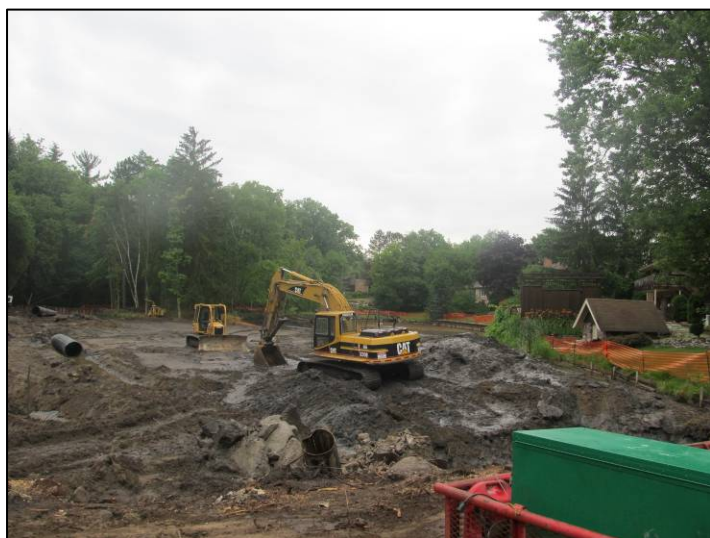
**June 18, 2012:**  
Site, view looking west, after a rain event

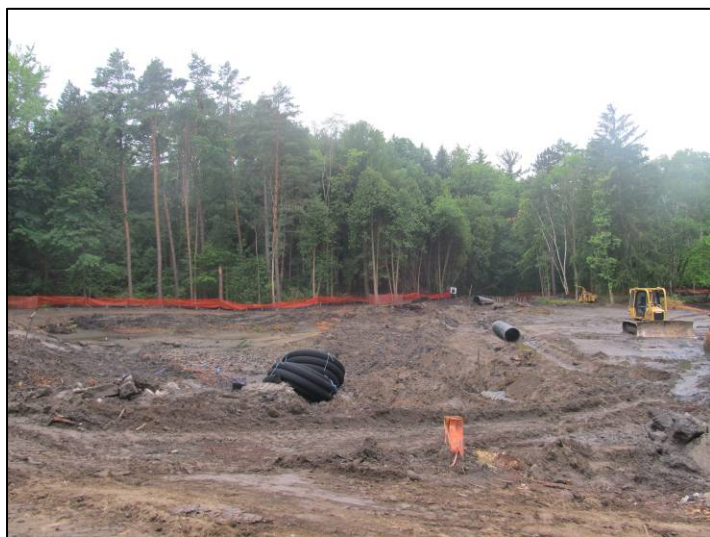
**June 18, 2012:**  
Site, view looking northwest, after a rain event

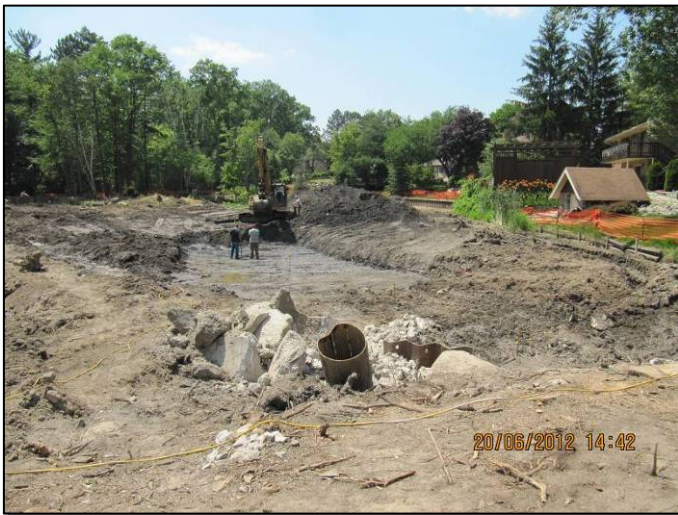
**June 18, 2012:**  
Site, view looking west, after a rain event

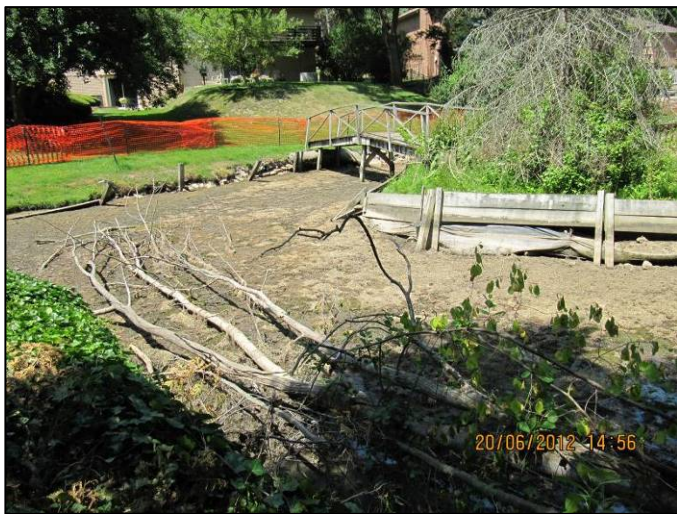
**June 20, 2012:**  
Plugging leaks in temporary dam – close up

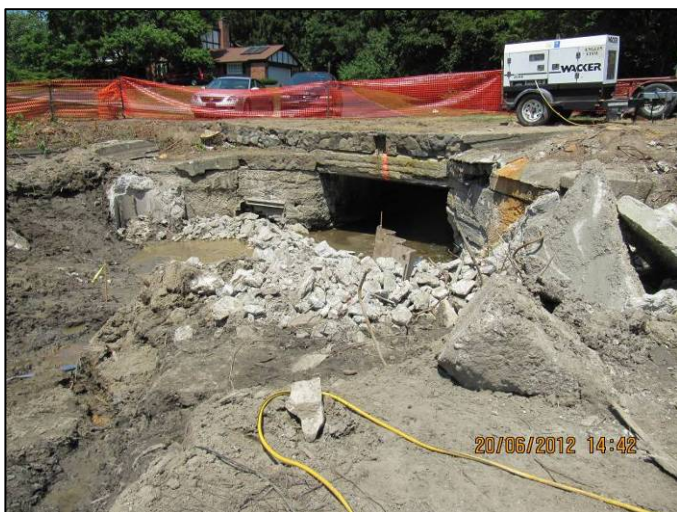
**June 20, 2012:**  
West side of pond – completely dredged

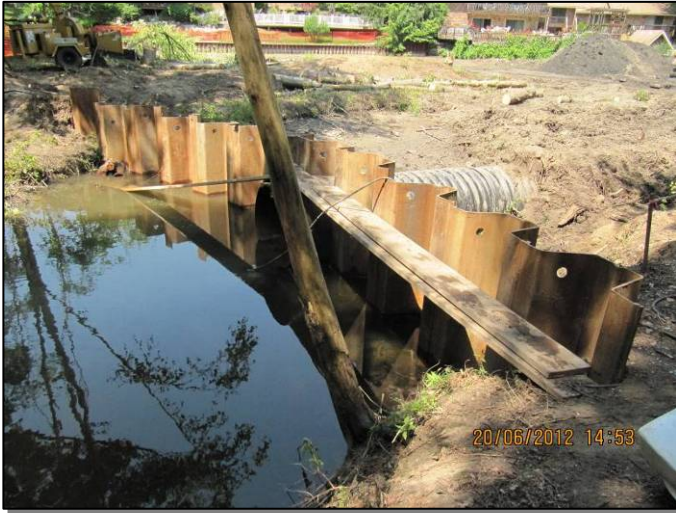
**June 20, 2012:**  
Demolished dam

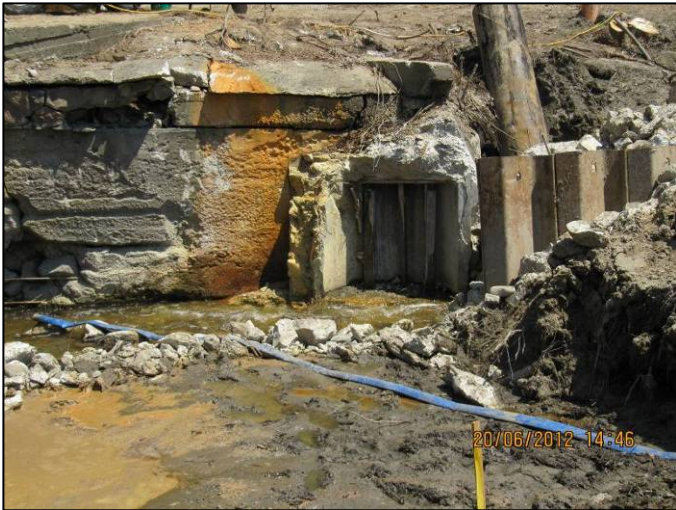
**June 20, 2012:**  
Water pumped from west side of pond to upstream of temporary dam

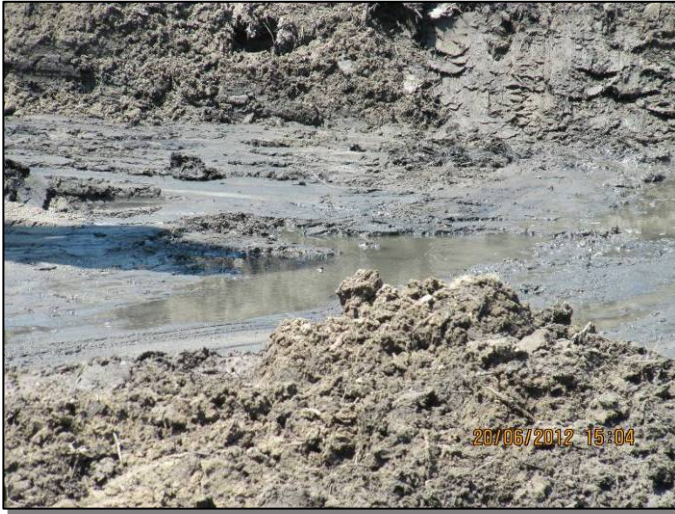
**June 20, 2012:**  
Groundwater surfacing on west side of former pond

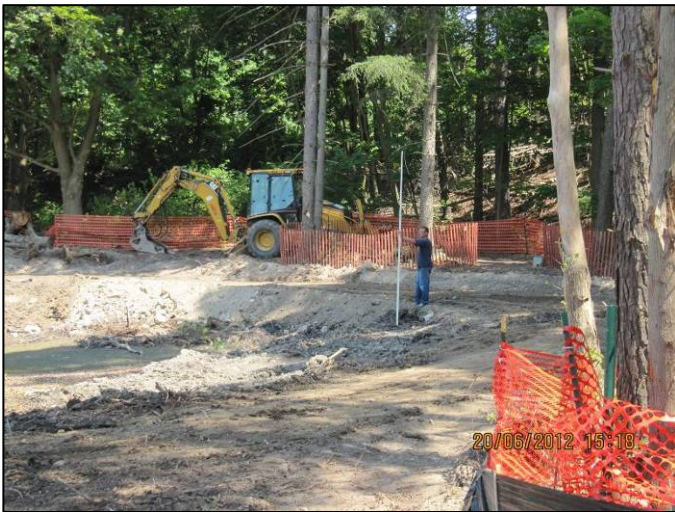
**June 20, 2012:**  
Grading the proposed streambank

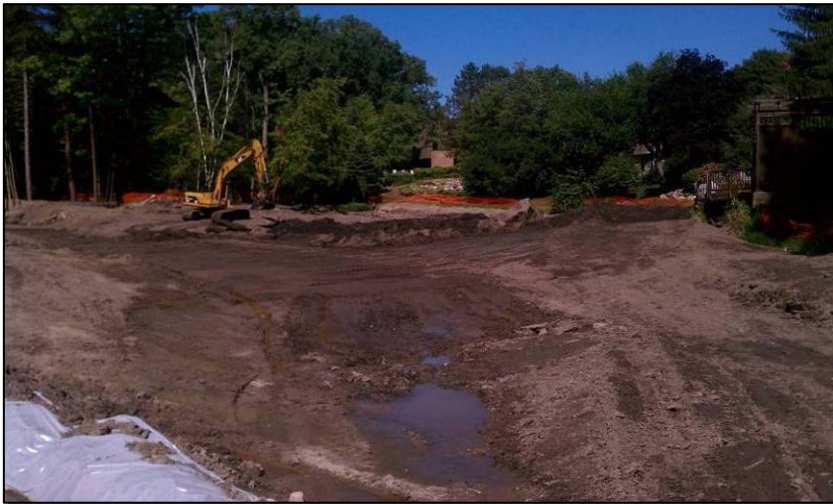
**July 11, 2012:**  
Temporary emergency spillway  
channel

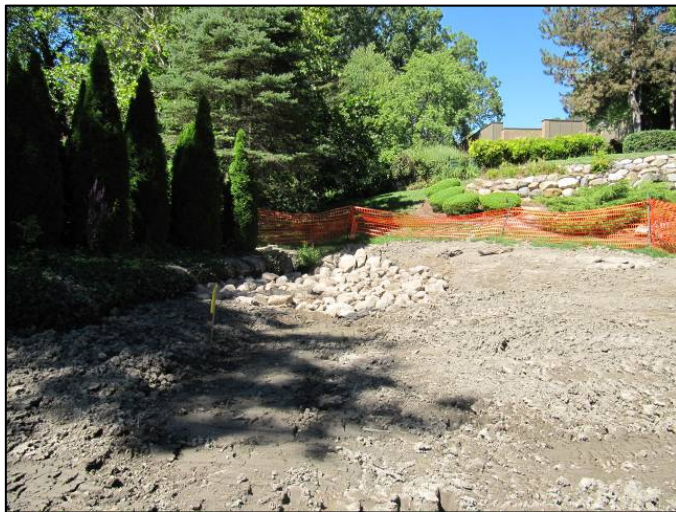
**August 6, 2012:**  
Rock apron at north storm sewer outfall

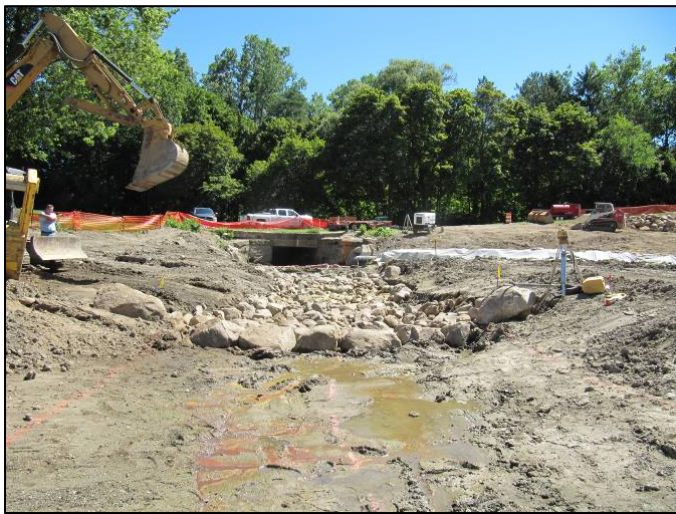
**August 6, 2012:**  
Rock Apron at west storm outfall

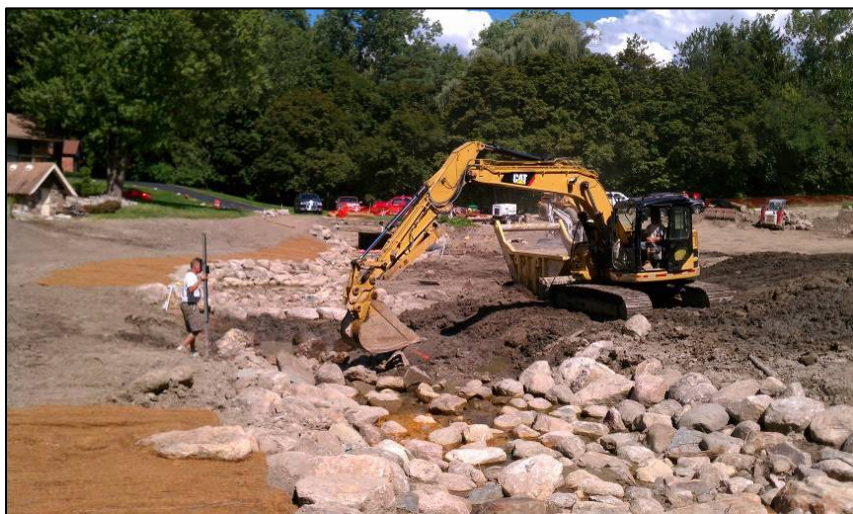
**August 20, 2012:**  
Stream channel looking upstream

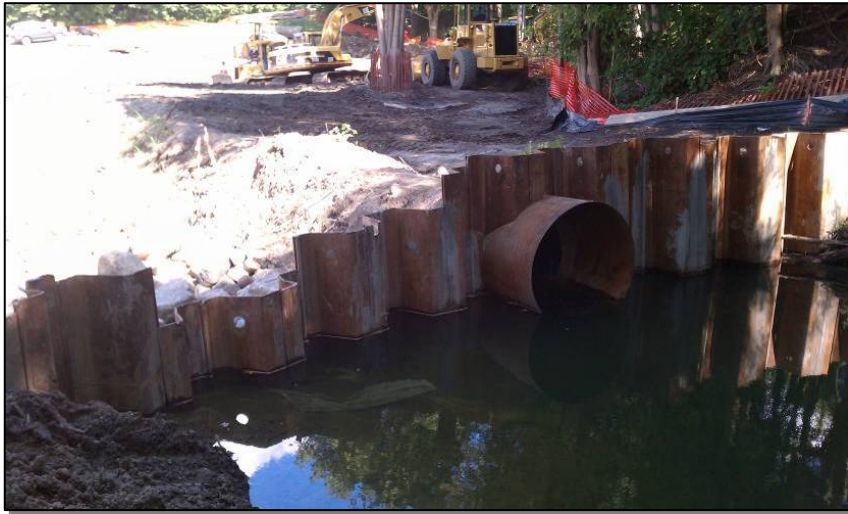
**August 20, 2012:**  
Riffle 2 construction

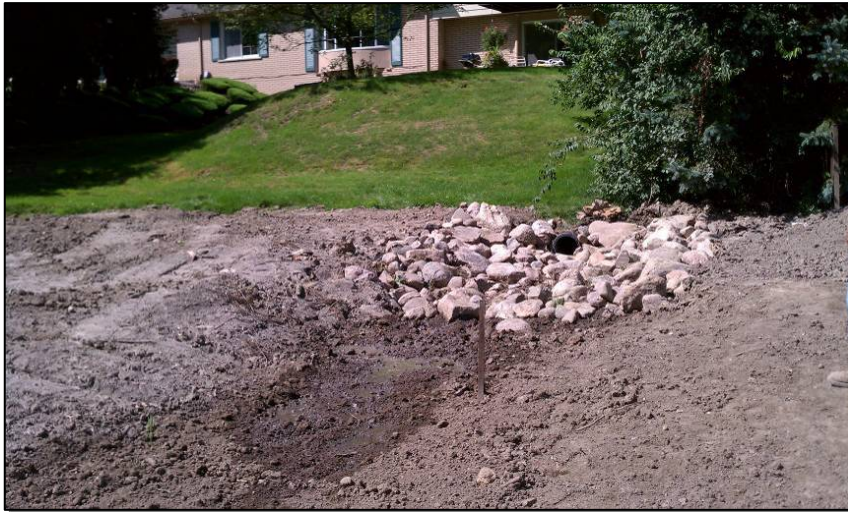
**August 20, 2012:**  
Coffer dam

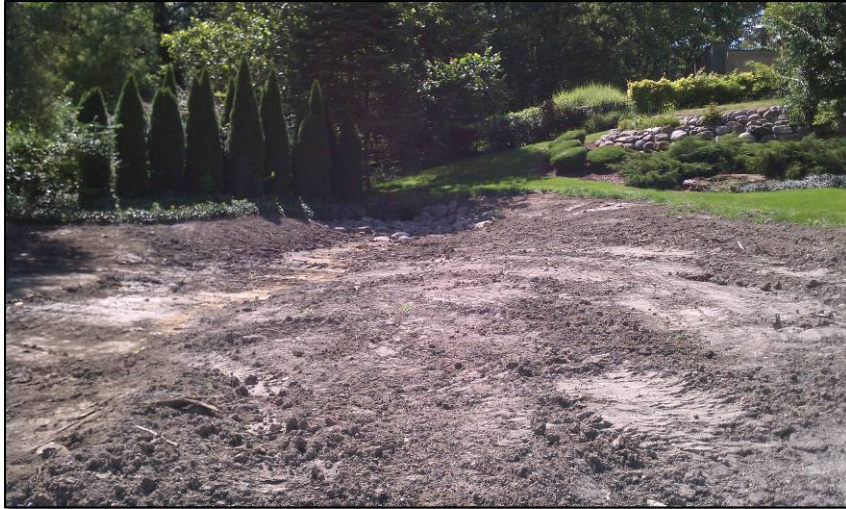
**August 20, 2012:**  
North end of site, looking  
northeast

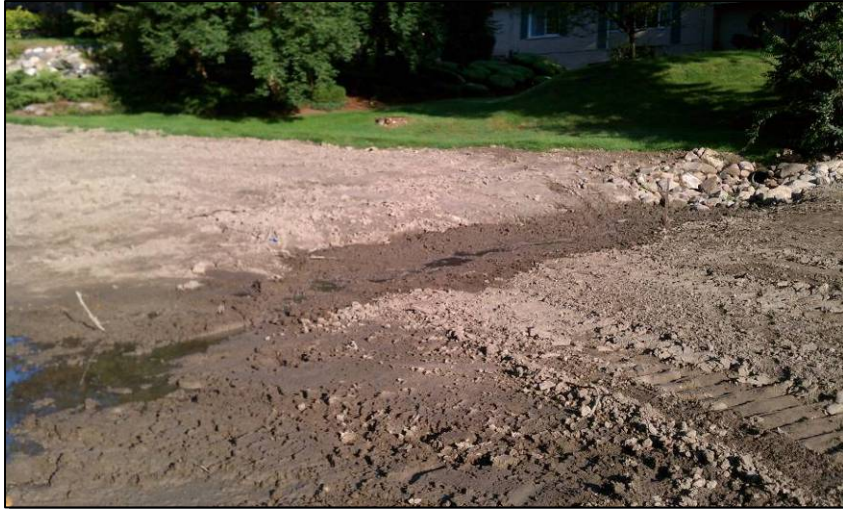
**August 22, 2012:**  
Riffle 3

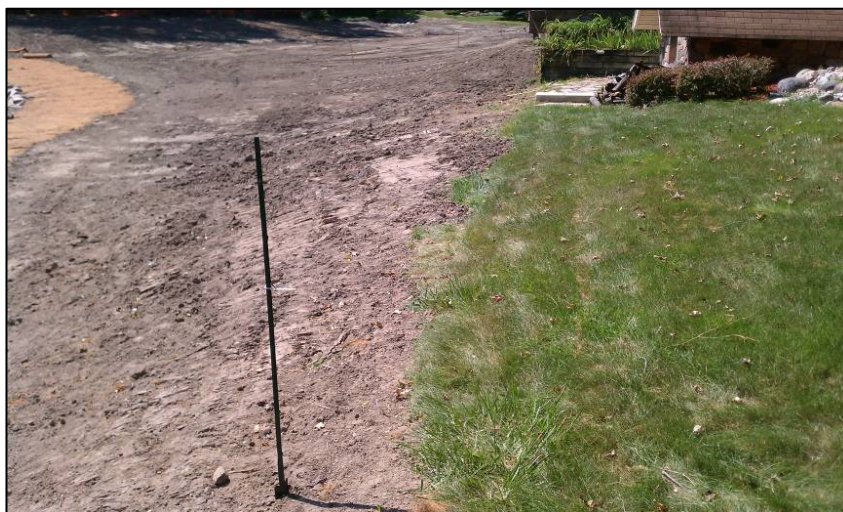
**August 23, 2012:**  
Stream channel looking upstream

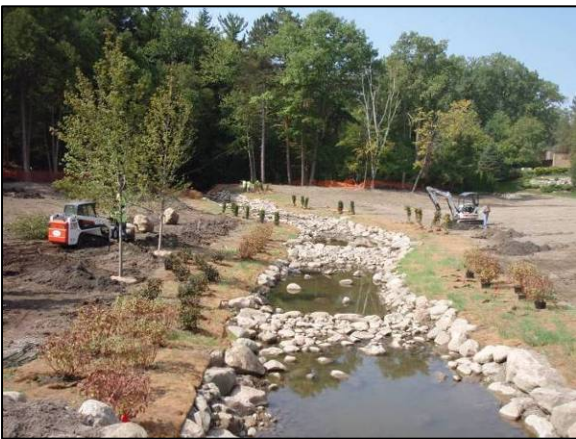
**September 6, 2012:**  
Unloading Trees

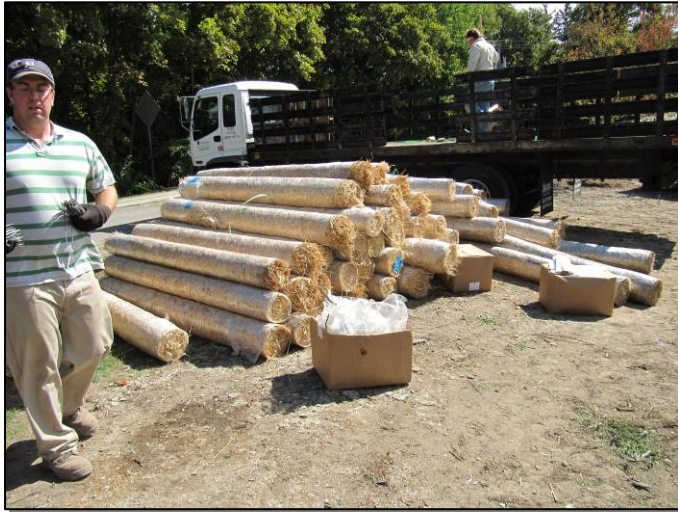
**September 18, 2012:**  
Seed installation

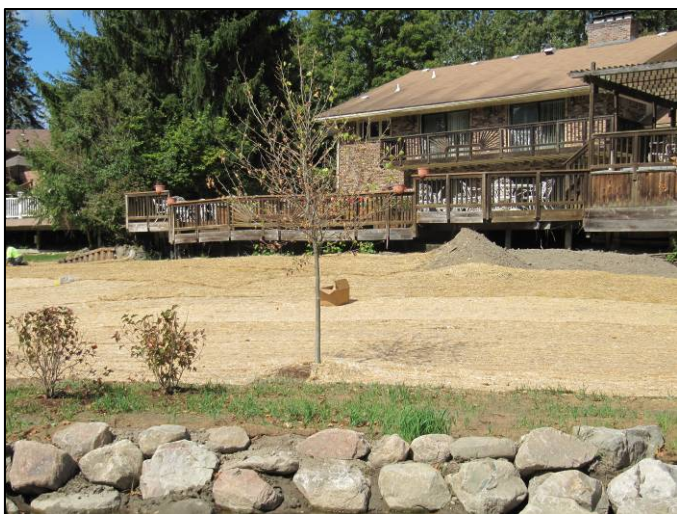
**September 18, 2012:**  
Corners covered
