Annette DeMaria, P.E., PMP
Executive Director

SUBJECT: 2022 IDEP Investigation Summary

SUBJECT: IDEP Investigation Results: Outfall BV51 (Sleepy Hollow Lane)

SUBJECT: IDEP Investigation Results: Outfall L1619

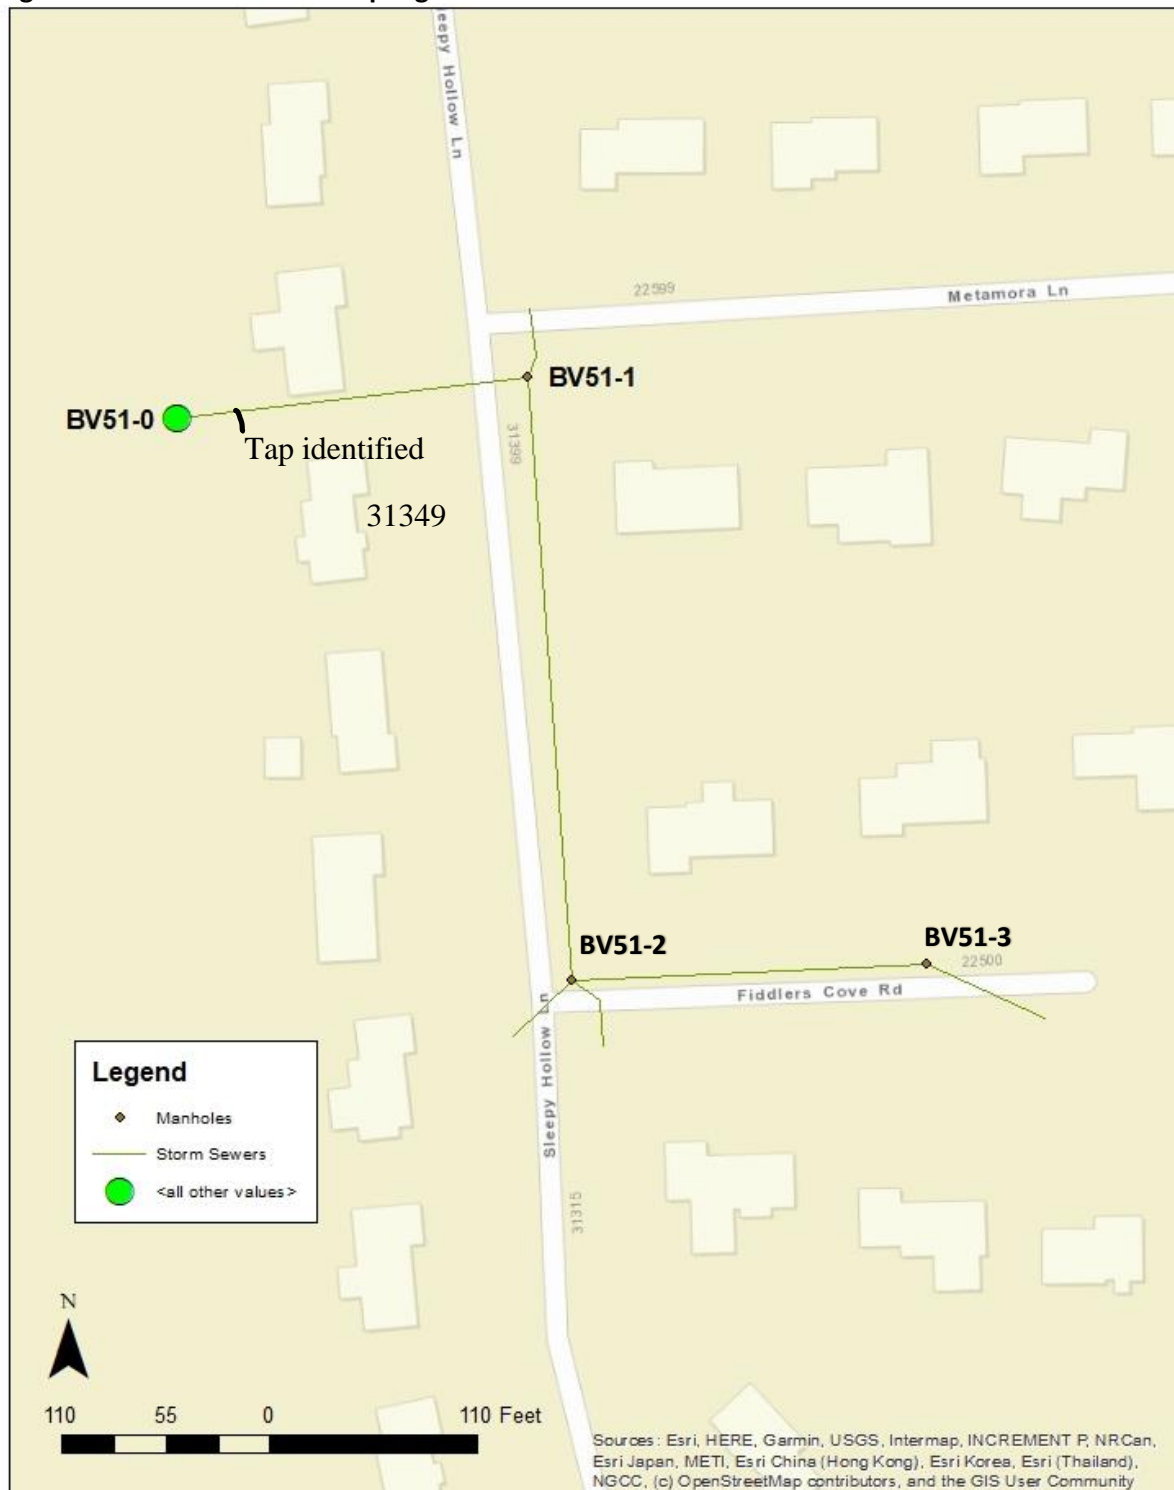
Figure 1. Storm Drain and Sampling Locations

The outfall drains a portion of Sleepy Hollow Lane, Fiddlers Cove Road, and Metamora Lane. The receiving water is an unnamed tributary of the Rouge River (Figure 1).

ARC staff coordinated with the Village of Beverly Hills and OCWRC to televise the remainder of the storm drain on July 26, 2022. The drains from BV51-1 to BV51-2, and the drain from BV51-3 to BV51-2 were televised. BV51-2 is buried. No possible illicit connection was identified.

Work to date indicates that no illicit connection has been identified upstream of BV51. The manhole at BV51-2 is buried. We recommend digging up BV51-2 to be able to further investigate it and sample the manhole.

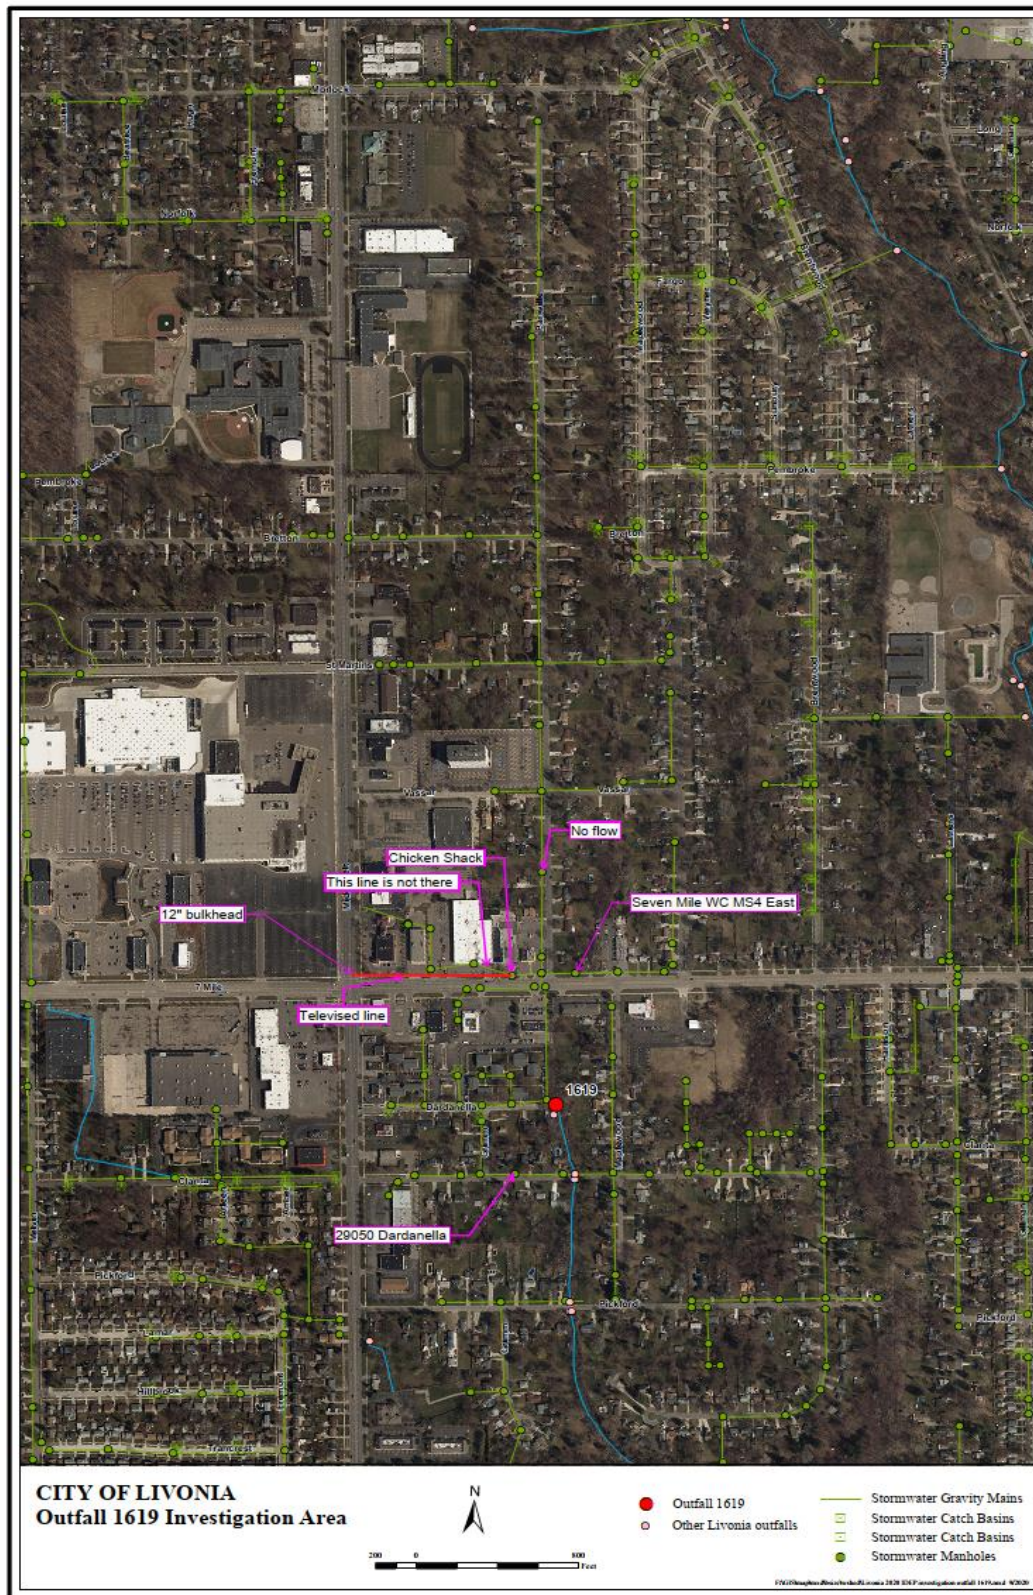
Figure 1. Storm Drain and Sampling Location

Outfall L1619 was investigated due to the high *E. coli* concentrations found during the outfall survey conducted in 2018. At that time, the *E. coli* concentration was 15,531 MPN/100 ml which is indicative of an illicit discharge containing sanitary sewage. Wayne County conducted follow-up investigations, which narrowed down the source to being upstream of a manhole located in the grass along the north side of Seven Mile Road, near a Chicken Shack restaurant (Figure 1). *E. coli* and Human *Bacteroides* levels at this manhole have been found to be elevated (Table 1).

The drainage area of the manhole in front of the Chicken Shack was unclear, as the storm drain map provided by the City of Livonia appears to be incomplete. Therefore, televising was recommended to determine the extent of the storm drain and search for any illicit connections.

The source of the elevated *E. coli* at this outfall remains unclear. Additional inspections of catch basins and their connections along Seven Mile Road, upstream of the Chicken Shack are recommended.

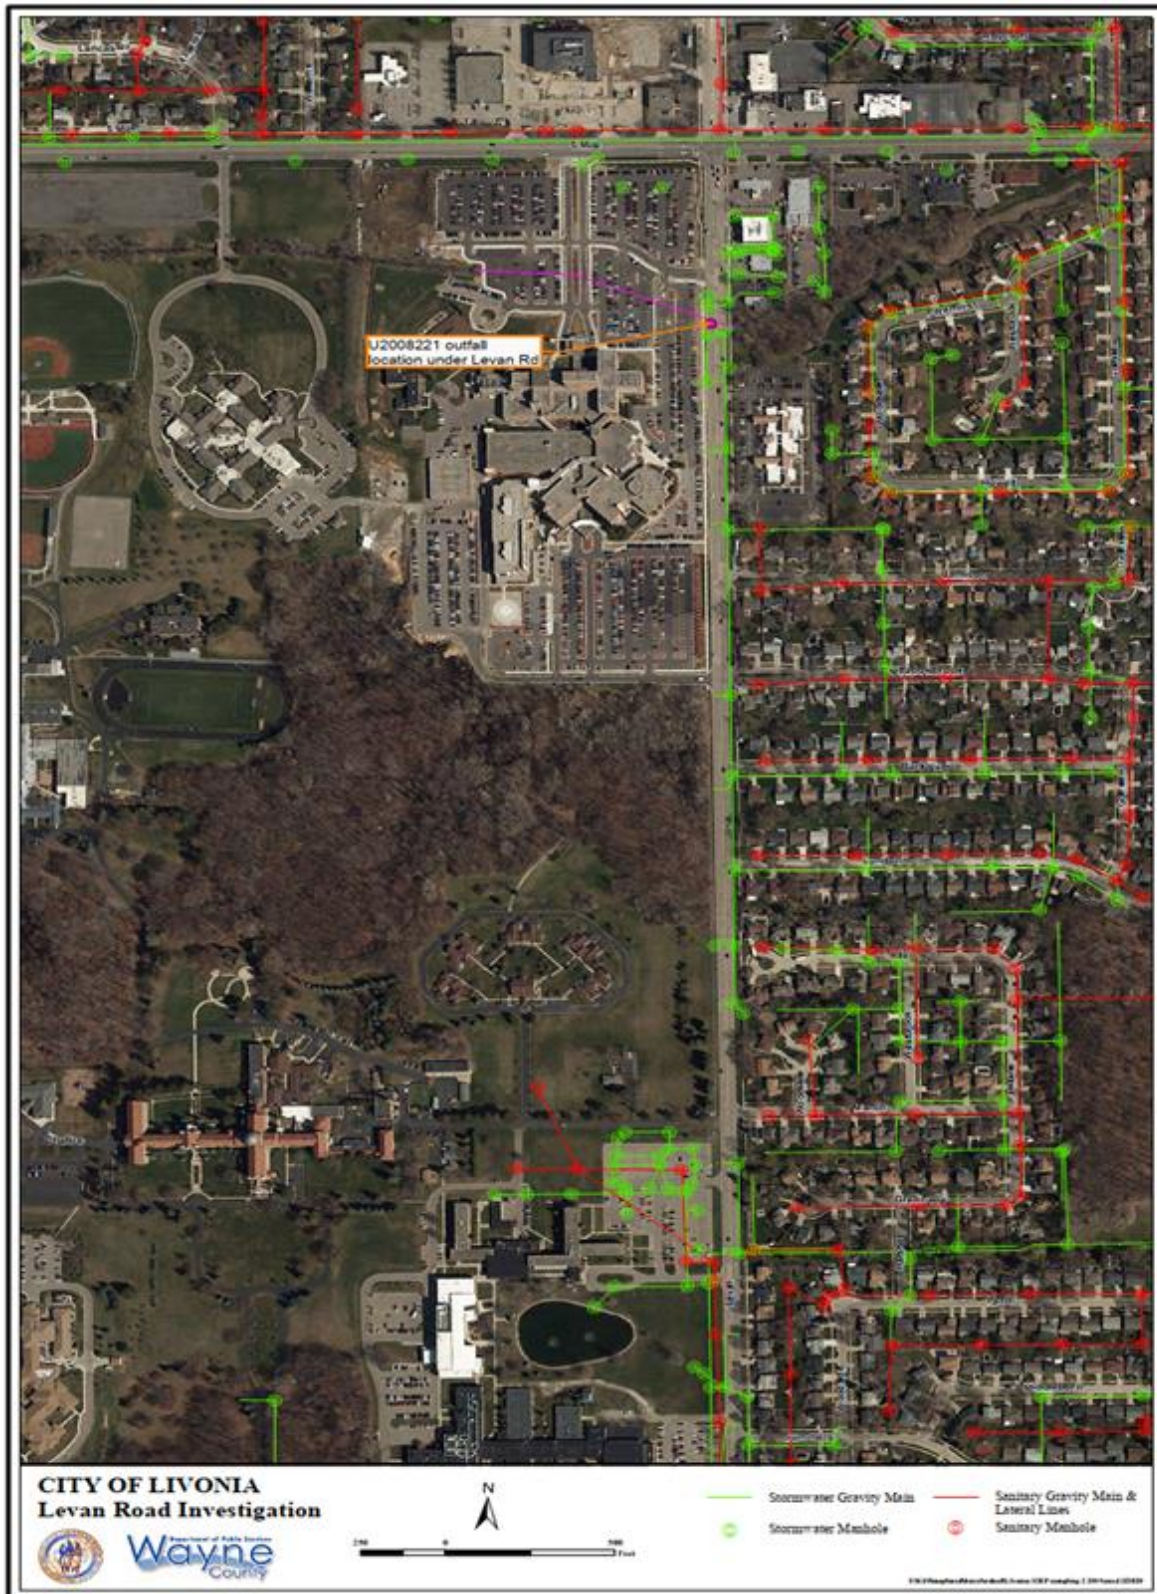
Figure 1. Storm Drain and Sampling Location

It was initially uncertain where the outfall was draining from, as it is located in a culvert underneath Levan Road (Figure 1). Nonetheless, in 2019 and 2021 Wayne County conducted sampling within the manholes along the east side of Levan Road. However, these investigations did not reveal the source of the suspicious discharge.

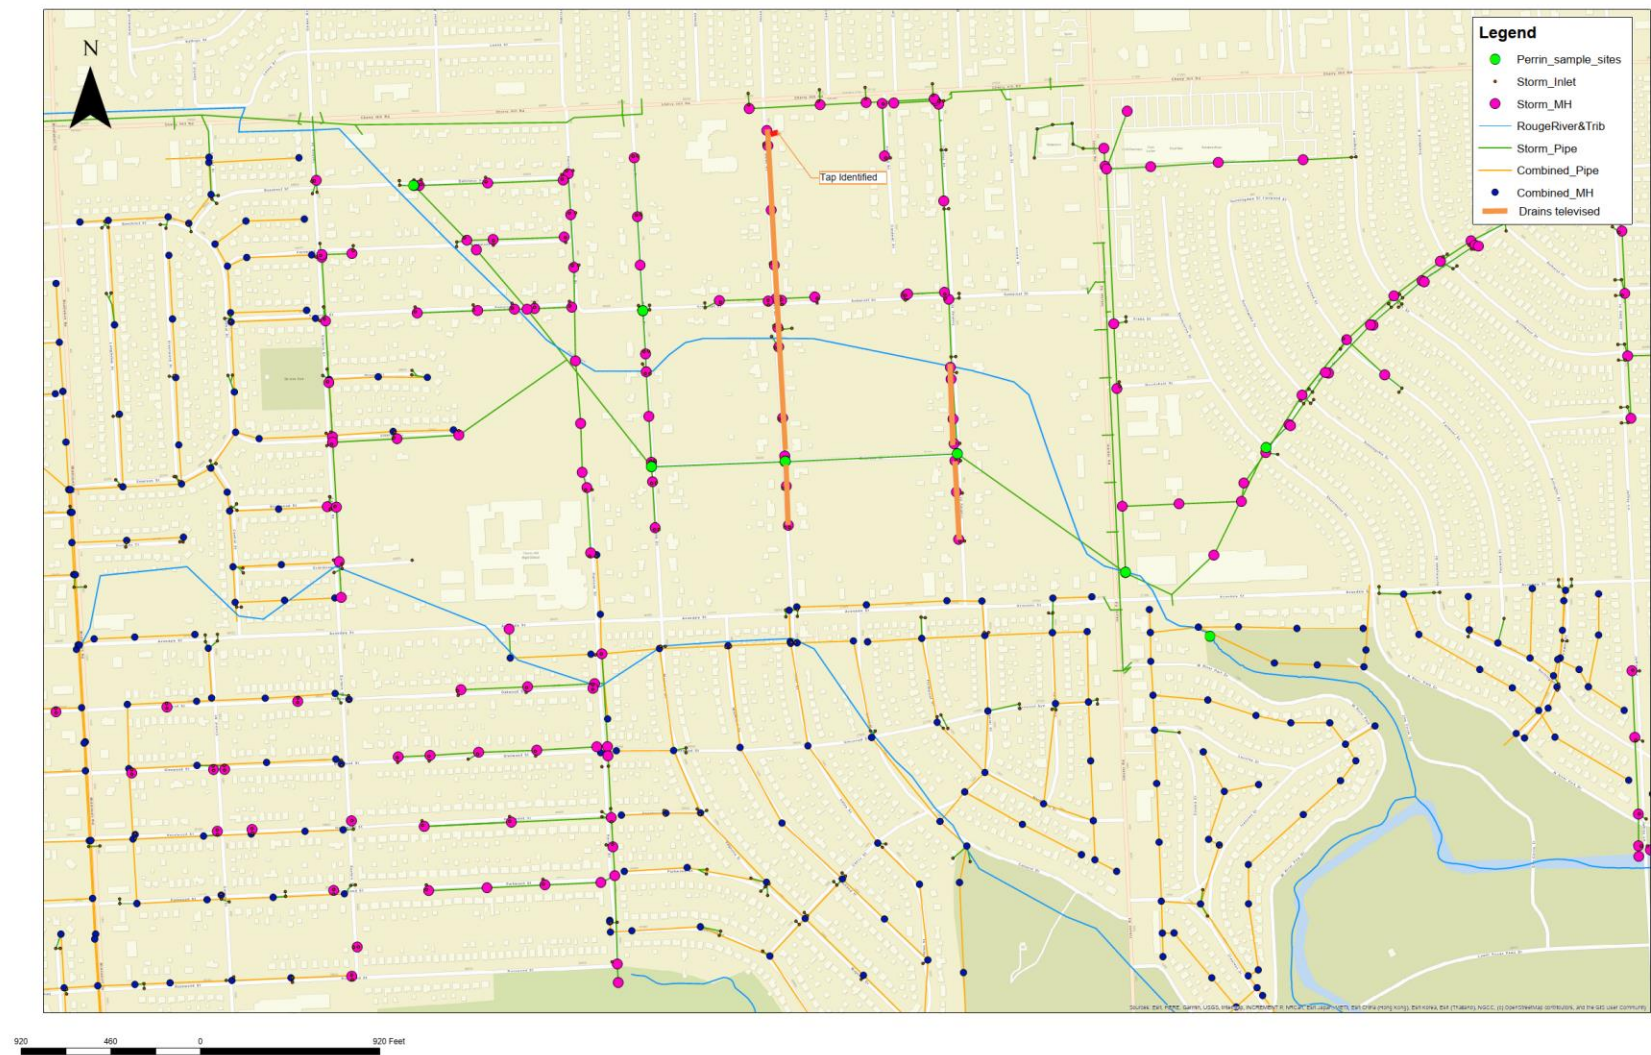
Figure 1. Storm Drain and Sampling Locations

Based on the sample results from 2020 and 2021, ARC staff had the drains along Helen Street and Tromley Street televised in December of 2022. Although excessive sediment was found in the storm drain on Tromley Street, no evidence was found of illicit connections. On Helen Street, a tap was identified coming from the east side of Helen Street, south of the intersection with Cherry Hill Road (Figure 1).

It is unclear whether the tap that was identified is an illicit connection or draining stormwater. Therefore, additional sampling immediately downstream of the tap is recommended to test for *E. coli* and human *Bacteroides*. If elevated levels are found, then dye testing the nearby apartment building may be the recommended next step.
