2024 AOC Habitat Restoration Monitoring Site Report Cottrellville Township

Report Prepared for: Cottrellville Township, MI Project: Cottrellville Habitat Restoration Project Completion Year: 2014 GLRI Investment: \$2,500,000 Funding Provided by: The Michigan Department of Environment, Great Lakes, and Energy (EGLE) Owner: Cottrellville Township Site Visit Date: August 29, 2024 Report Prepared by: Friends of the St. Clair River Report Date: December 1, 2024

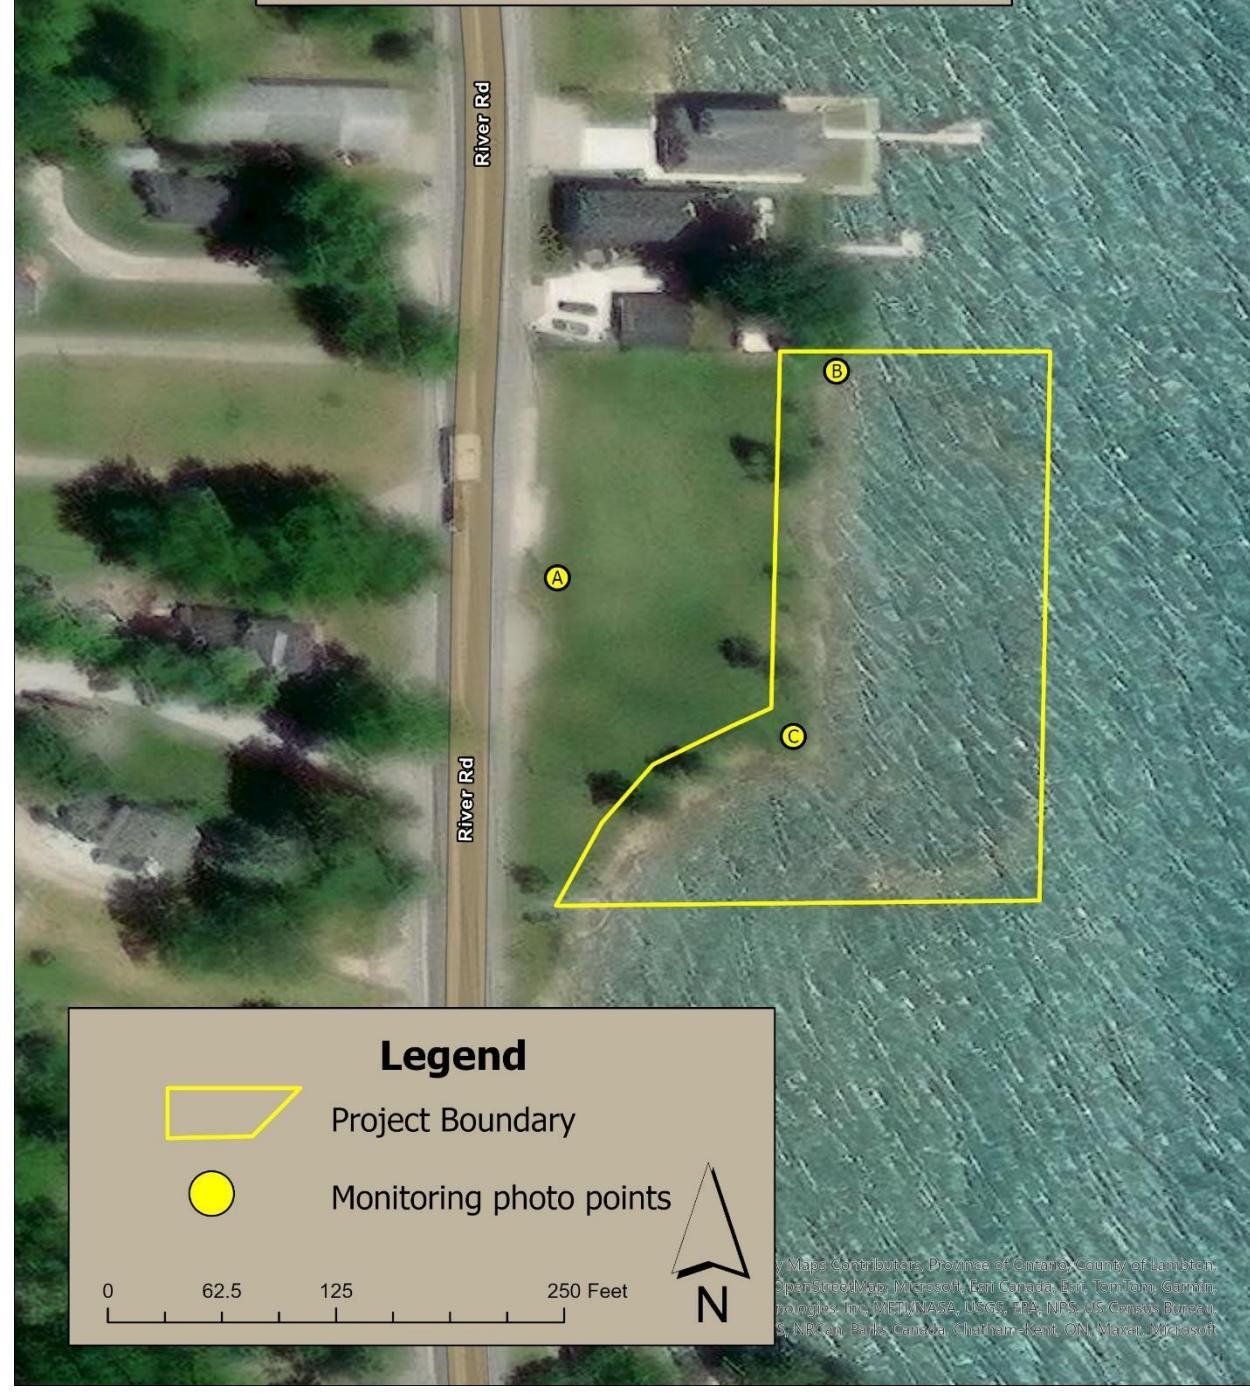
Map 2. The yellow line outlines the project boundary and includes in-water habitat improvement and shoreline restoration. The yellow circles identify photo monitoring points.

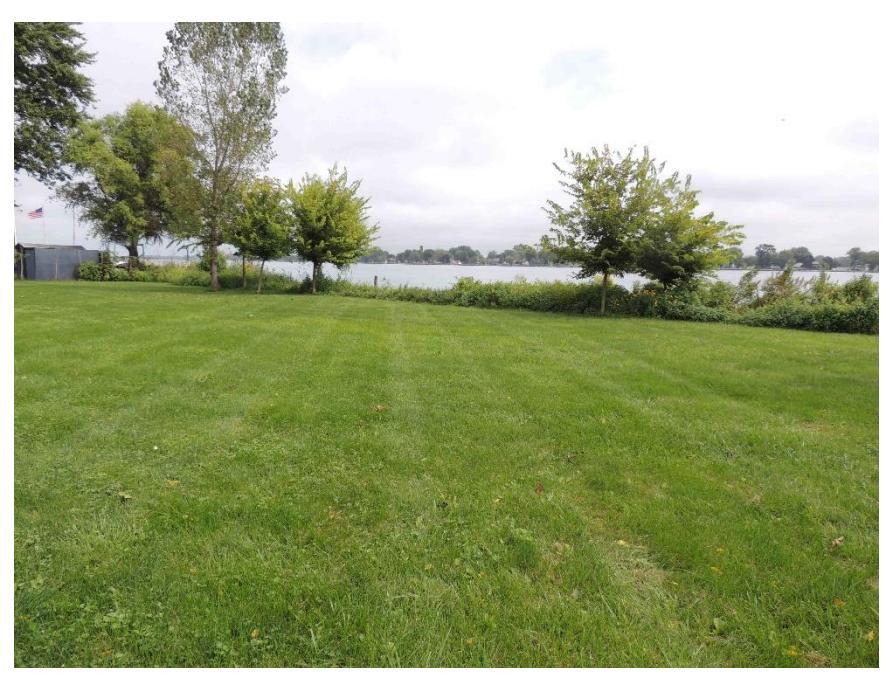
Figure 1. Photo was taken from the park boundary along the road showing the mowed lawn and restored shoreline boundary, shooting upriver. Maintaining the unmown border along the shoreline is important to retain the structural stability of the shoreline and the economic investment of the project.

Most of the park was mowed to encourage public use with the exception of a 15-foot riparian buffer strip adjacent to the water to maintain the natural shoreline. Such maintenance is highly encouraged at this site, especially of the unmown area next to the shoreline. Additional maintenance that includes removal of invasive species once or twice a year would benefit the structural and ecological integrity of this location. This would be an excellent opportunity to involve the local community and help showcase this township park as benefiting both the residents and the environment.

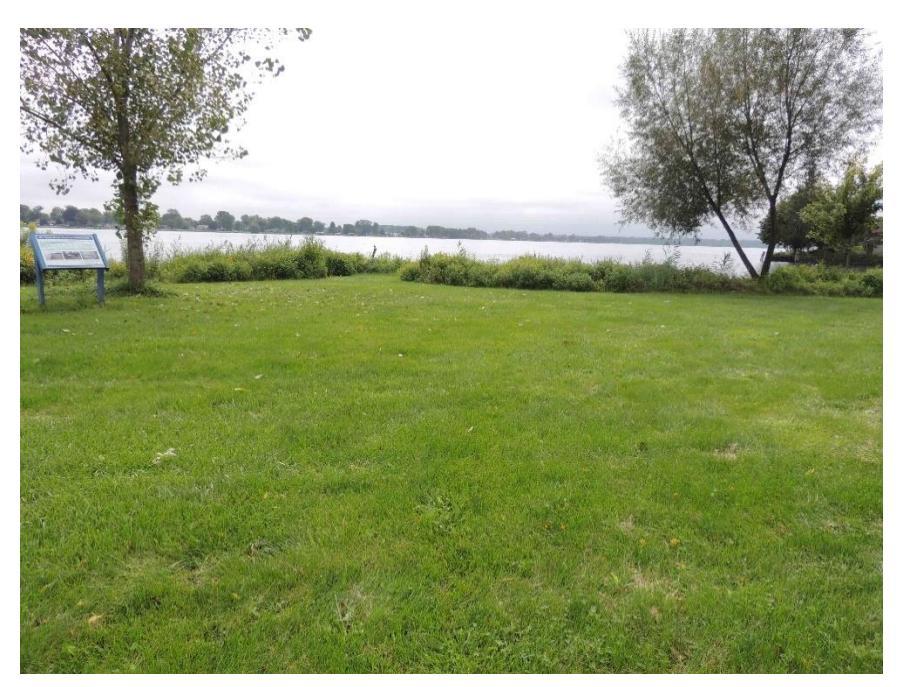
Figure 2: Photo was taken from the park boundary along the road, showing the mowed lawn and restored shoreline boundary, shooting downriver. Maintaining the unmown border along the shoreline is important to retain the structural stability of the shoreline and the economic investment of the project.

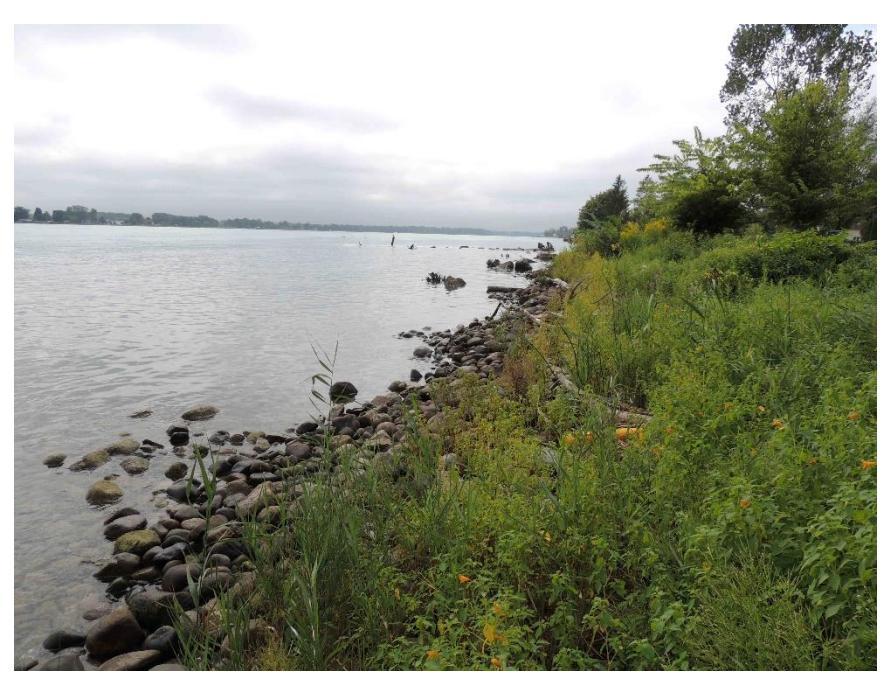
Public users regularly use the park, and patrons can be found walking along the natural beach shoreline. Some trash/litter was observed within the project site along the beach and in small paths leading to the shoreline. A trash receptacle that is regularly emptied at the park may encourage proper disposal of refuse and encourage more visitors. No trampling or destruction of shoreline habitat was observed.

Figure 3: North boundary of shoreline habitat restoration showing the rocks and vegetation that stabilize the shoreline. Some trash is visible in this photo. Removing invasive species will maintain the structure of the shoreline and increase public visual appeal.

- Removal of invasive vegetation such as phragmites, multiflora rose, and Canada thistle within the project area once or twice a year would significantly increase the integrity of the shoreline by maintaining riverbank stabilization, and it would provide a welcoming view for the public. Such removal could be accomplished with a few volunteers and would prevent the site from being overrun with invasives. Friends of the St. Clair River could help identify plants in need of removal, and best methods of removal.
- Replacing the removed invasive species with native wildflowers or low-growing shrubs would prevent invasive species from growing back and increase shoreline stability because of their large root systems. They will also provide attractive blooms for park users. Friends of the St. Clair River could help identify and source native plants for the park.

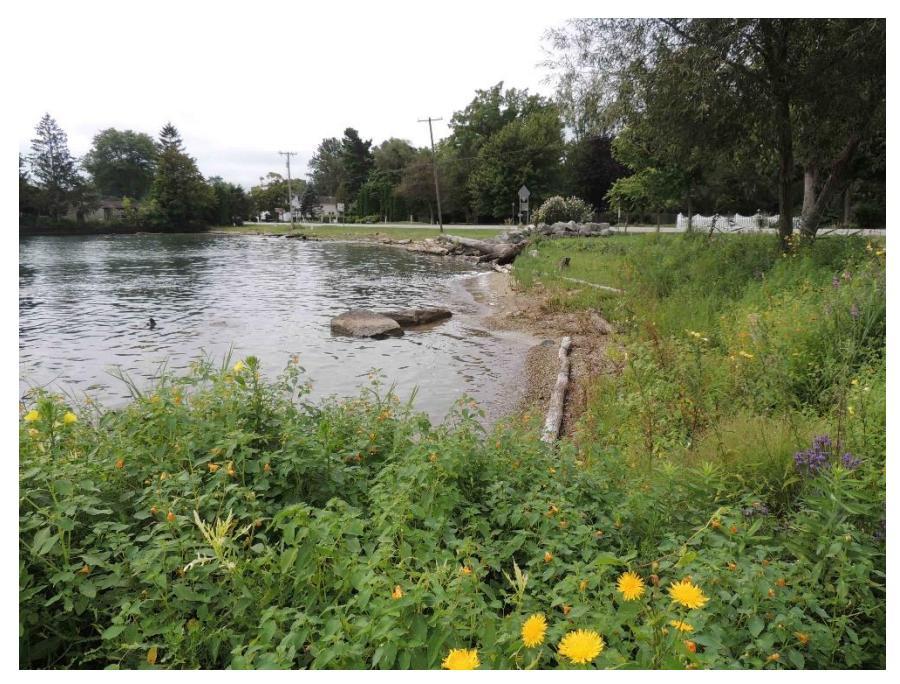
Figure 4: The restored beach habitat of the park replaced the failing steel seawall when this project was implemented. The beach is protected by the rocky breakwater (not shown in picture) and is an important habitat improvement for the St. Clair River. The shallow slope, sandy beach and natural vegetation provide important habitat for fish and wildlife.

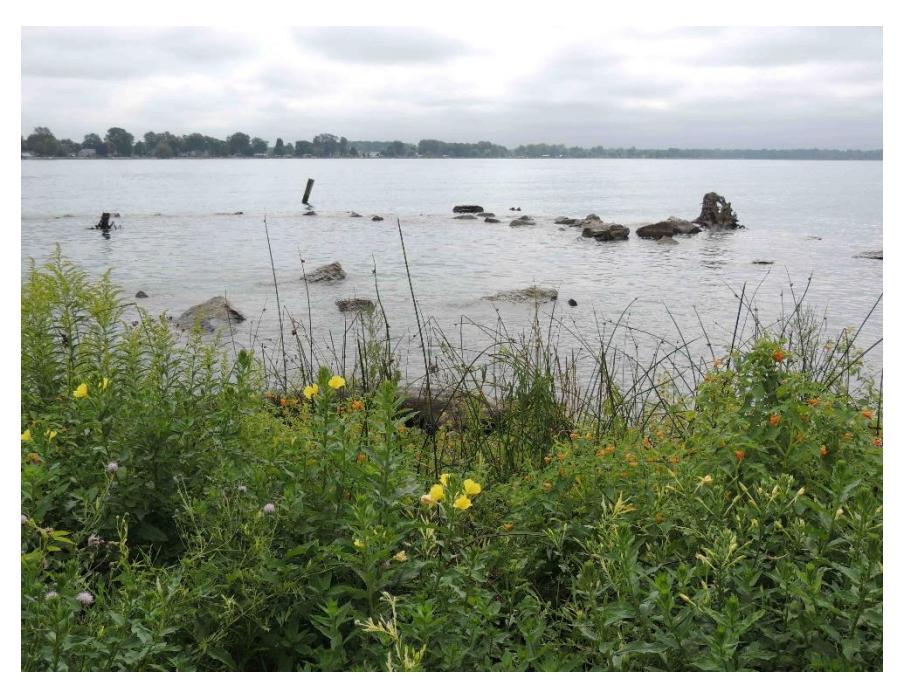
The installed rocky break walls and restored shoreline appeared to be intact and functioning. The break wall provides protection from heavy wave action of the St. Clair River, it also provides habitat for a variety of fish and wildlife. Ducks, geese, gulls, and cormorants were observed using the breakwater. Several logs washed up within the project area, adding diversity to the habitat.

The water was at an average level, and the reef structures were visible with no signs of erosion.

Figure 5: Outer reef rocks create a breakwater, reducing water current and wave action on the shoreline which helps to reduce shoreline erosion of the restored shoreline. The rocks also provide aquatic and semi-aquatic habitat for fish and wildlife.

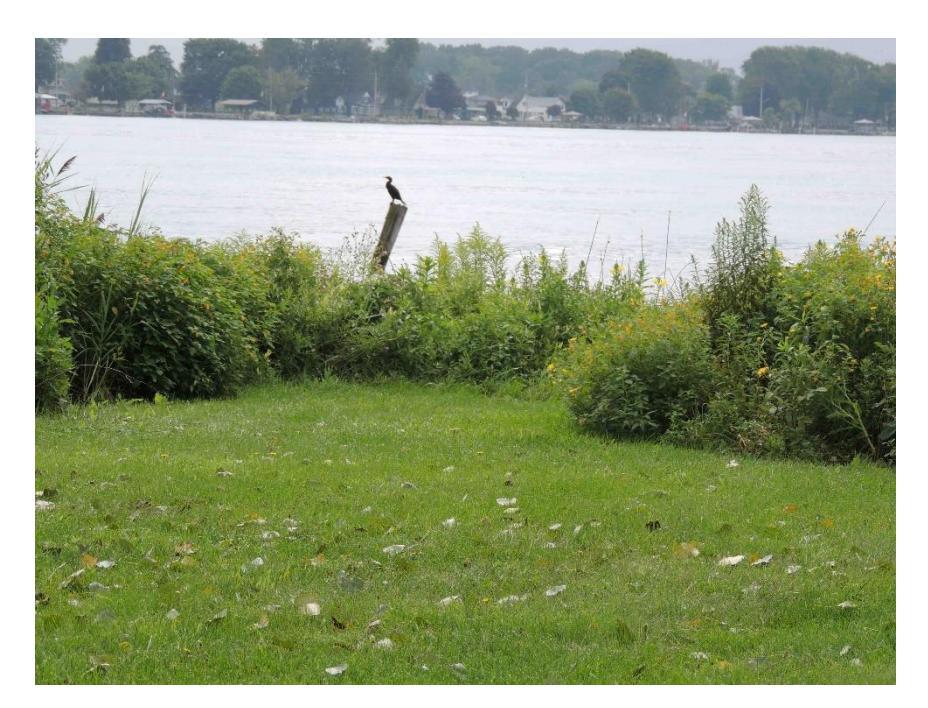
Figure 6: A cormorant used the restored habitat during the monitoring visit and was observed resting on a piling, located at the edge of the breakwater habitat.
