2014 ILLICIT DISCHARGE INVESTIGATIONS IN OAKLAND COUNTY'S PORTION OF THE ROUGE RIVER WATERSHED

FINAL REPORT

PREPARED FOR: ALLIANCE OF ROUGE COMMUNITIES

PREPARED BY: OAKLAND COUNTY WATER RESOURCES COMMISSIONER

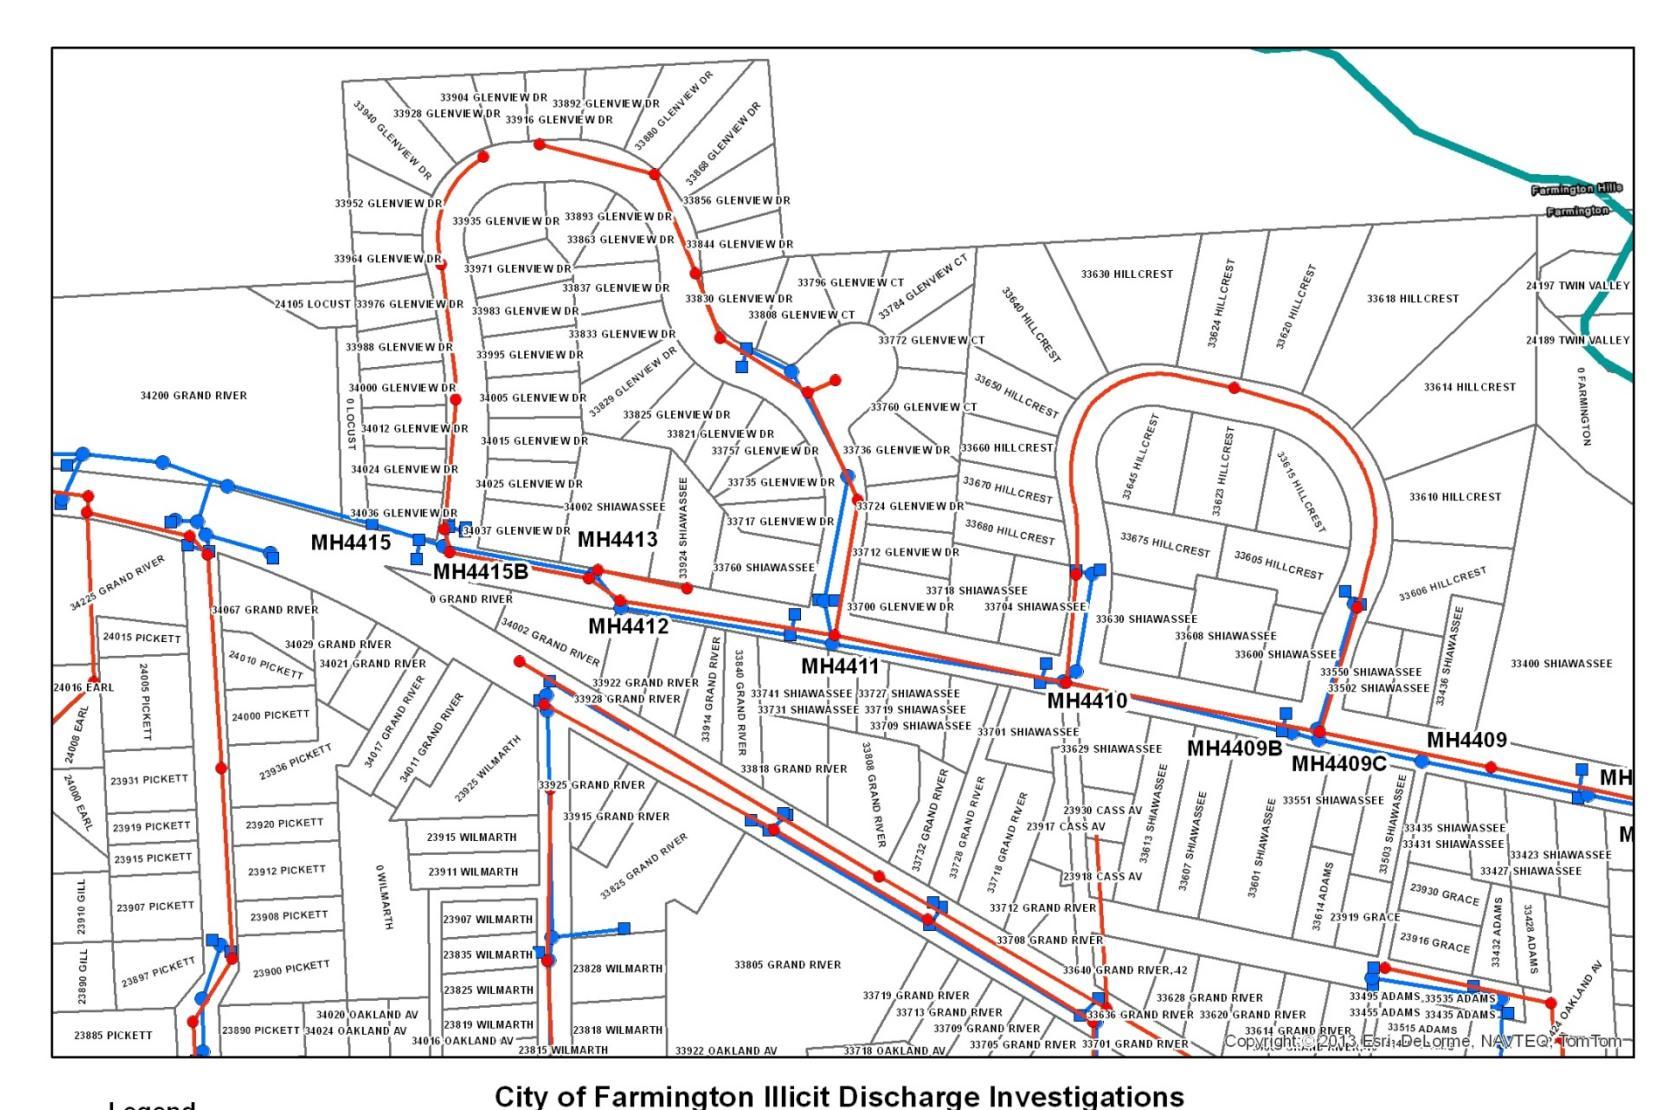
US-16 Drain Upstream Target Area

The US-16 Drain is a large enclosed storm drain located along the northern border of Farmington and Farmington Hills. The Drain parallels Grand River Ave. and Shiawassee Rd. and discharges to the Upper Rouge River in Shiawassee Park near Farmington Rd. The Drain services local storm water laterals from residential subdivisions on both the north and south side of Shiawassee Rd. and businesses along Grand River Ave. west of Shiawassee Rd. In 2013, WRC identified high *E. coli* counts and other signs of potential illicit connections to the drain along Shiawassee Rd. between Grand River Ave. and the outlet. Therefore, the 2014 investigations targeted this segment of drain as shown in Figures 2a and 2b.

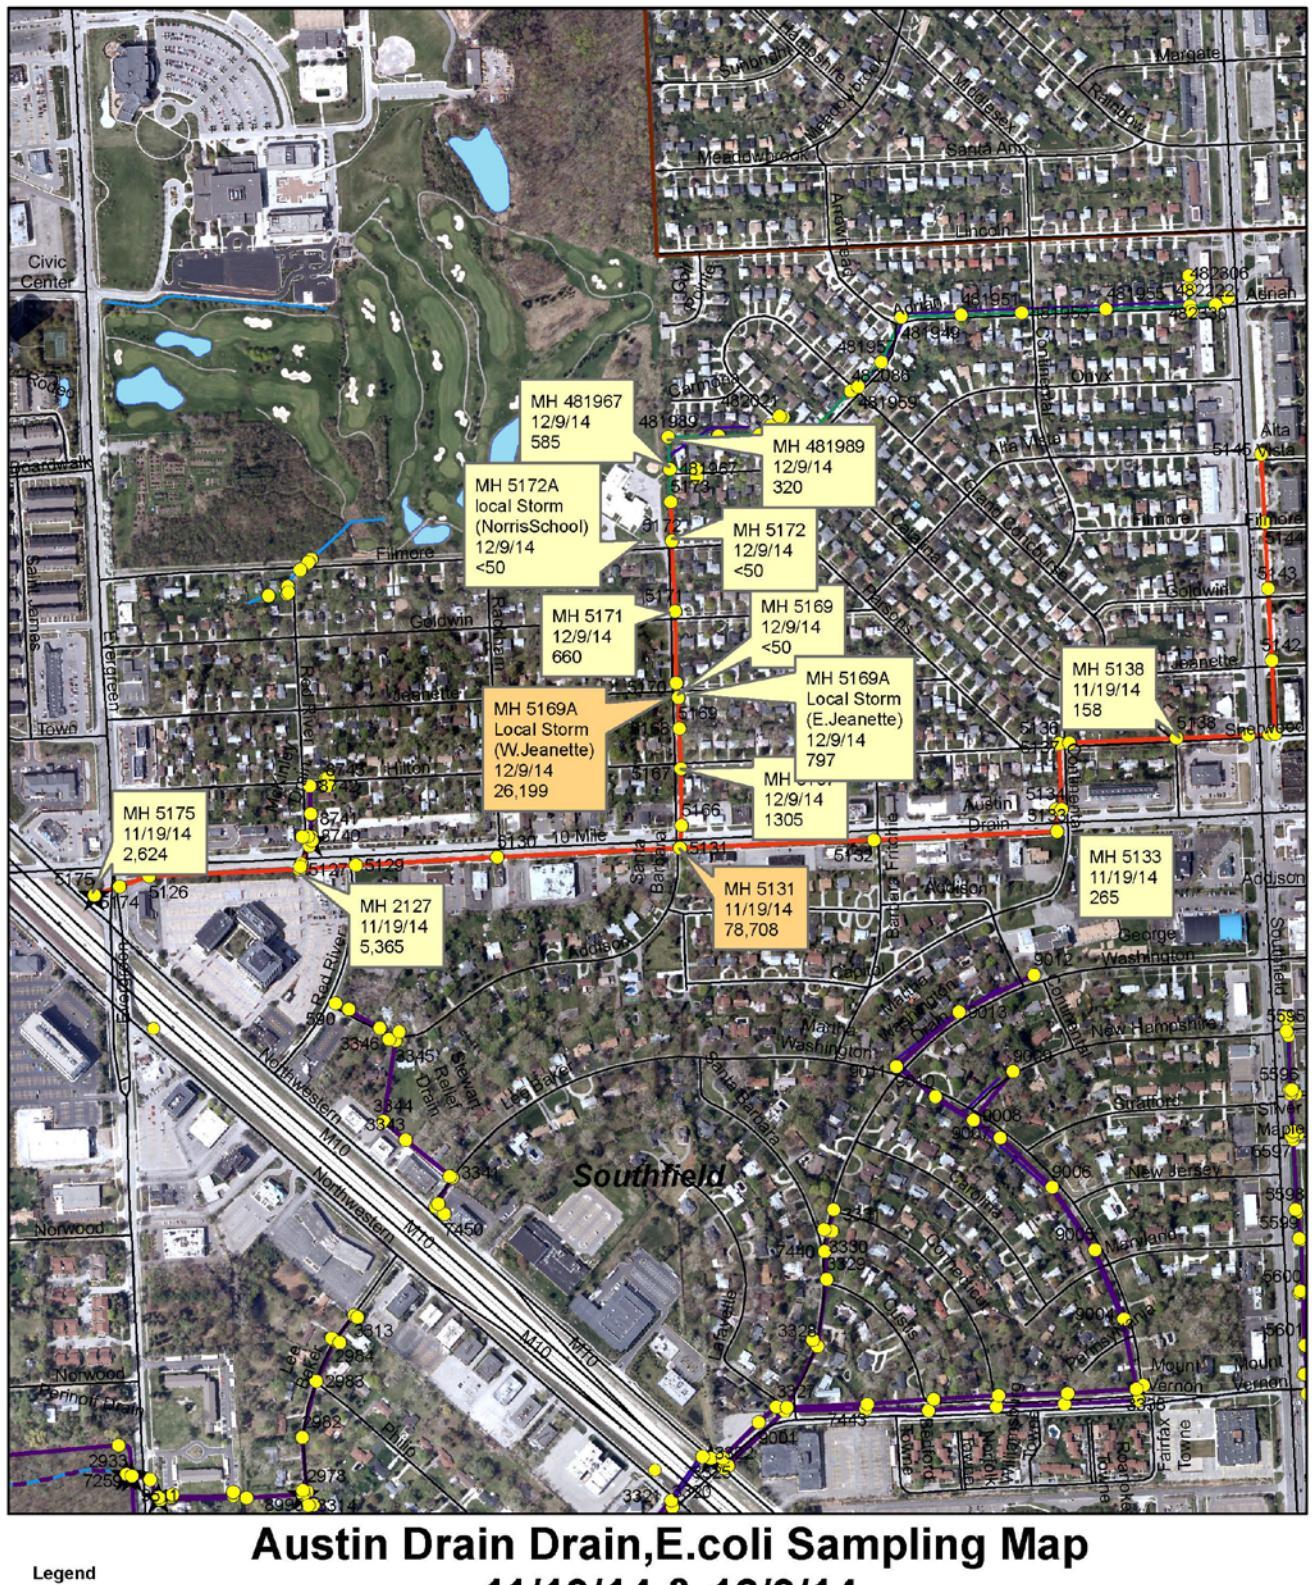
Austin Drain Drain,E.coli Sampling Map Austin Drain County_Drains_Enclosed Open Water Course Municipal Boundary

In November, samples were collected and inspections conducted at the outlet of the drain and at select manholes locations along 10 mile Rd. and Sherwood St. Locations were selected in order to evaluate the upstream portions of the drain and flow coming in from the street laterals. Elevated *E. coli* levels ranging from 2,624 cfu/100 mL to 78,708 cfu/100 mL were found at the drain outlet and at the intersection of 10 Mile Rd. and Santa Barbara St. as shown in Figure 5. Samples collected east of Santa Barbara St. indicated that any illicit discharges were probably limited to the lateral on Santa Barbara St.

In December, the storm drain on Santa Barbara St. was investigated. Storm manholes along this street were inspected and *E. coli* samples were collected in order to isolate any potential illicit discharge source coming into the drain from local side street laterals. The local storm drain connecting Jeanette St. west of Santa Barbara St. was found to have *E. coli* concentrations of 26,199 cfu/100 mL. Inspection and sampling at manholes north of this location did not indicate that there were any additional issues upstream of Jeanette St. This information was forwarded to the City of Southfield as the storm system on Jeanette St. is City-owned and operated. The City of Southfield is in the process of reviewing local storm drain maps and sanitary records for properties along Jeanette St. Further investigations along Jeanette St. had not occurred at the time of this report.

- Review local storm sewer maps to determine the extent of the drainage area along Jeanette St. and further west;
- Review sanitary records for potential suspect properties;
- Segment and sample the local storm drain at select locations to narrow down the source of the high *E. coli*;
- Conduct CCTV inspections and dye testing based on records, inspections and sampling results; and
- Conduct or oversee any necessary corrective actions for any identified illicit connections.

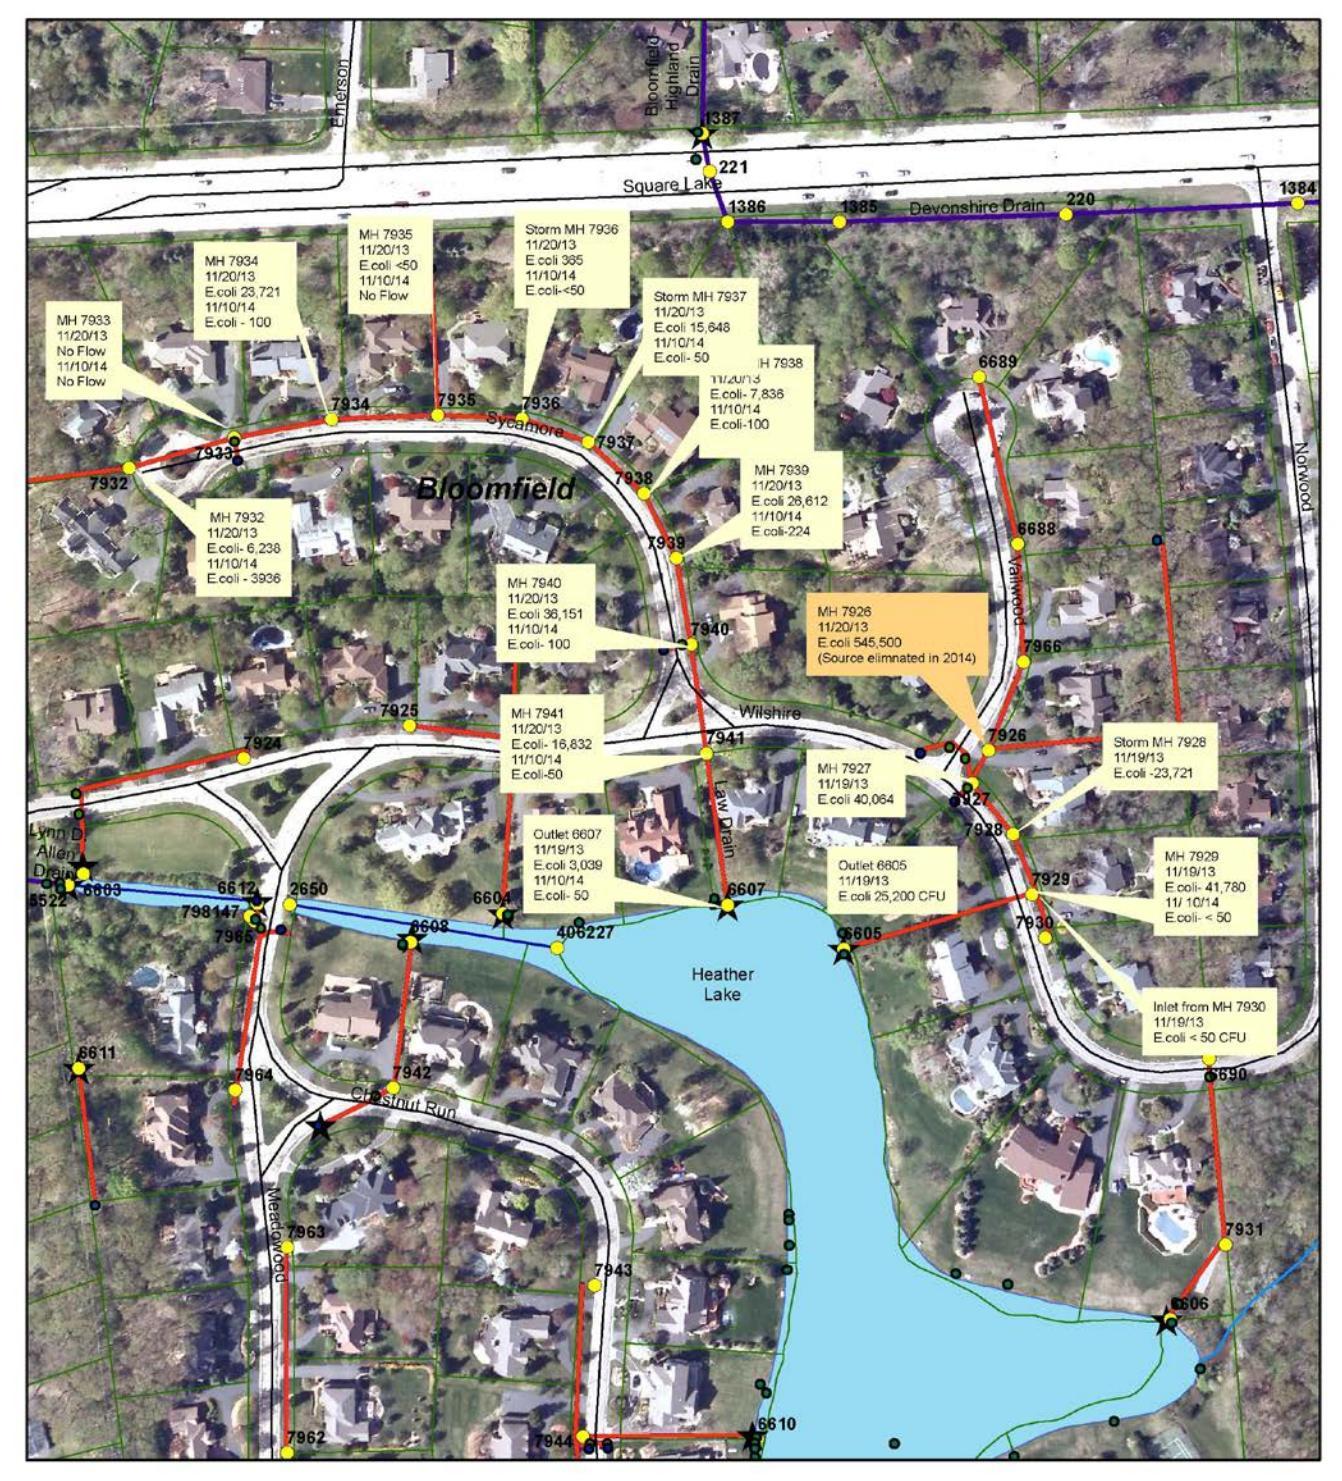
Figure 6: Law Drain Sampling Results

The 2014 sampling on Wilshire St. at manhole 7929 showed *E. coli* concentrations of less than 50 cfu/100 mL and upstream manhole inspections found no trace of sanitary debris (See Figure 6). Therefore, it is believed that the correction on Vailwood St. resolved issues found in 2013. There is no need for further investigation on this segment of the drain.

It is recommended that outlet of the Law Drain on Sycamore St. be put back on the list of drains for periodic monitoring under WRC's IDEP program. Subsequent dry weather screening inspections and *E. coli* data will be used to determine if any additional investigation activities are necessary.

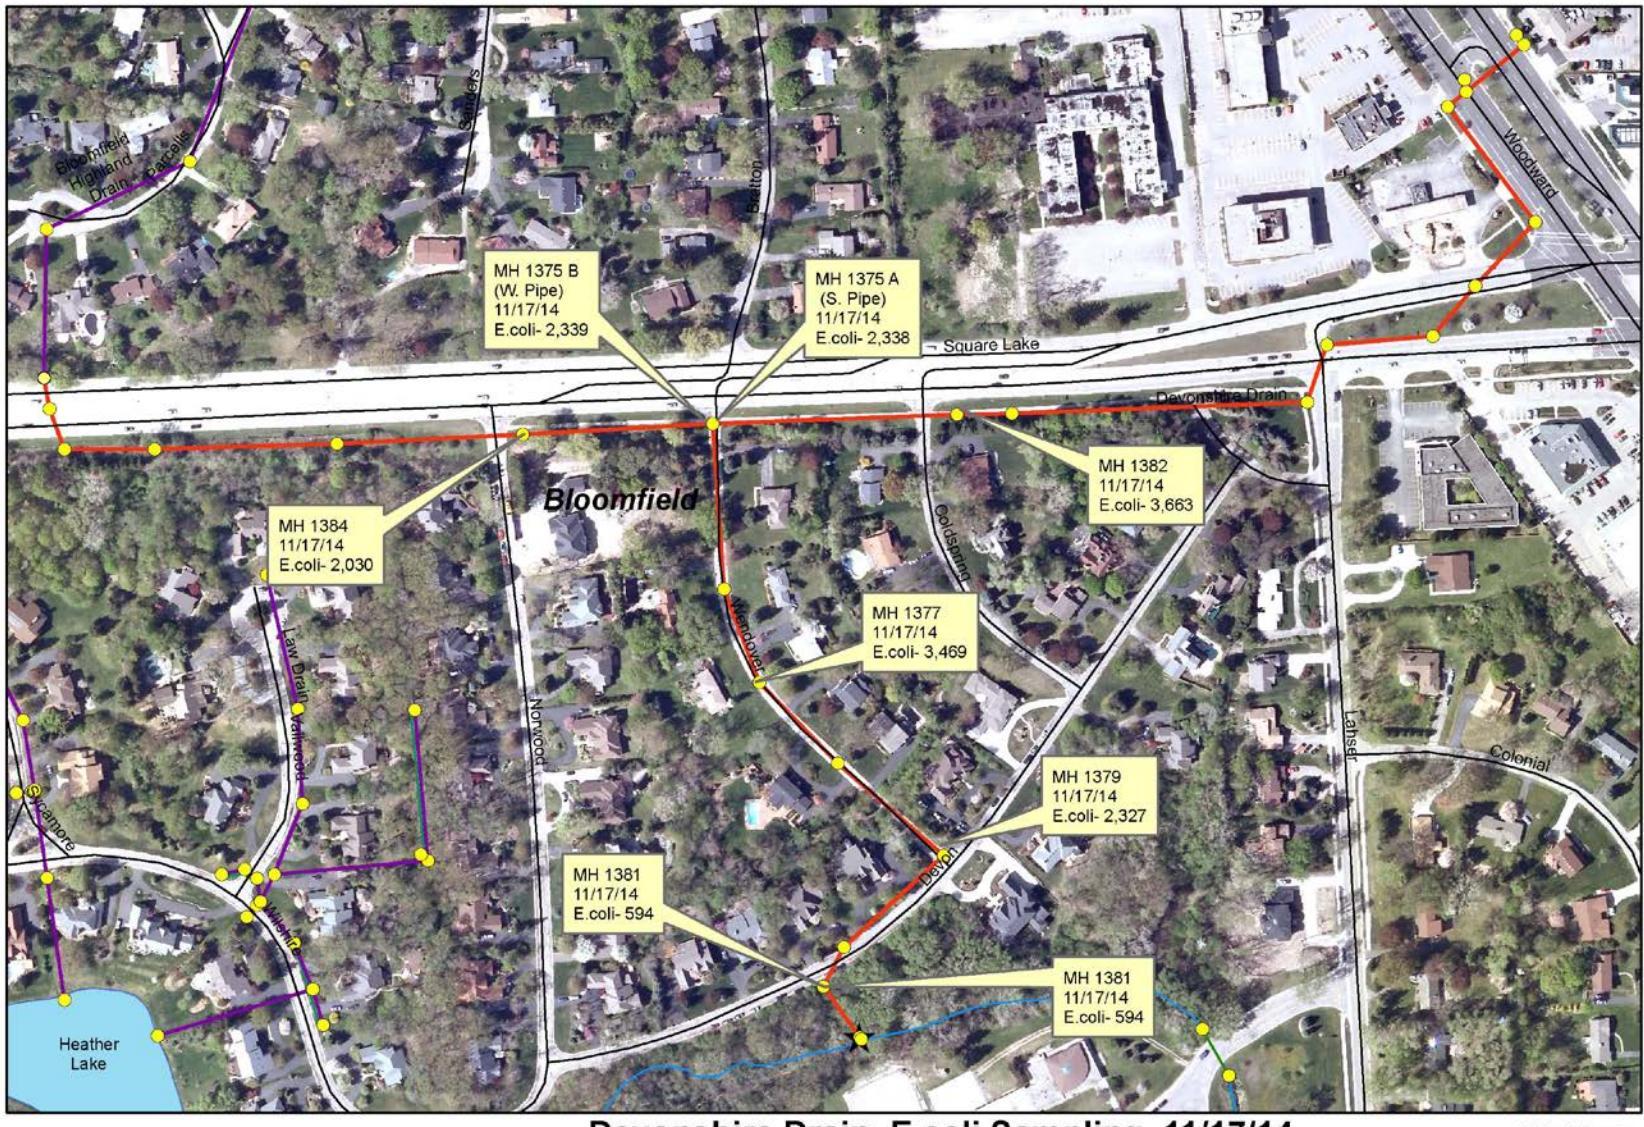
All samples exhibited moderately high *E. coli* concentrations between 2,030 cfu/100 mL and 3,666 cfu/100 mL as shown in Figure 7. However, no physical evidence of sanitary sewage (i.e., floatables, solids, color, odor, etc.) was observed. The presence of an illicit discharge cannot be ruled out. Additional upstream locations further east near Woodward Ave. and further west near the Bloomfield Highlands Drain confluence need to be evaluated to determine if additional IDEP investigation work is necessary.

- Select additional upstream sampling locations and schedule dry weather screening inspections and *E. coli* sampling; and
- Evaluate additional screening and sampling data and conduct IDEP investigations as necessary to locate discharges sources based on results.

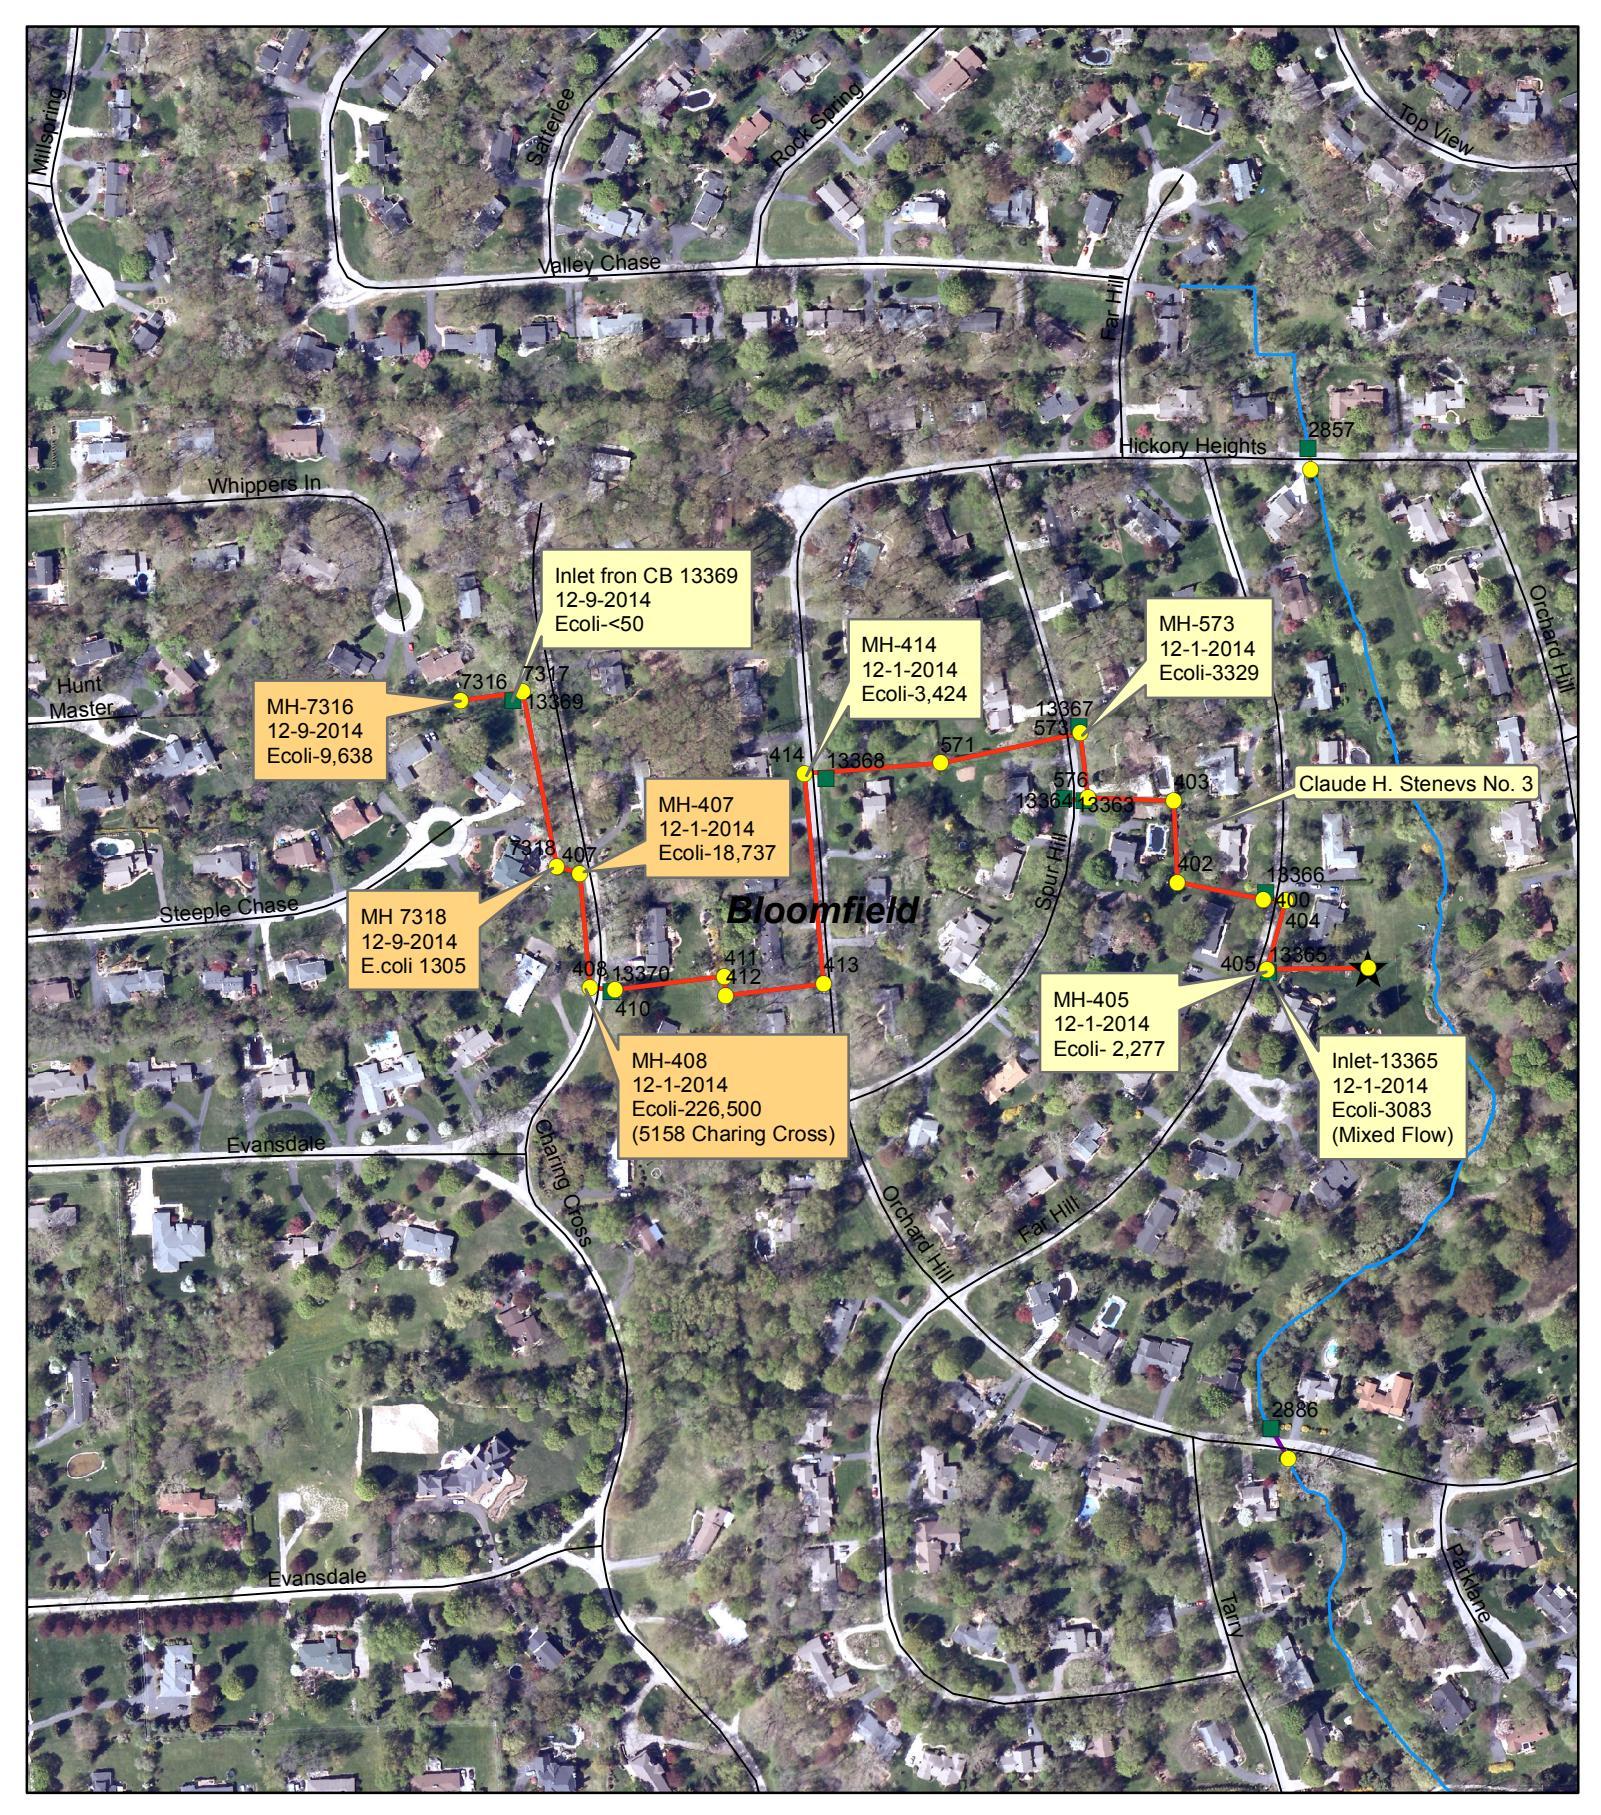
Claude H. Stevens No. 3 E.coli Sampling 12/1/2014 & 12/10/ 2014 Bloomfield Twp.

The Claude H. Stevens No. 3 Drain was inspected and sampled for *E. coli* at the first upstream manhole and at manholes located at upstream road crossings. All manholes indicated elevated *E. coli* counts with the highest being manhole 408 (226,500 cfu/100 mL) as shown in Figure 8. High *E. coli* and physical evidence of sewage at this location (floatable, suds, solids) indicated a likely illicit discharge. Inspections of manholes upstream of this location did not find any physical evidence of sanitary sewage. However, the presence of flow and elevated concentrations of *E. coli* indicated that there is a possible illicit connection with an intermittent discharge upstream of manhole 408. This illicit connection is potentially coming from a property(ies) on Charing Cross Rd. or from the surrounding subdivisions on Whippers Lane, Hunt Master St. or Steeple Chase St. It should be noted that manhole 7316 is the upper terminus manhole for the County Drain system and local storm drainage is connected to the west of this location. Bloomfield Township was contacted and indicated that subdivisions to the west of Charing Cross are private and that storm drainage is either privately owned or under the jurisdiction of the Rd. Commission for Oakland County (RCOC). RCOC was contacted and is in the process of obtaining storm drain plans for these subdivisions.

- Obtain local storm plans for subdivisions on Whippers Lane, Hunt Master St., and Steeple Chase St. from RCOC to determine extent of the drainage systems and storm manhole locations;
- Perform upstream investigation and sampling of upstream manholes to isolate potential segments of the drains with illicit connections;
- Conduct CCTV inspections on Charing Cross and portions of local storm drains based on additional inspections and sampling in order to locate potential illicit connections;
- Dye test suspect properties with connections to confirm illicit discharges; and
- Follow up with homeowners, Bloomfield Twp. and RCOC for corrective actions.

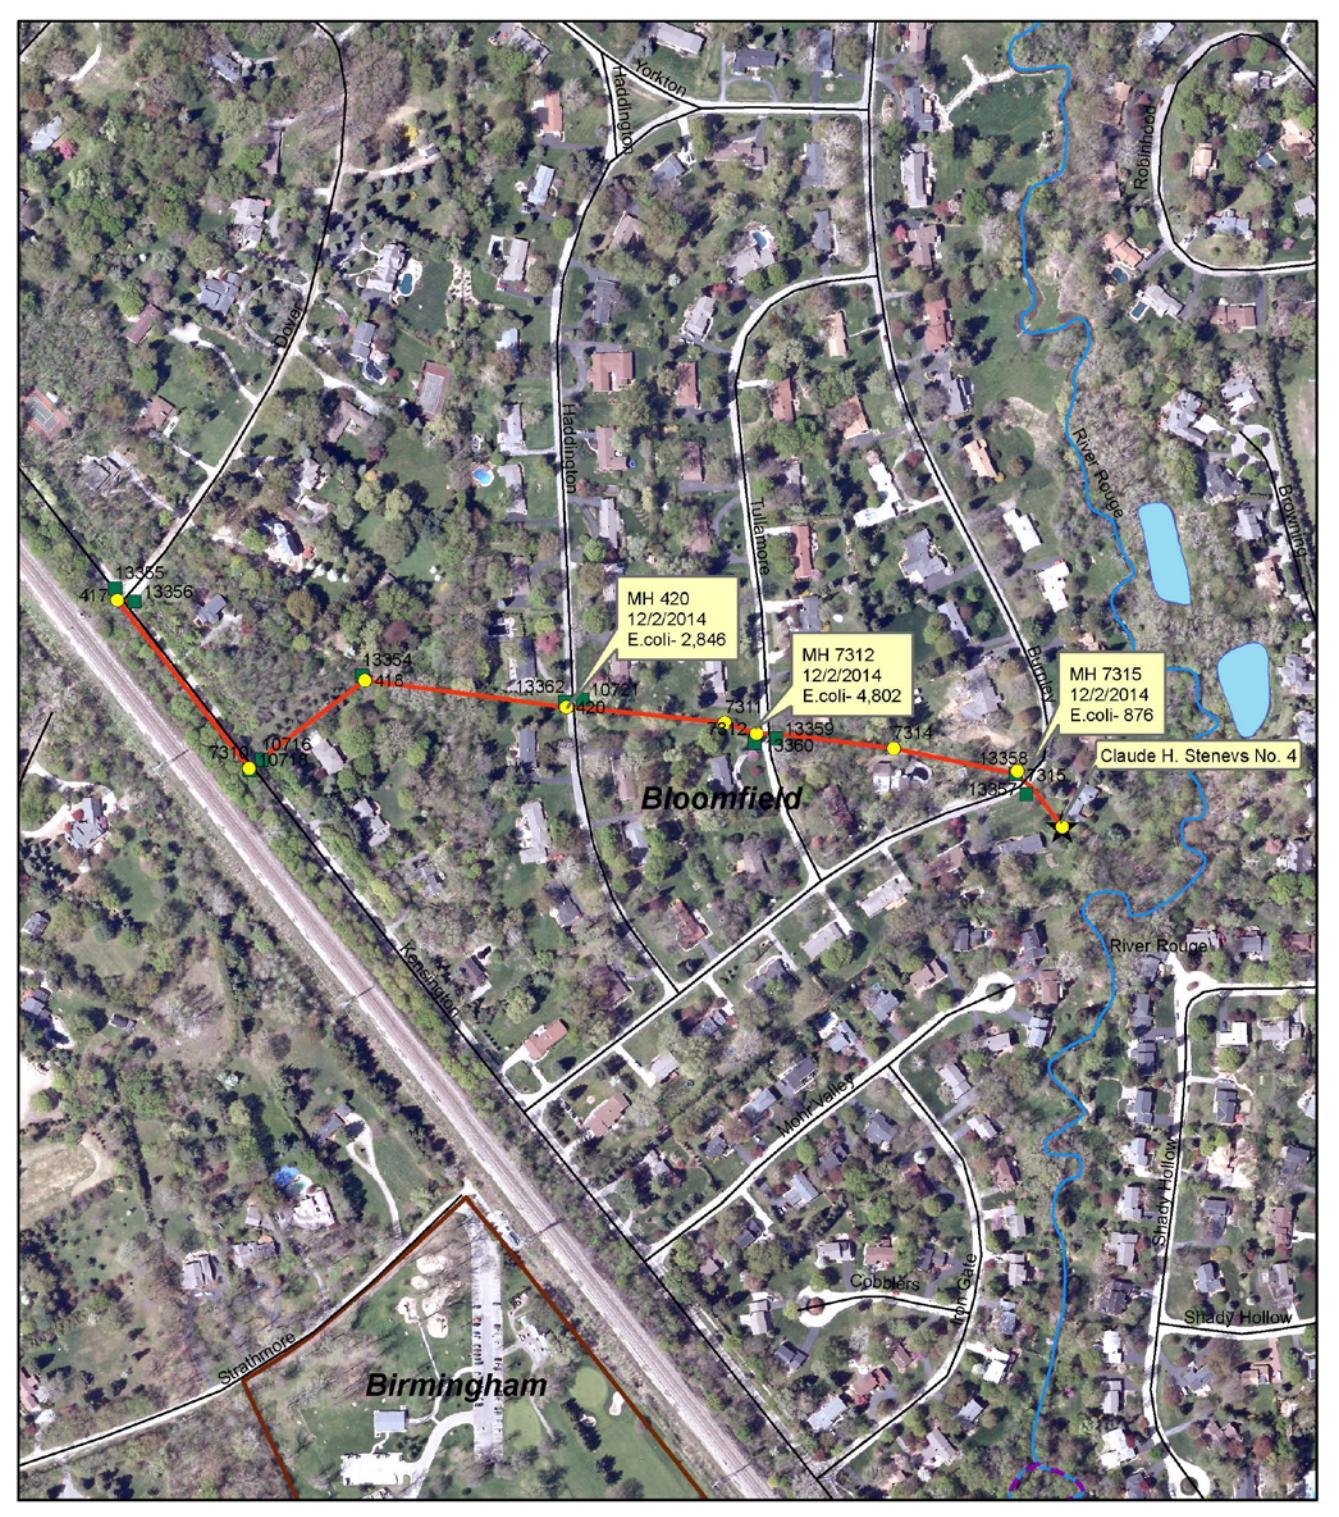
Claude H. Stevens No. 4 E.coli Sampling 12/1/2014 Bloomfield Twp.

The Claude H. Stevens No. 4 Drain was inspected and sampled for *E. coli* at the first upstream manhole location and manholes located at Tullamore and Haddington streets. All manholes had elevated *E. coli* counts ranging from 876 cfu/100 mL to 4,802 cfu/100 mL as shown in Figure 9. Inspections of manholes did not find any other physical evidence of sanitary sewage in the drain. Manholes along Kensington were not sampled due to their location in the roadway and concerns of working in a lane of traffic. Based on results it is inconclusive as to whether the drain is receiving illicit discharges, but the possibility cannot be ruled out.

- Additional investigations should be conducted along Kensington and any upstream local storm drains to determine if an illicit discharge is occurring, and
- Conduct follow up illicit discharge investigations as needed based on inspections and sampling results.

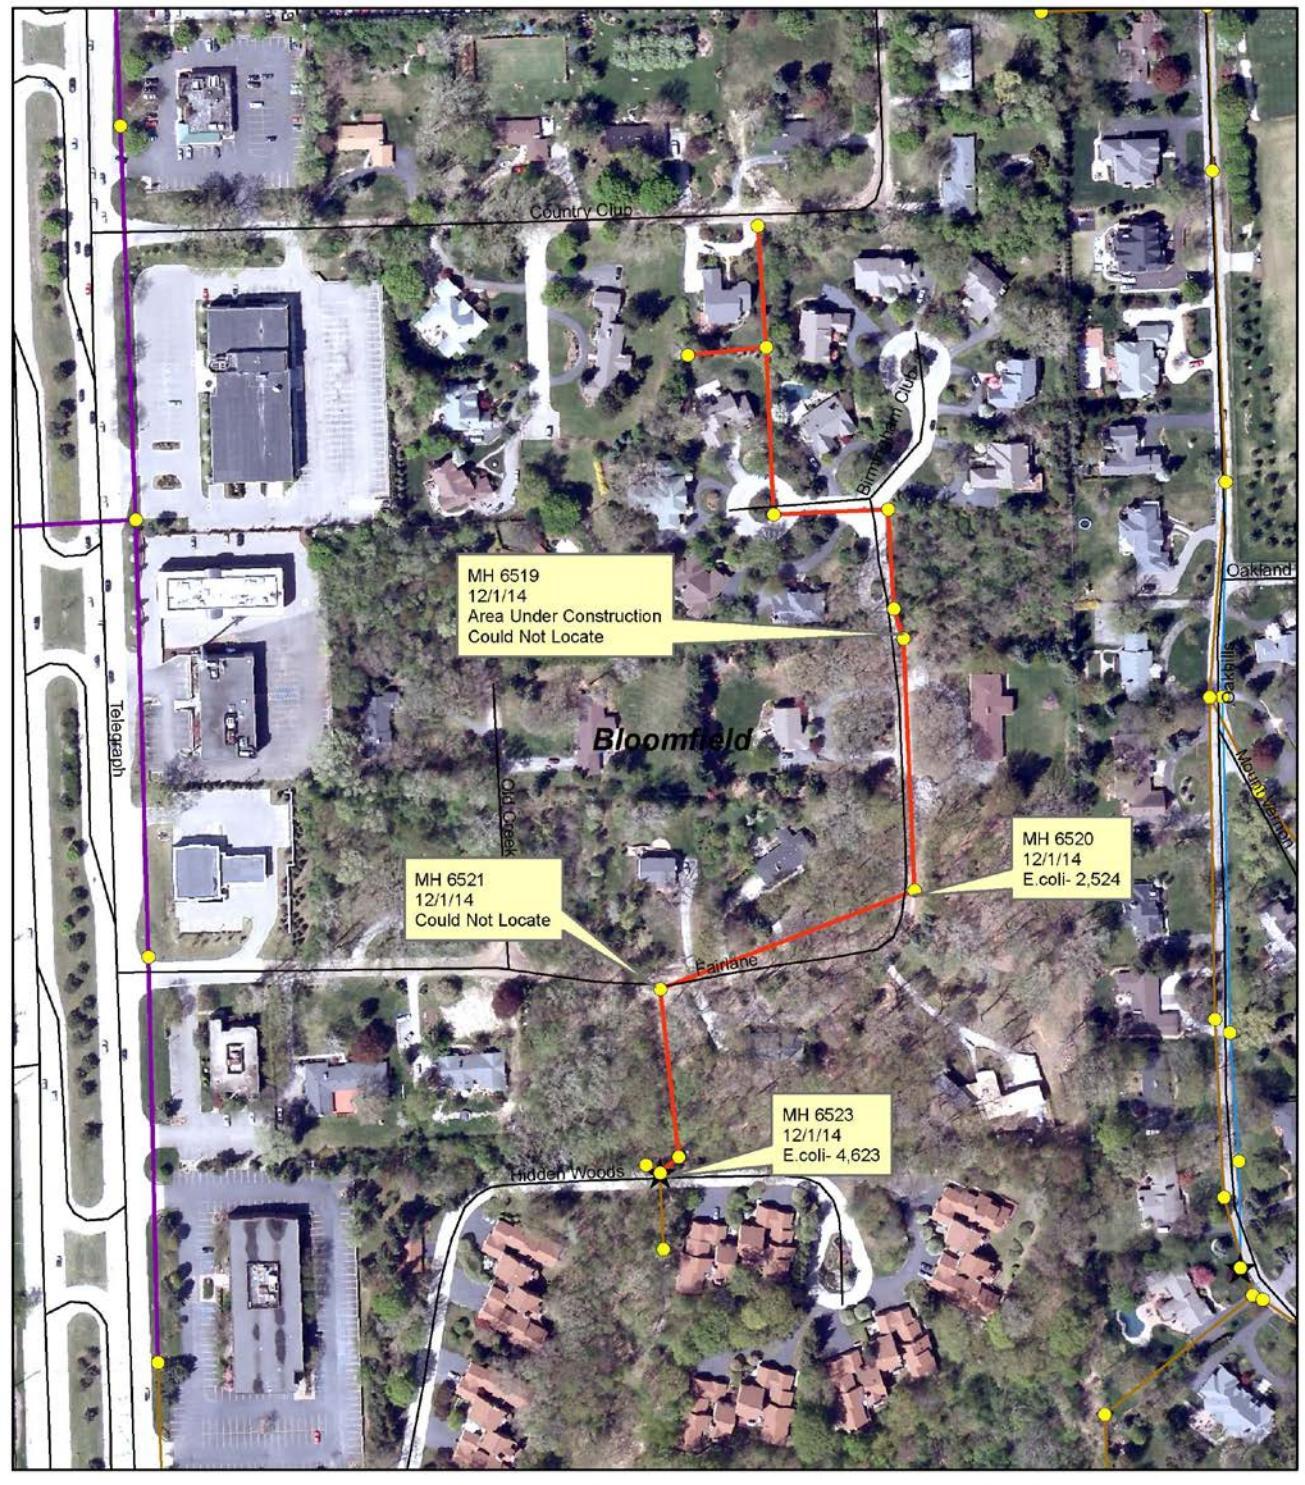
Claude H. Stevens No.10 Drain, E.coli Sampling, 12/1/14 Bloomfield Twp.

The Claude H. Stevens No. 10 Drain was investigated and sampled for *E. coli* on December 1, 2014. Results of sampling showed *E. coli* concentrations of 4,623 cfu/100 mL and 2,524 cfu/100 mL as shown in Figure 10. Although these counts are elevated, they are not extremely high. The lack of the physical evidence of sanitary sewage makes it inconclusive as to whether or not a sanitary discharge is occurring. It should be noted that additional manhole locations on Fairlane could not be located as multiple properties and the storm drainage system in this area are currently under development.

- Obtain updated storm drain plans from Bloomfield Township, and
- Schedule additional IDEP investigations and sampling of the drain.

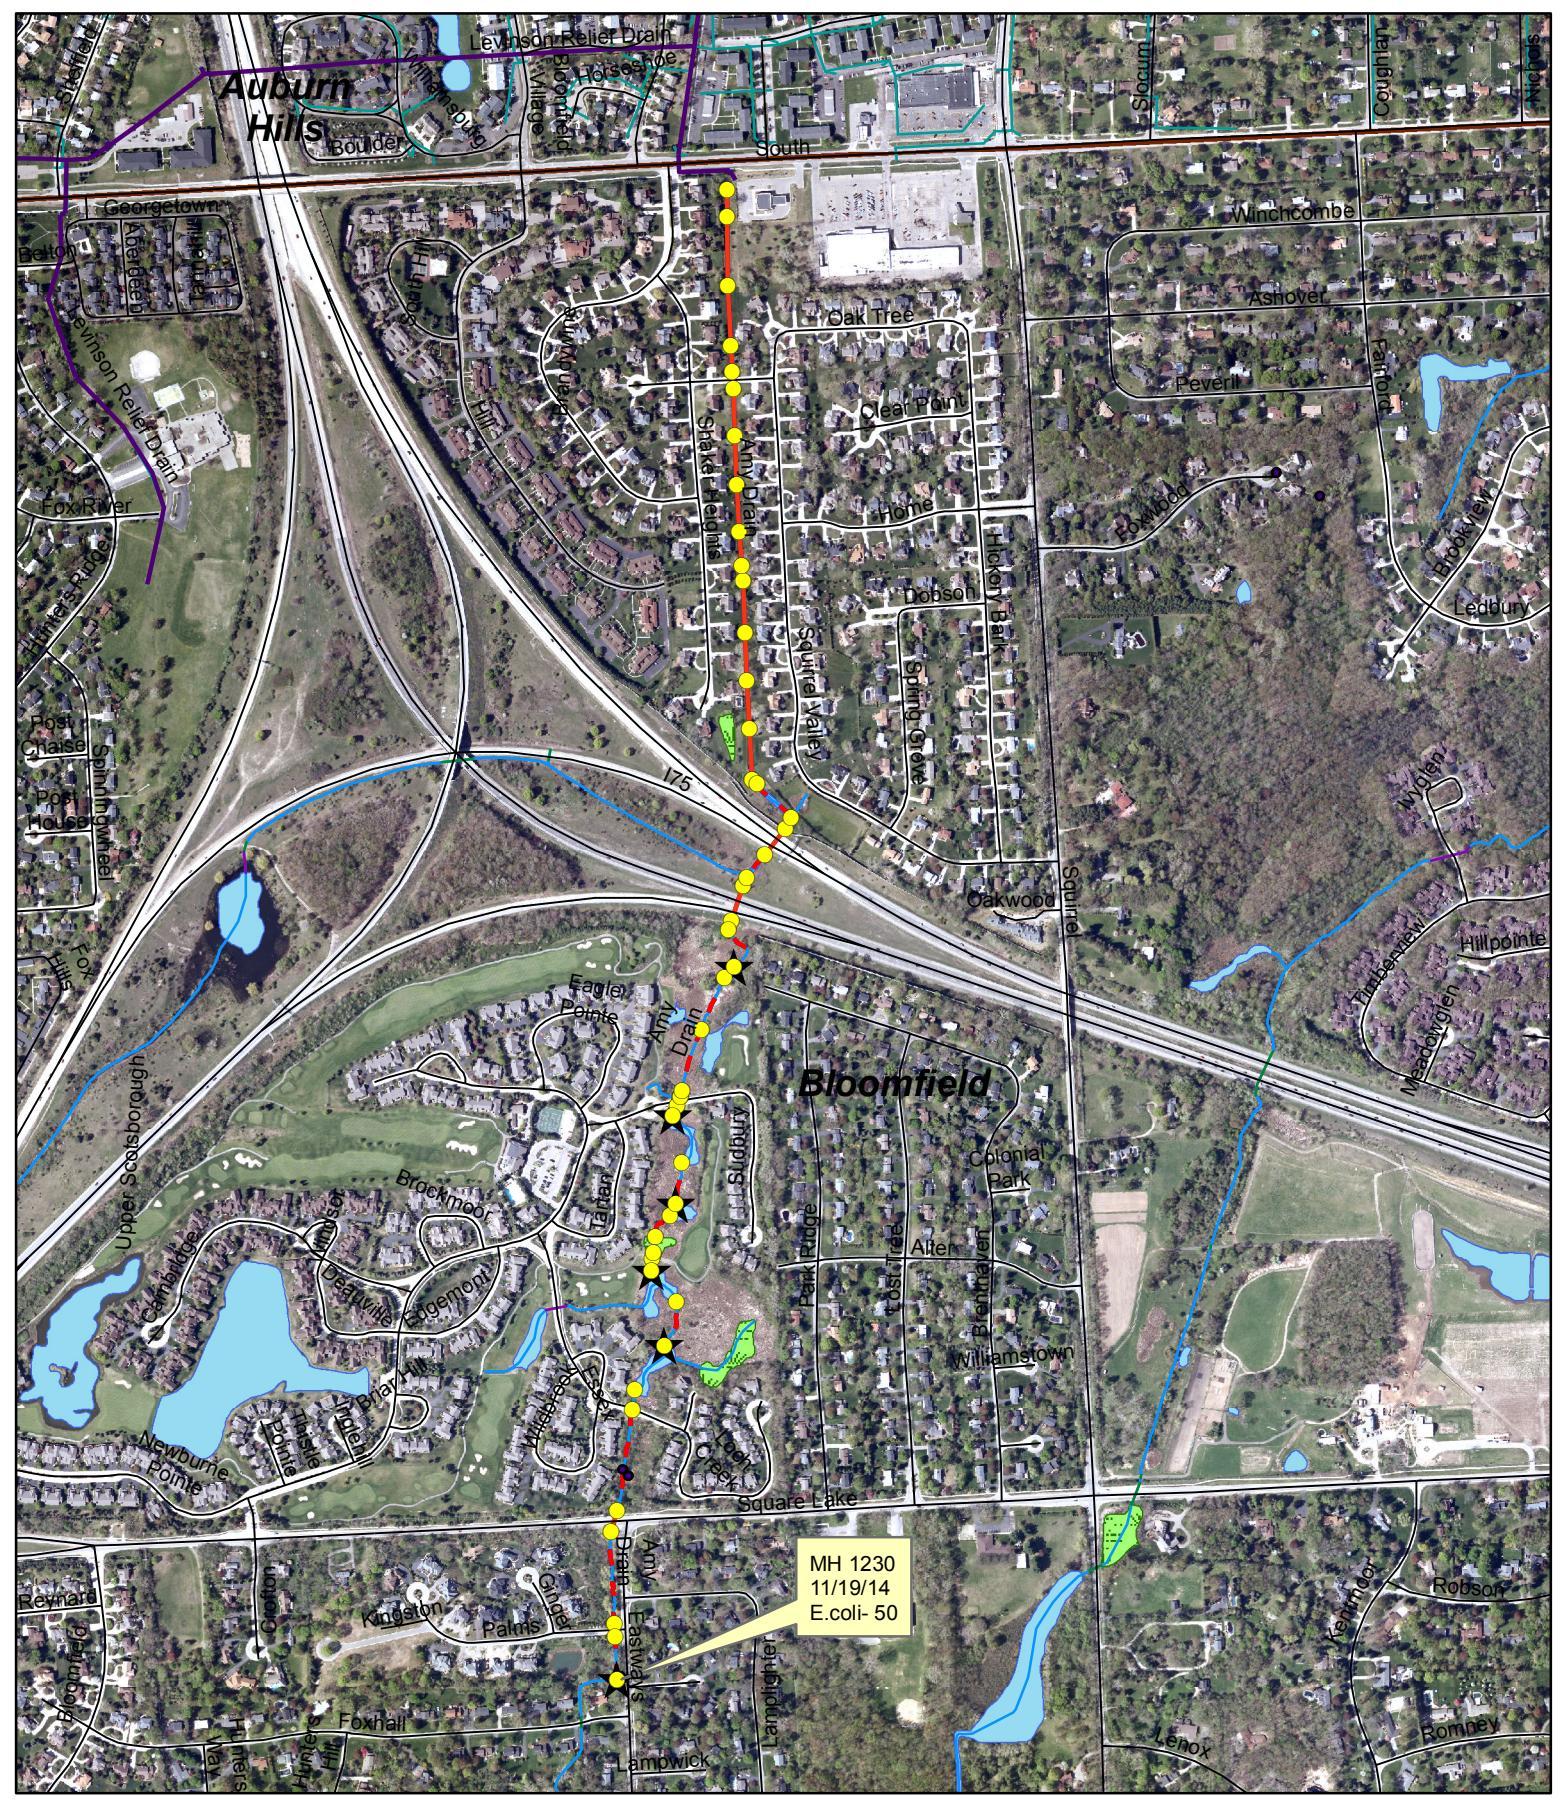
Amy / Dan Devine Drain, E.coli Sampling, 11/19/14 Bloomfield Twp.

Results of inspections did not find any physical evidence of sanitary sewage and *E. coli* concentrations did not indicate that any of these drains are a cause for concern with regards to illicit discharge sources. No additional investigations on these drains were conducted. See Figures 11-16 for locations of drains and sampling results.

It is recommended that no further investigations be conducted on the Amy/Dan Devine, Lynn D. Allen, Nichols, Wagner, McClung and Townline drains. However, the drains should be part of the periodic monitoring schedule under WRC's IDEP Program.
