# Danvers Pond Dam Removal and Stream Restoration Project

## Great Lakes Restoration Initiative Grant Final Report

US EPA Contract Number E-00639

December, 2012

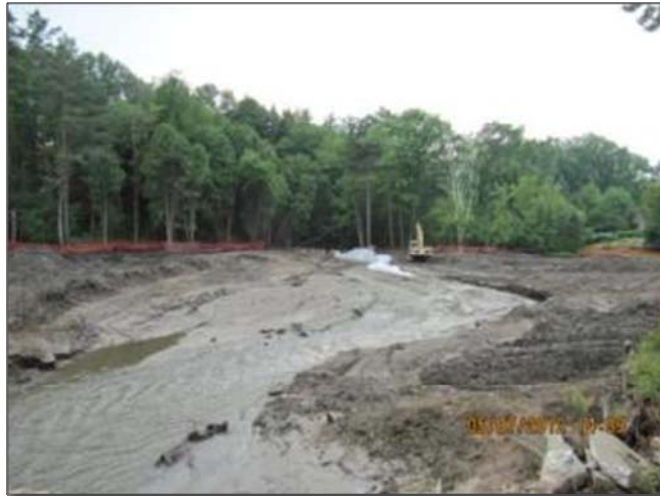
**July, 2012-** Late July 4/ early July 5 an intense rain event occurred at the project site. The river flow rose considerably, the bypass flume was plugged with logs and debris and the river flowed through the site temporarily.

**Water flow through site**

Once onsite, the contractor isolated the flow using sandbags and started pumping from upstream of the cofferdam across the site and into the culvert at Danvers Drive. Additional sheet piling was installed at both ends of the cofferdam and the banks were restored.

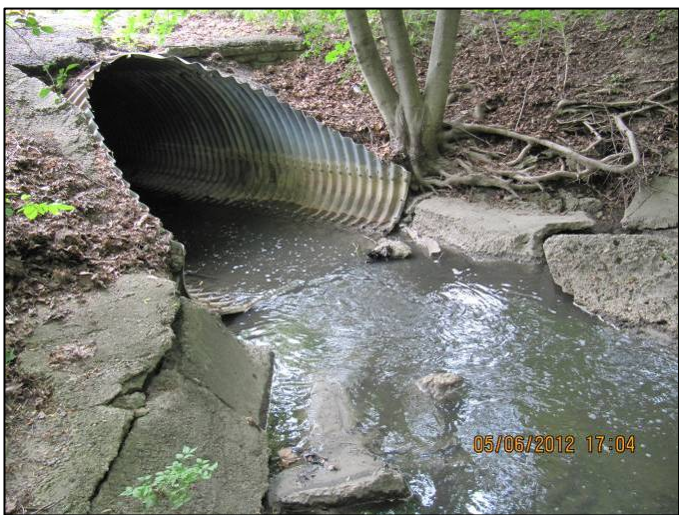
**June 5, 2012:**  
Water flowing from pond

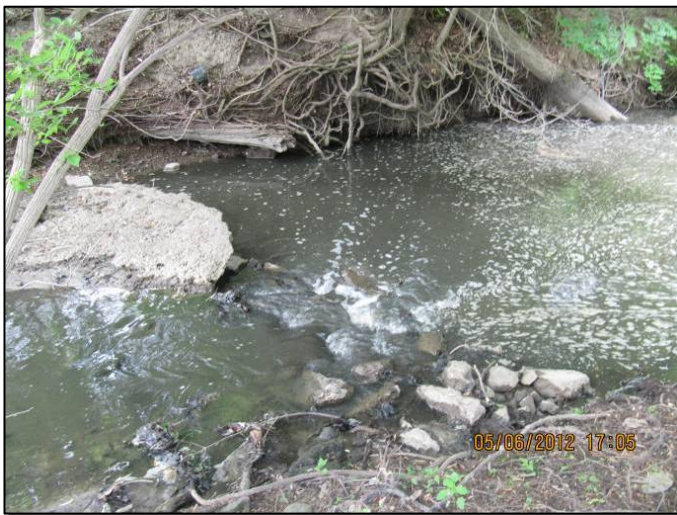
**June 5, 2012:**  
Small rapids immediately downstream of dam

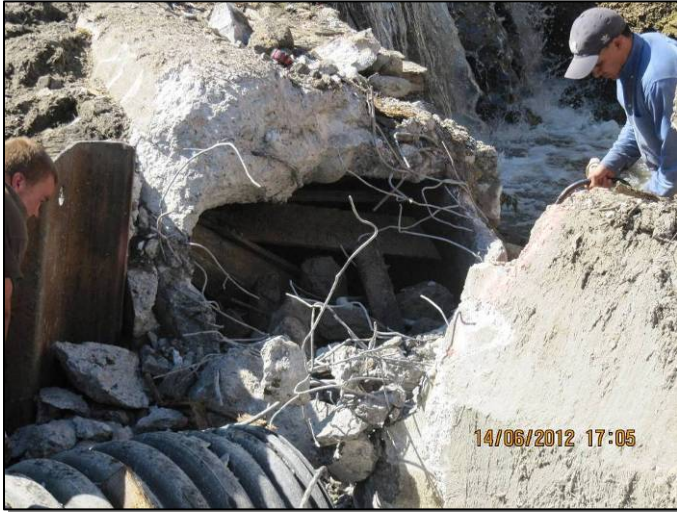
**June 14, 2012:**

Dam appears to have been constructed from manhole structures turned on their sides

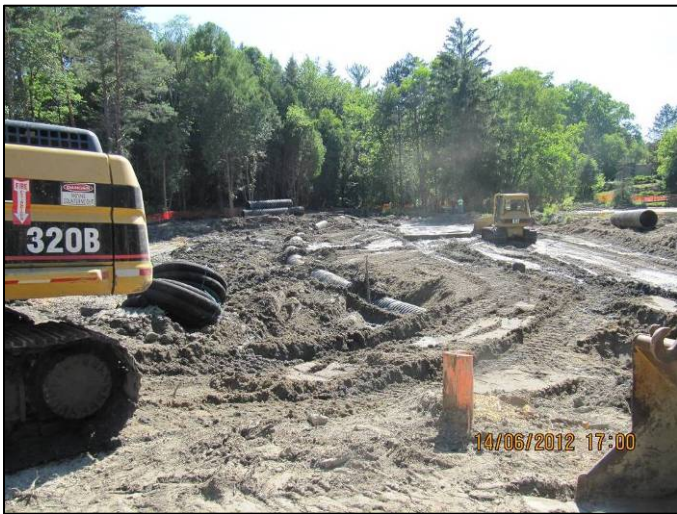
**June 14, 2012:**

View south across pond. The bypass pipe has been placed

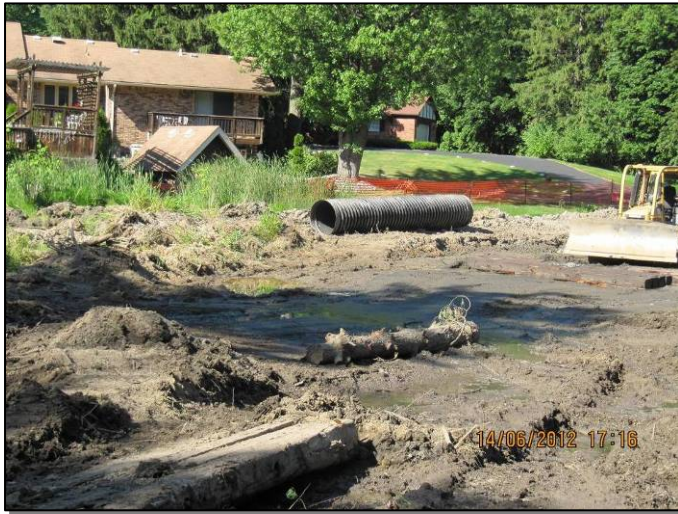
**June 14, 2012:**  
Temporary dam

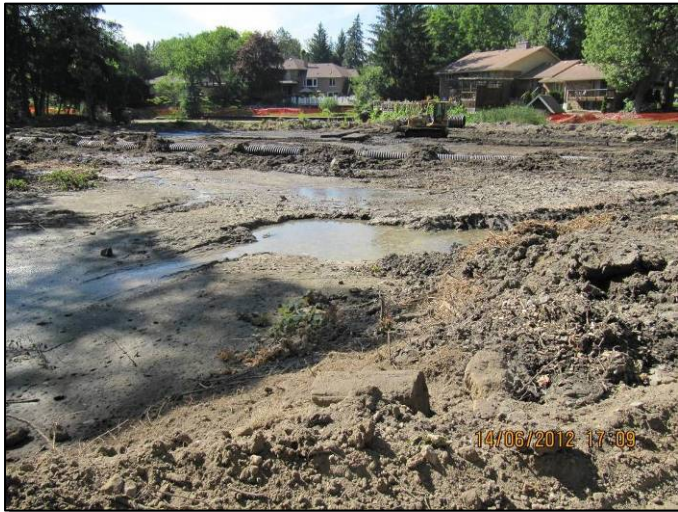
**June 14, 2012:**  
Groundwater surfacing

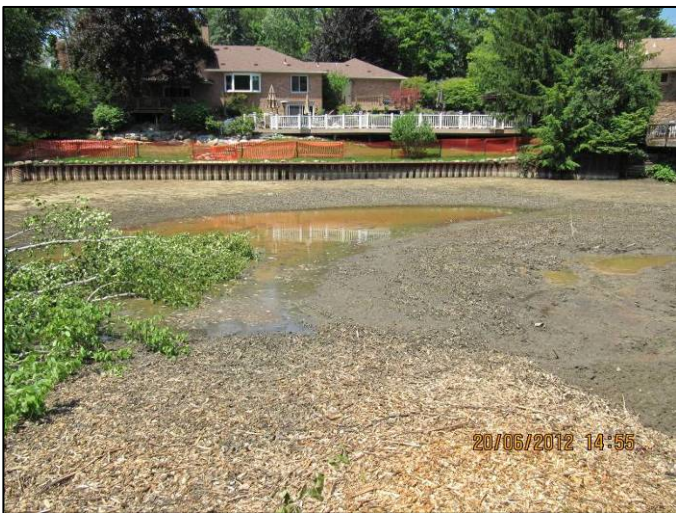
**June 20, 2012:**  
Water exiting bypass pipe

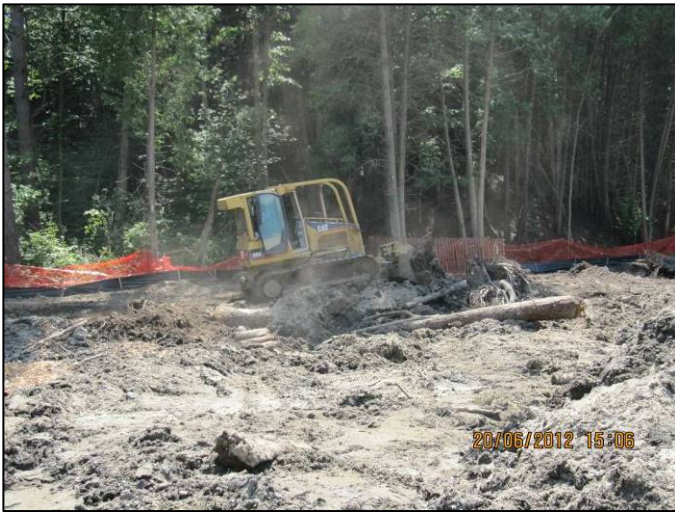
**June 20, 2012:**  
Groundwater surfacing as channel is being excavated

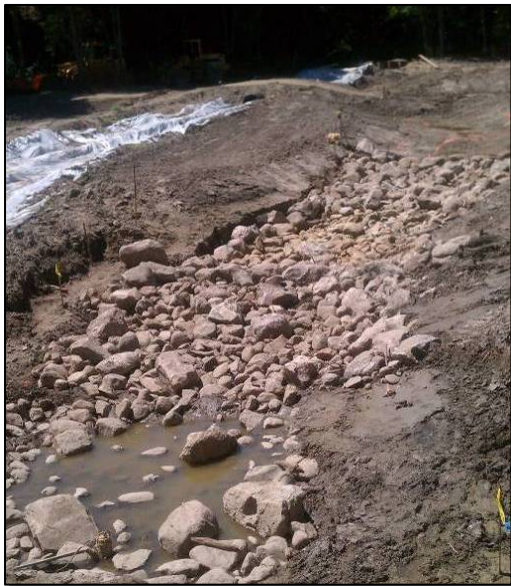
**July 30, 2012:**  
North end of site, placing rock  
aprons

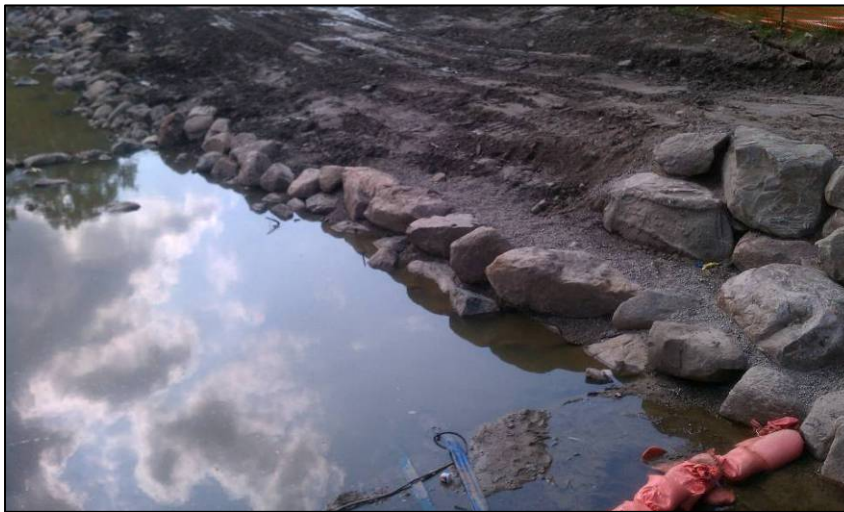
**August 15, 2012:**  
North boulder wall

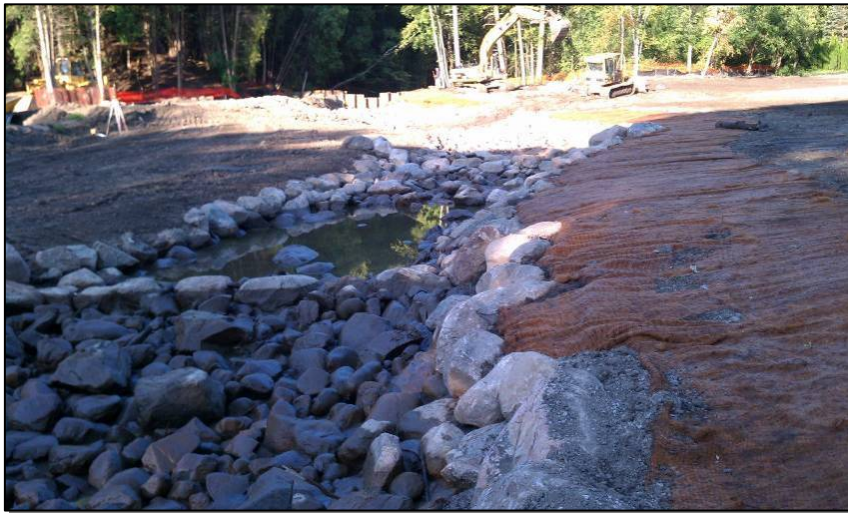
**August 15, 2012:**  
North boulder wall

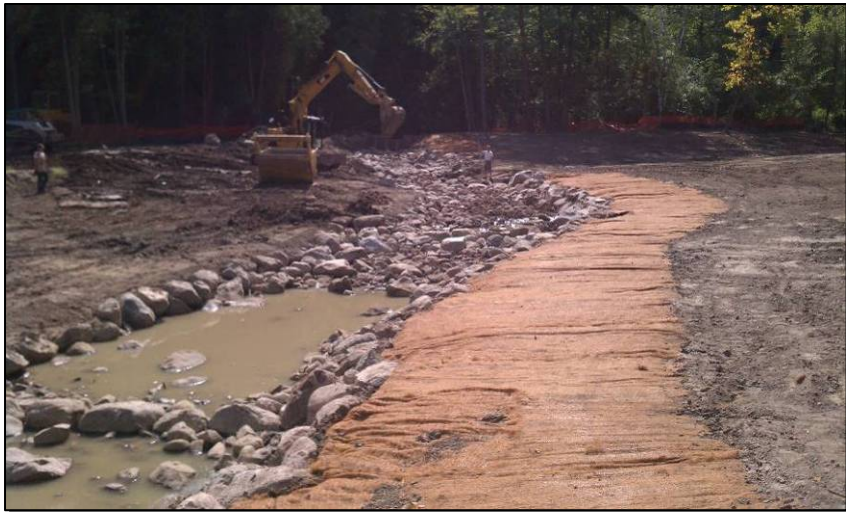
**August 20, 2012:**  
North end of site, looking  
northwest

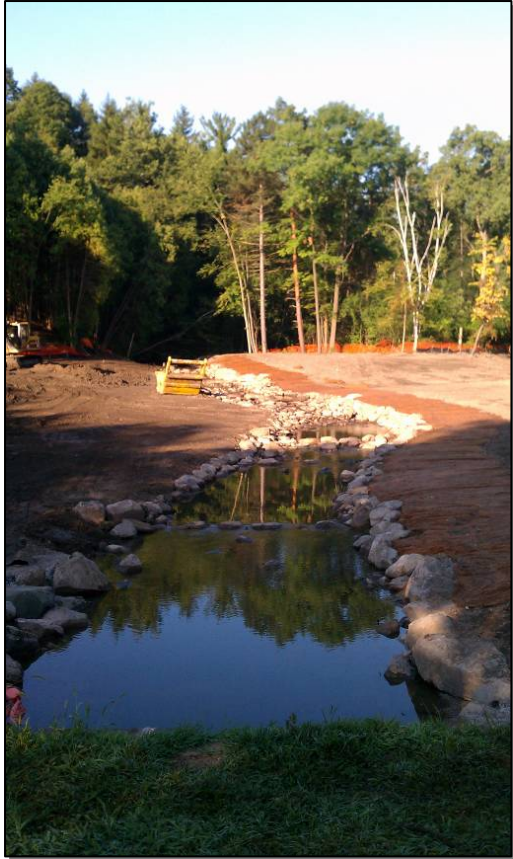
**August 22, 2012:**  
Riffle/pool 5

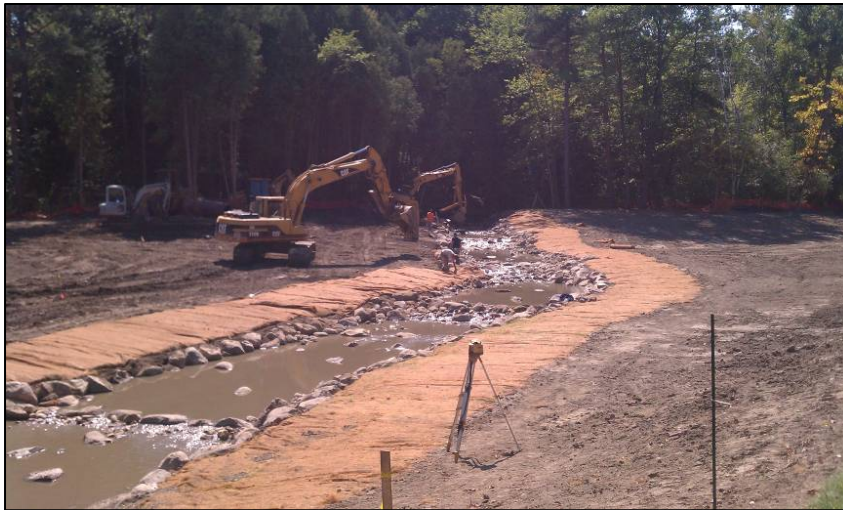
**August 22, 2012:**  
Swale near north storm water  
outfall

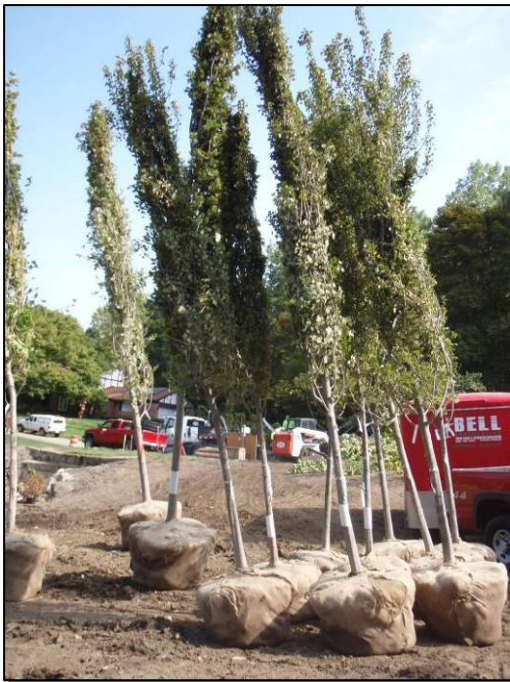
**September 6, 2012:**  
Tree and shrub delivery

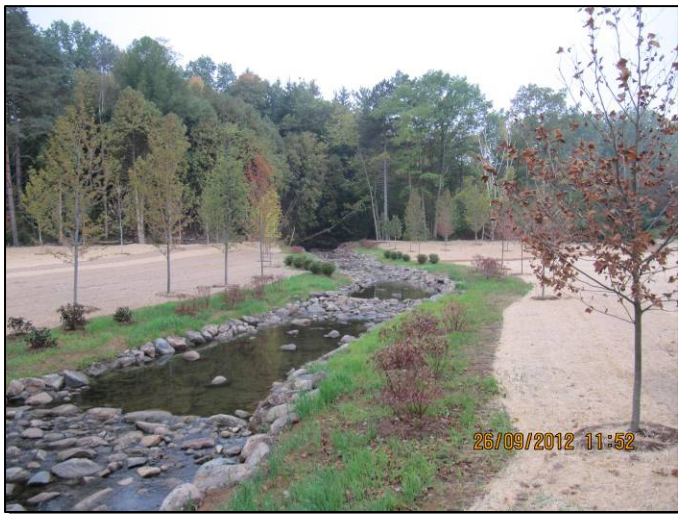
**September 18, 2012:**  
Erosion Control Blanket

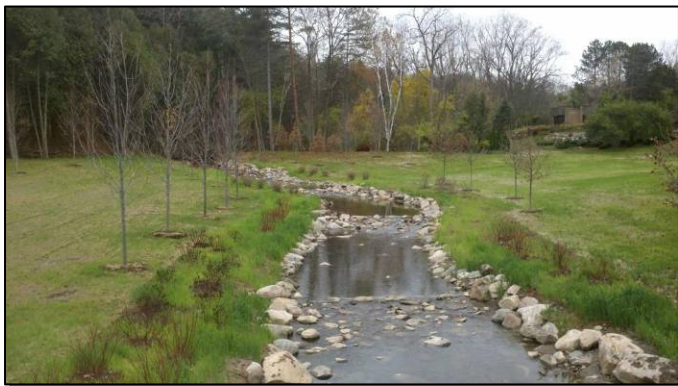
**September 26, 2012:**  
Restored Site
